# Move Out

1883 W Creek Ct, Nampa, ID 83686, US

2019-01-31

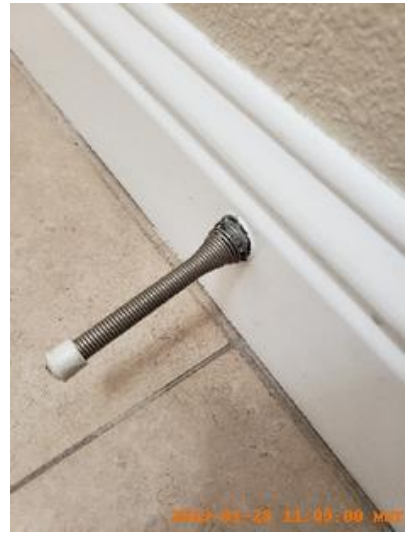
| Entry: Entry Way | CONDITION | ACTION | COMMENTS |
|---|---|---|---|
| Other | - - - D | None | door stop is stretched out, closet door in the entry way has a hole from the door stop, door trim is damaged |

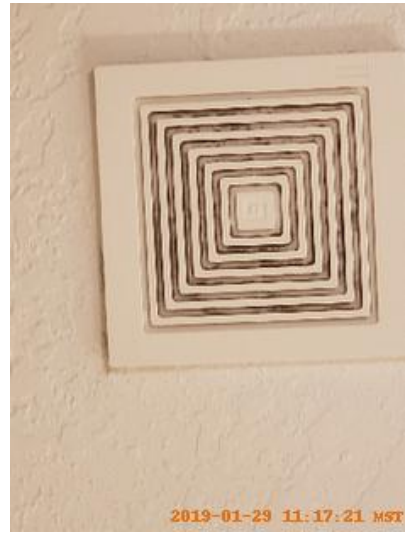
| Bathroom 1: Master Bath #1 | CONDITION | ACTION | COMMENTS |
|---|---|---|---|
| Exhaust Fan | - - - D | None | Dirty |

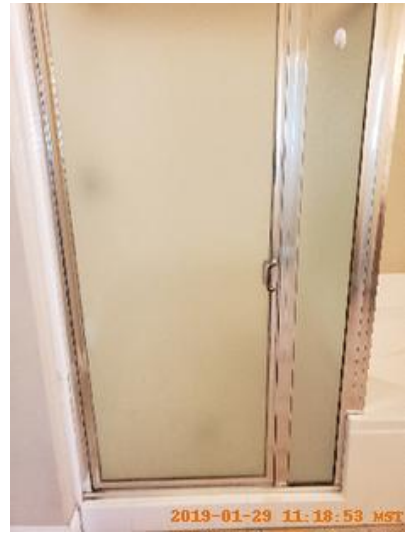
| Bathroom 1: Master Bath #1 | CONDITION | ACTION | COMMENTS |
|---|---|---|---|
| Shower Door/Rail/Curtain | - - - D | None | Command hook on shower glass,<br>shower door has hard water<br>spots |

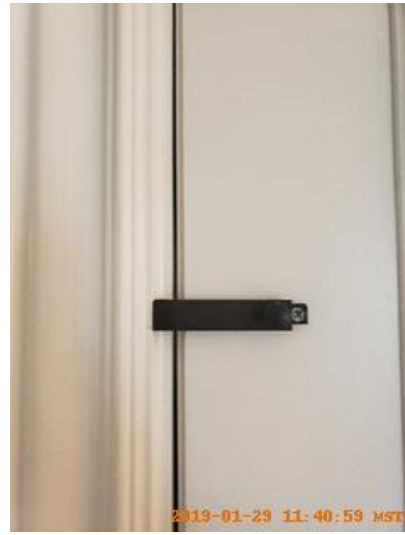
Door/Knob/Lock  
Taken on: 2019-01-29 11:40:59  
Taken at: [43.56523398, -116.60388778](#)  
[Image](#)

| Door/Knob/Lock | - - - D | None | - Door that leads to the outside, weather stripping is damaged, sliding lock on door - Door that lease from bedroom to bath is scratched |

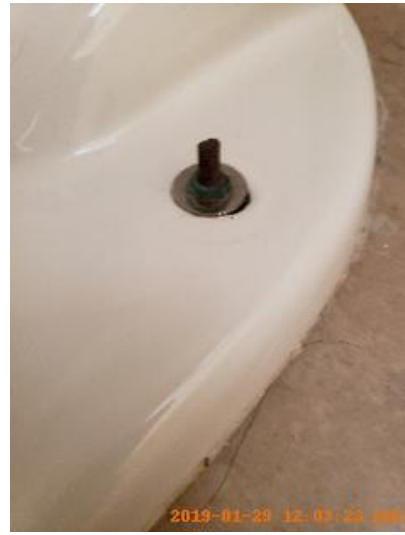
| Toilet | - - - D | None | on bottom of toilet white cap is missing showing exposed screw |

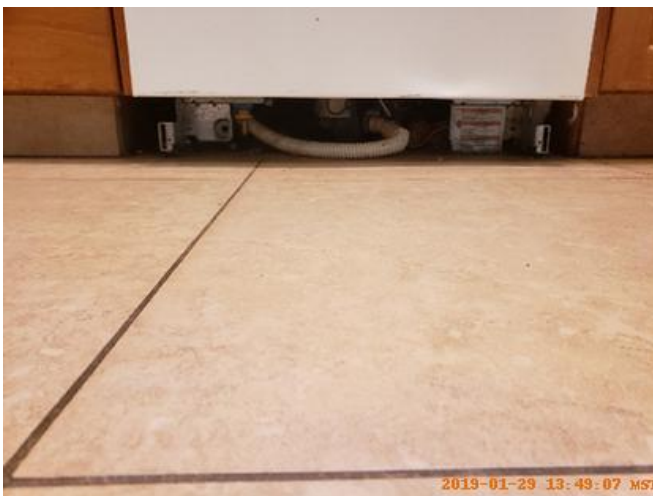
| Kitchen: Kitchen | CONDITION | ACTION | COMMENTS |
|---|---|---|---|
| Dishwasher | - - - D | None | dirty, below dishwasher the kick plate is missing |

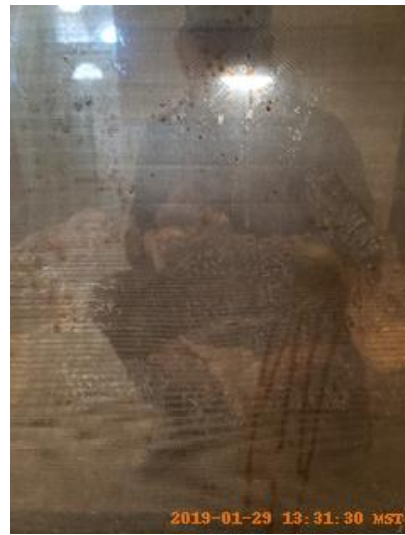
Other  
 Taken on: 2019-01-29 13:31:30  
 Taken at: [43.56528857, -116.60384607](#)  
[Image](#)

| Fireplace/Chimney: Fireplace | CONDITION | ACTION | COMMENTS |
|---|---|---|---|
| Other | - - - D | None | unknown substance on glass and screen |
