, Meridian, ID 83642 Move Out  
2019-11-01

## Move Out Condition Summary

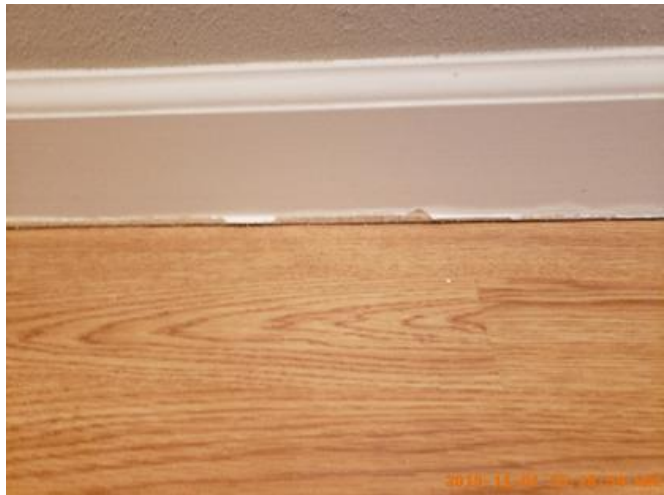
Flooring/Baseboard

| Entry | CONDITION | ACTION | COMMENTS |
|---|---|---|---|
| Flooring/ Baseboard | - - - D | None | chip paint on baseboard |

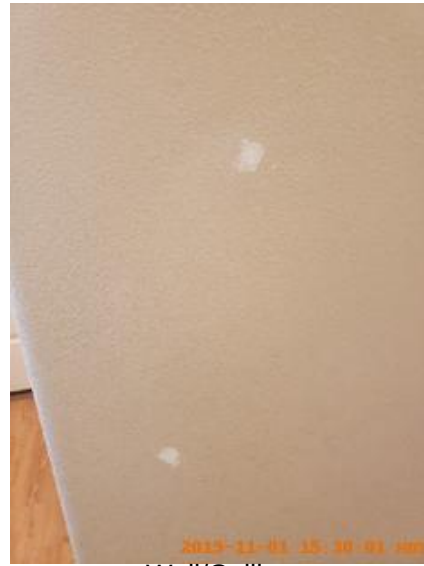
Wall/Ceiling

| Entry | CONDITION | ACTION | COMMENTS |
|---|---|---|---|
| Wall/ Ceiling | - - - D | None | patched but not painted or texture holes in wall, banister has paint on it, owner would like the holes texture |

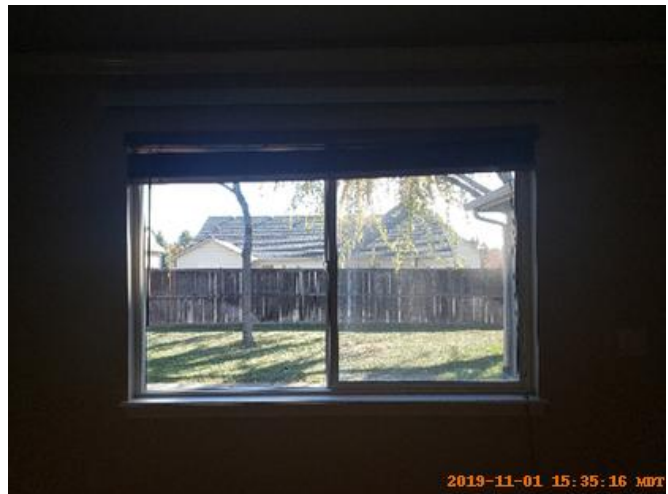
Window/Lock/Screen

| Family Room | CONDITION | ACTION | COMMENTS |
|---|---|---|---|
| Window/ Lock/ Screen | - - - D | None | screen is worn |

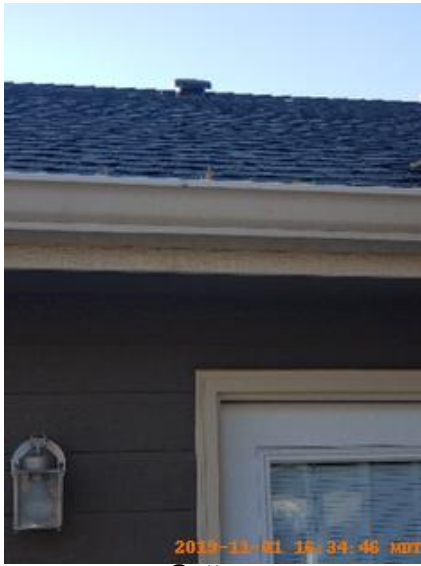
| Roof | CONDITION | ACTION | COMMENTS |
|---|---|---|---|
| Gutters | - - - D | None | debris in gutters |

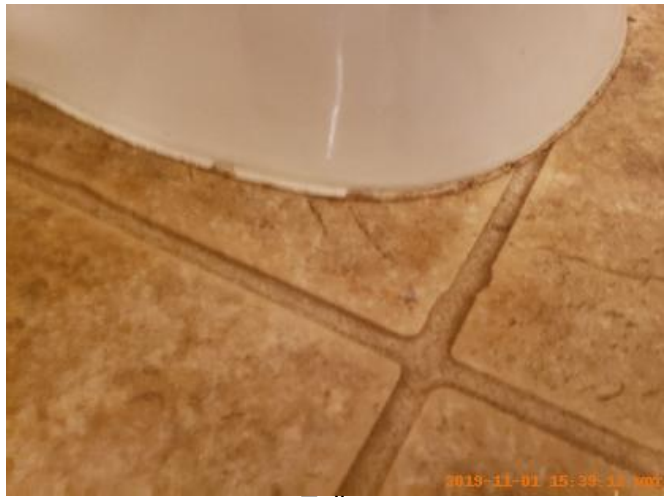
| Bathroom 1: bathroom1 | CONDITION | ACTION | COMMENTS |
|---|---|---|---|
| Toilet | - - - D | None | caulking around toilet is cracking and peeling |

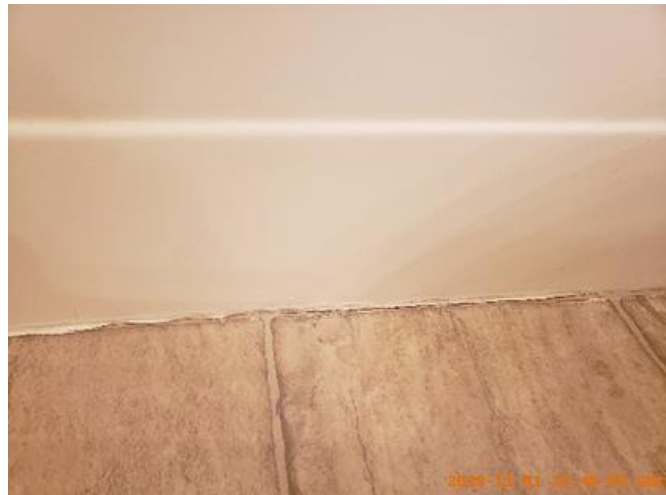
Tub/Shower

| Bathroom 2: bathroom2 | CONDITION | ACTION | COMMENTS |
|---|---|---|---|
| Tub/ Shower | - - - D | None | caulking around tub on floor is cracking and peeling |

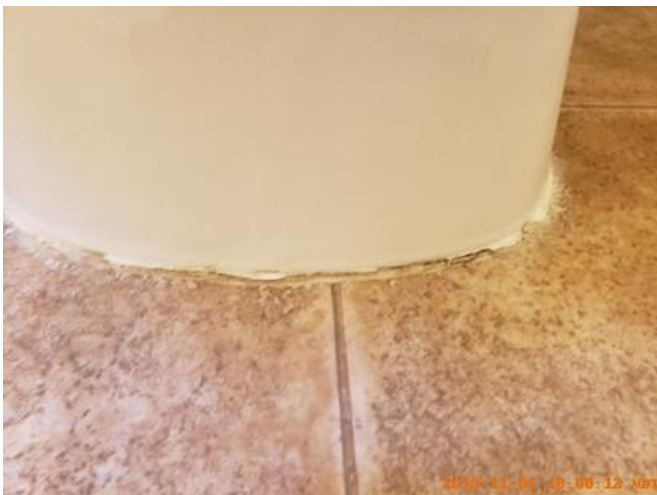
| Toilet | - - - D | None | caulking around toilet is cracking and peeling |

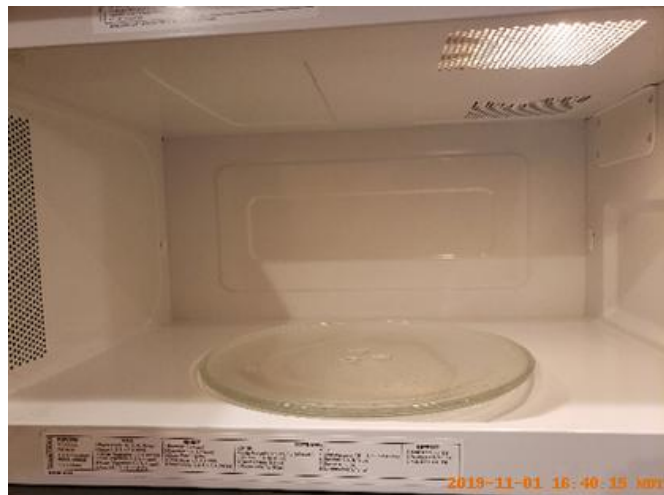
| Kitchen | CONDITION | ACTION | COMMENTS |
|---|---|---|---|
| Microwave | - - - D | None | cracks on microwave door |

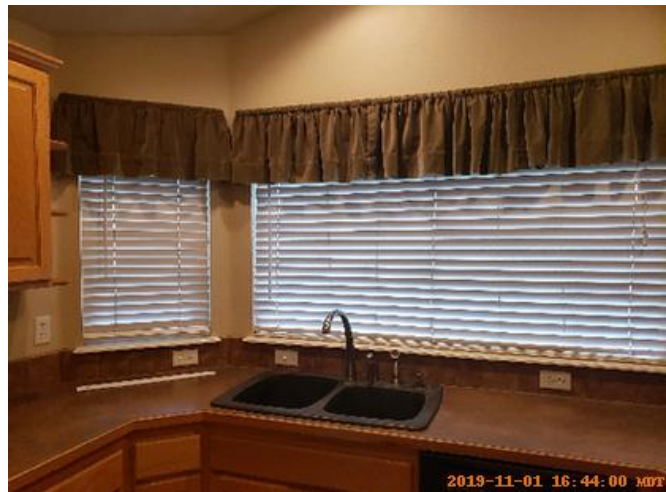
| Kitchen | CONDITION | ACTION | COMMENTS |
|---|---|---|---|
| Window Covering | - - - D | None | broken valance clips |

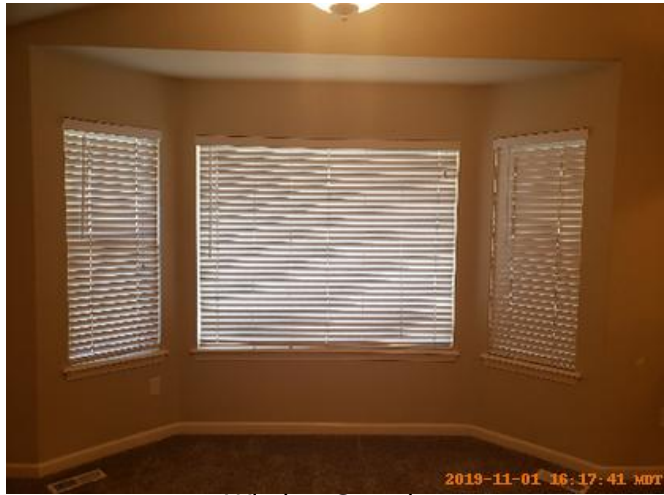
| Living Room | CONDITION | ACTION | COMMENTS |
|---|---|---|---|
| Window Covering | - - - D | None | broken valance clips |

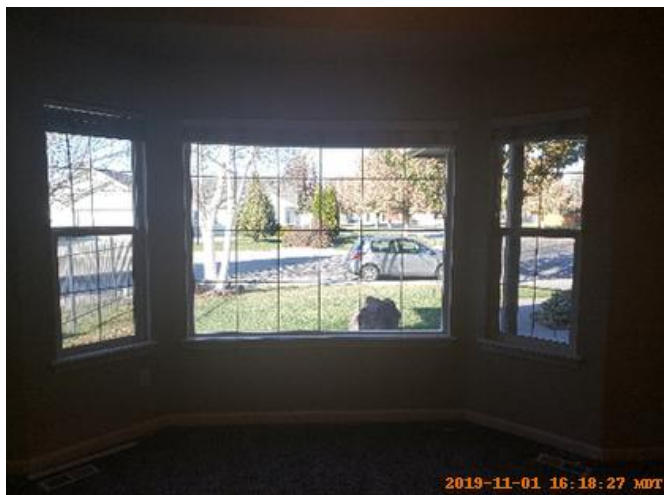
Window/Lock/Screen

| Window/ Lock/ Screen | - - - D | None | adhesive on window sill, ower<br>would like that remove |

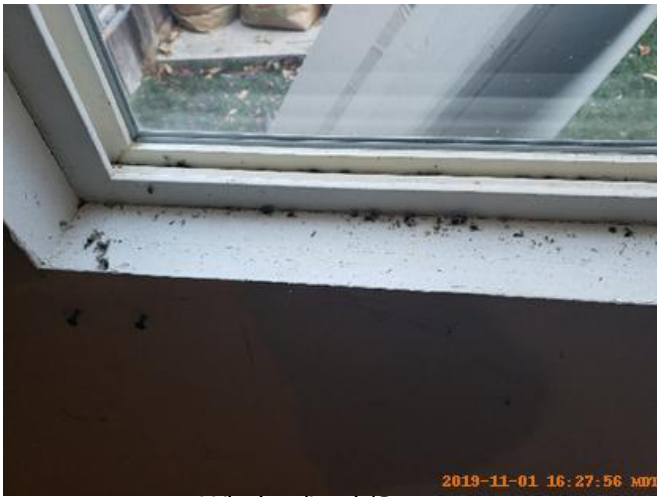
Window/Lock/Screen

| Garage/Parking | CONDITION | ACTION | COMMENTS |
|---|---|---|---|
| Window/ Lock/ Screen | - - - D | None | broken blind, dirty |
