# Move Out

201 w 1st st, Middleton , ID, US

2019-01-31

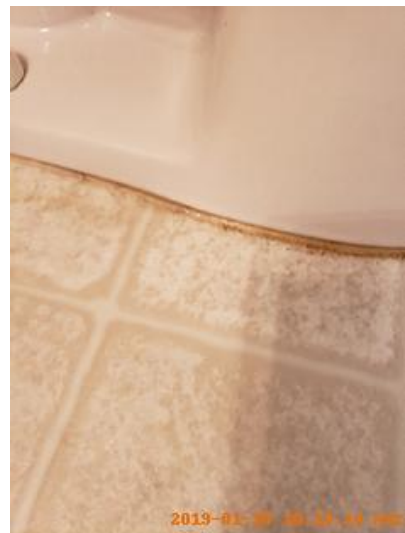
| Bathroom 2: bathroom 2 | CONDITION | ACTION | COMMENTS |
|---|---|---|---|
| Toilet | - - - D | None | caulking is missing around toilet |

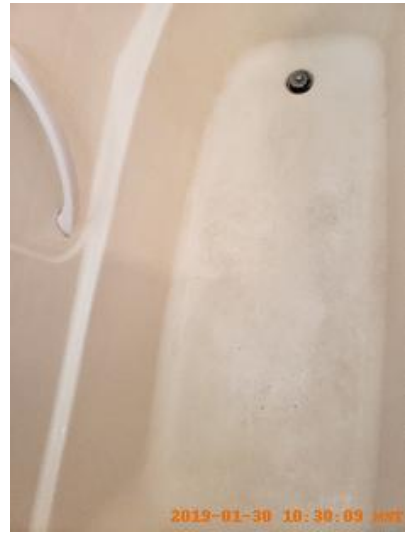
| Bathroom 2: bathroom 2 | CONDITION | ACTION | COMMENTS |
|---|---|---|---|
| Tub/Shower | - - - D | None | dirty |

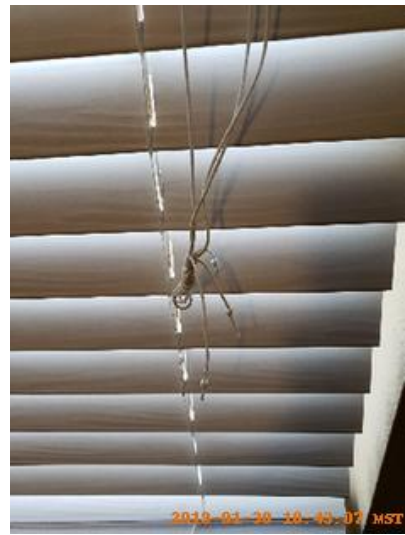
| Bedroom 1: master bedroom | CONDITION | ACTION | COMMENTS |
|---|---|---|---|
| Window Covering | - - - D | None | string caps on blind are missing |

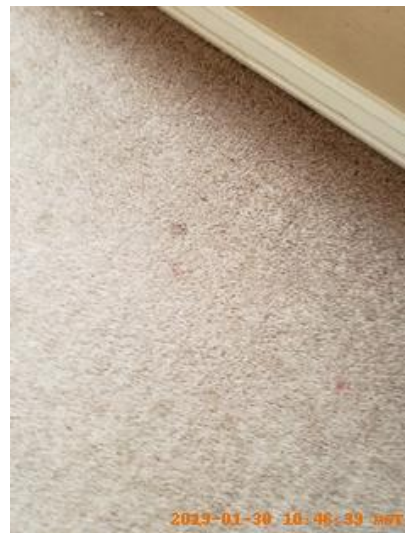
| Bedroom 2: bedroom 2 | CONDITION | ACTION | COMMENTS |
|---|---|---|---|
| Flooring/Baseboard | - - - D | None | chips in baseboard, carpet is stained |

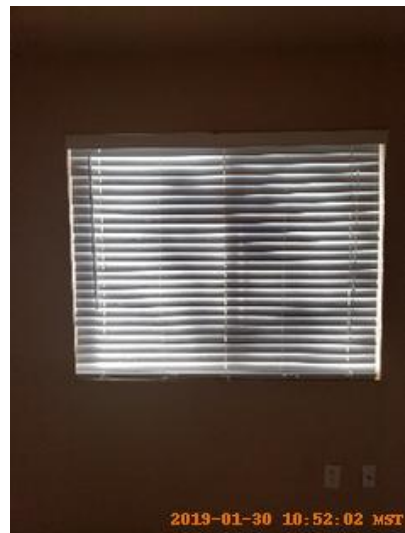
| Bedroom 2: bedroom 2 | CONDITION | ACTION | COMMENTS |
|---|---|---|---|
| Window Covering | - - - D | None | blinds are dirty, and missing string caps |

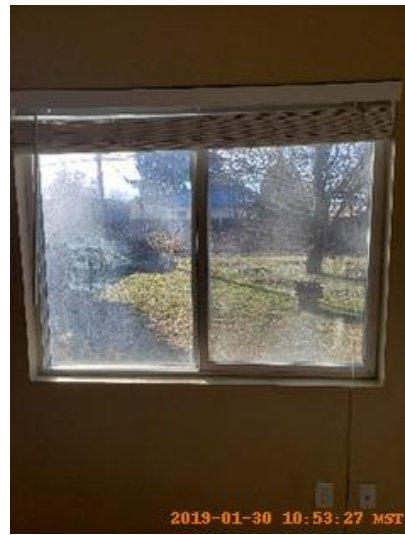
| Bedroom 2: bedroom 2 | CONDITION | ACTION | COMMENTS |
|---|---|---|---|
| Window/Lock/Screen | - - - D | None | bent screen |

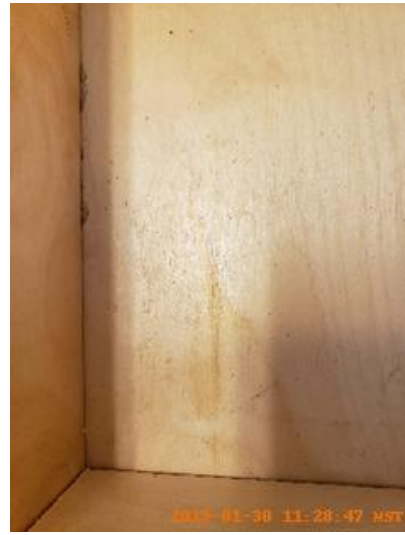
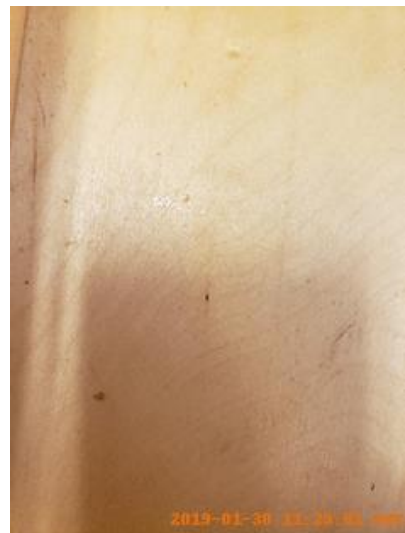
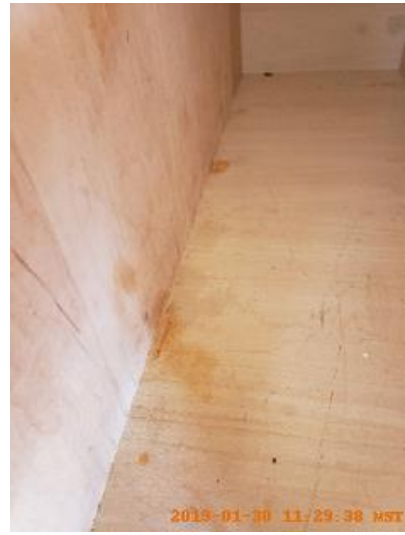
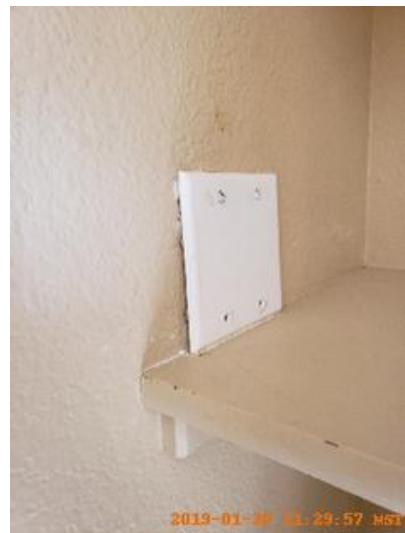
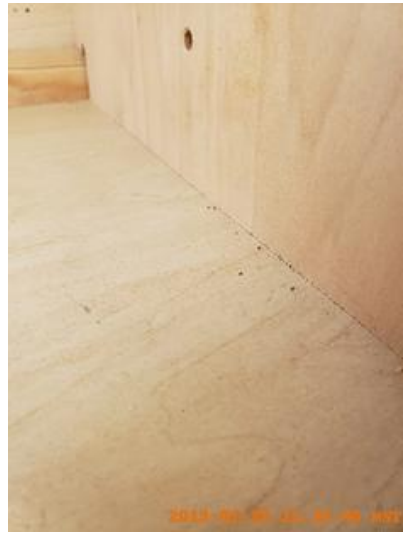
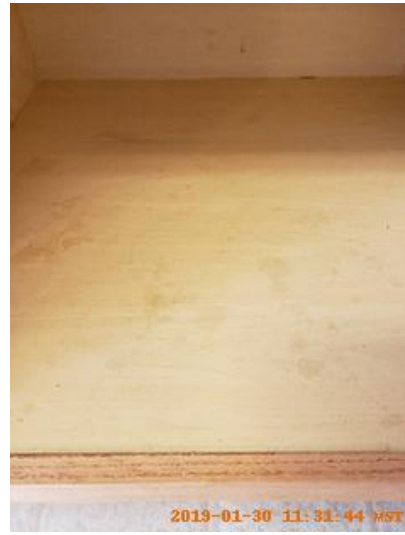
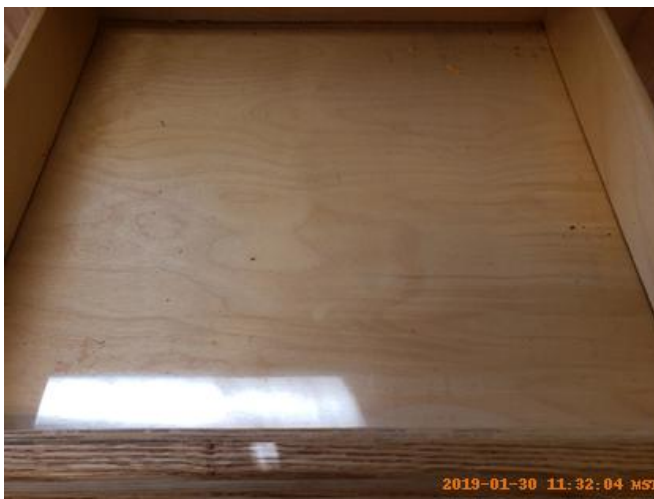
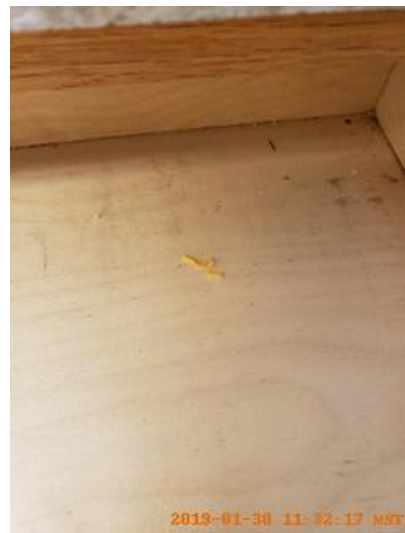
| Kitchen | CONDITION | ACTION | COMMENTS |
|---|---|---|---|
| Cabinets/Drawers | - - - D | None | scratched and worn |

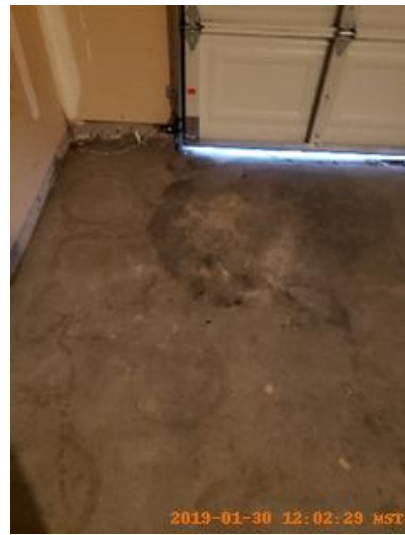
| Garage/Parking | CONDITION | ACTION | COMMENTS |
|---|---|---|---|
| Driveway/Floor | - - - D | None | near garage door chucks are missing in cement, rust and oil stains |
