# Move Out

1883 W Creek Ct, Nampa, ID 83686, US

2019-01-31

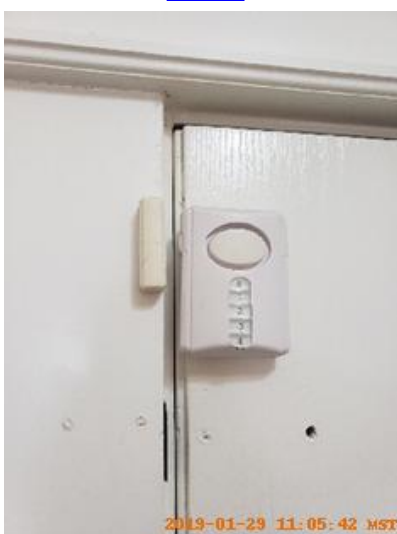
| Entry: Entry Way | CONDITION | ACTION | COMMENTS |
|---|---|---|---|
| Security/Screen Door | - - - D | None | Holes in door |

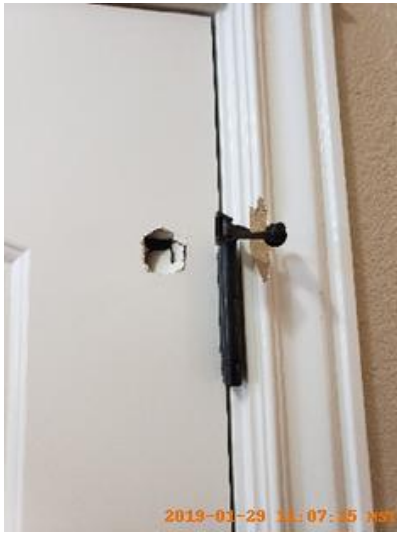
| Entry: Entry Way | CONDITION | ACTION | COMMENTS |
|---|---|---|---|
| Other | - - - D | None | door stop is stretched out, closet door in the entry way has a hole from the door stop, door trim is damaged |

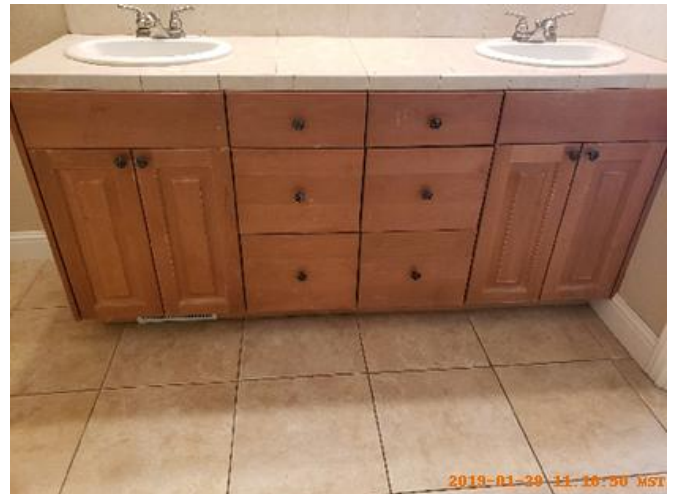
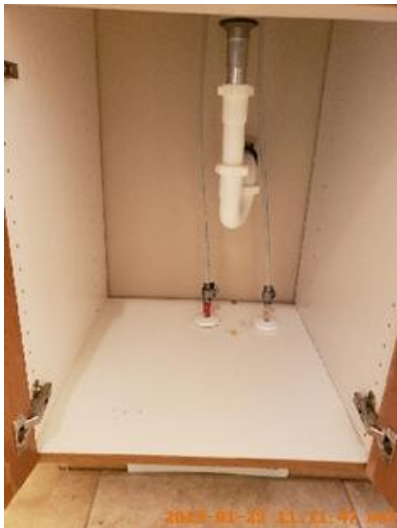
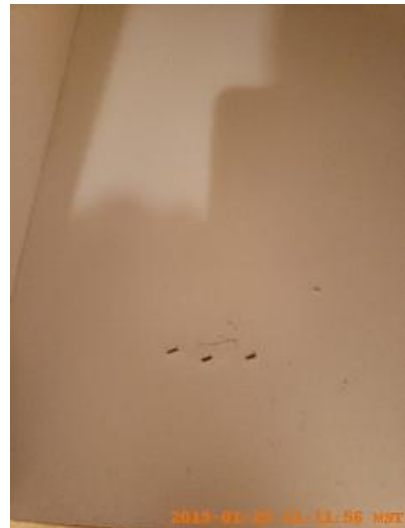
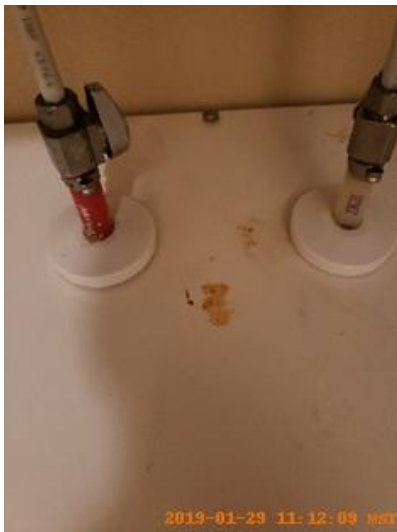
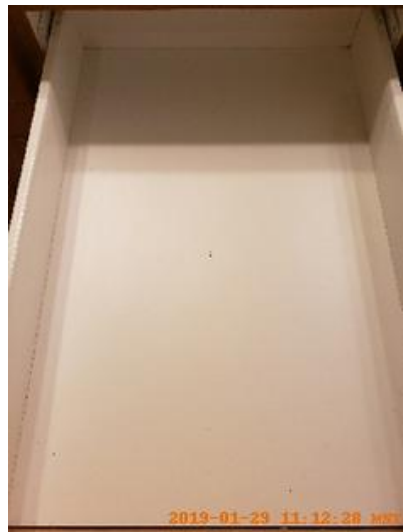
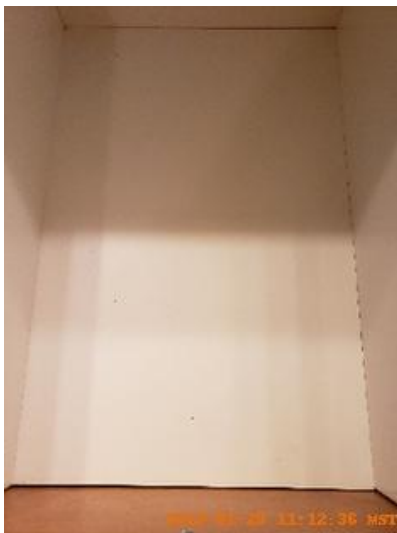
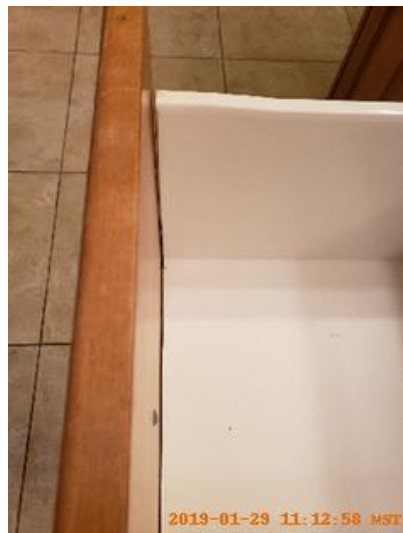
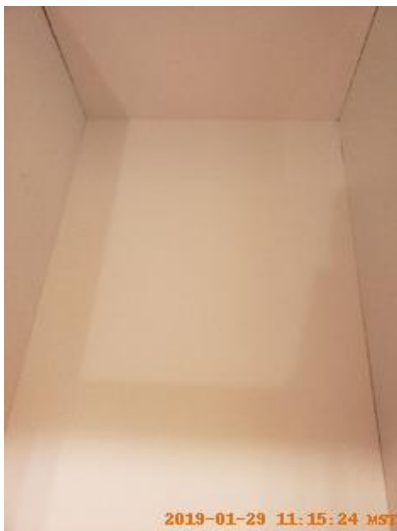
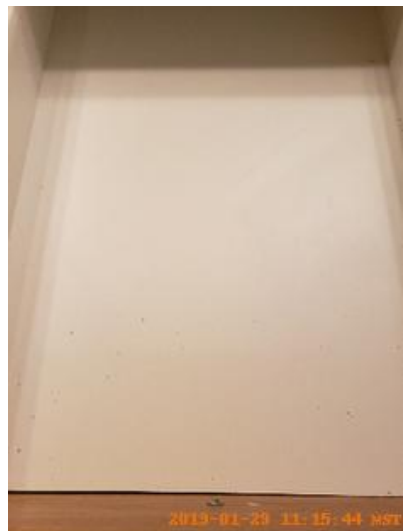
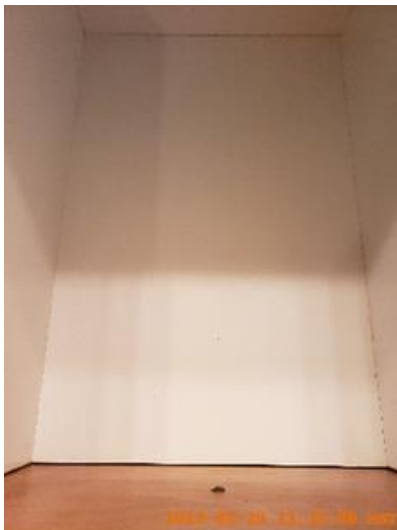
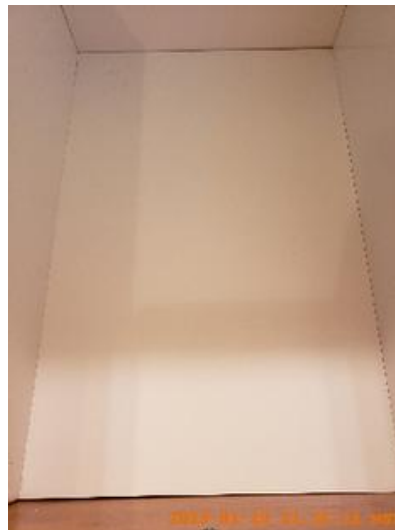
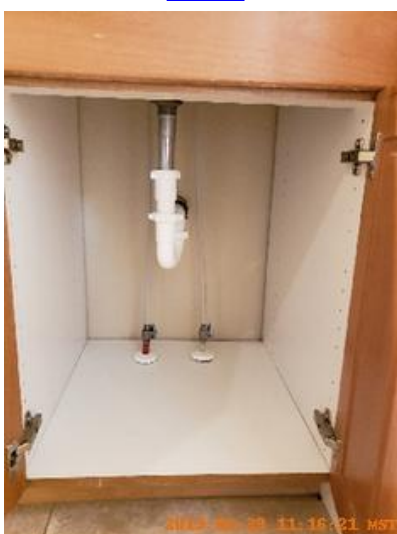
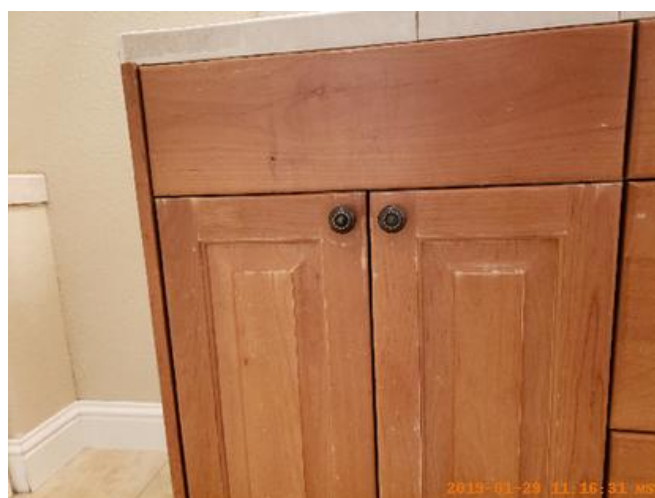
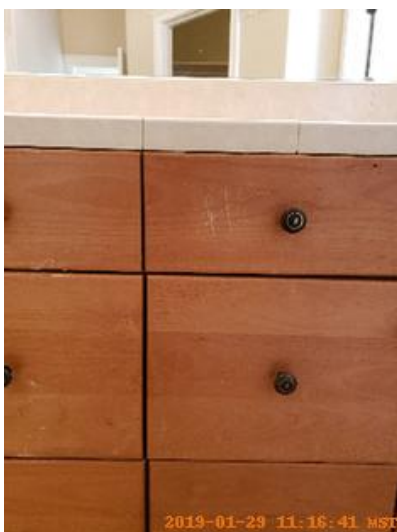
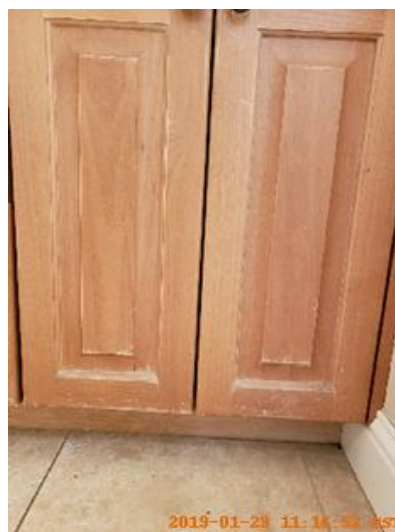
| Bathroom 1: Master Bath #1 | CONDITION | ACTION | COMMENTS |
|---|---|---|---|
| Cabinet/Counter/Shelving | - - - D | None | Cabinets are scratched and worn |

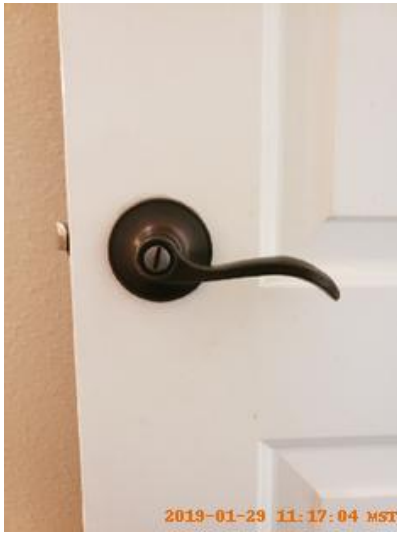
| Bathroom 1: Master Bath #1 | CONDITION | ACTION | COMMENTS |
|---|---|---|---|
| Door/Knob/Lock | - - - D | None | Lock slider near top of door |

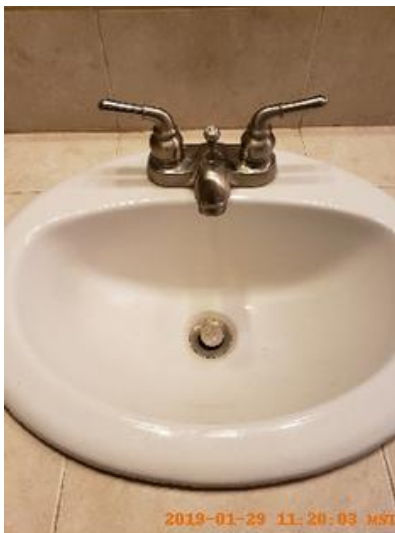
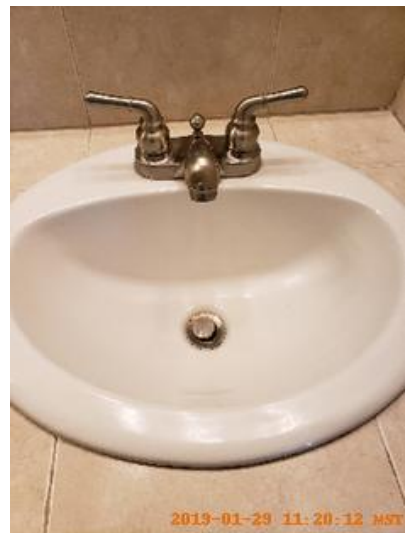
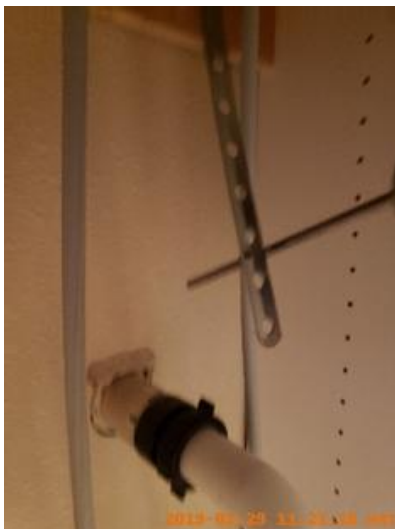
| Bathroom 1: Master Bath #1 | CONDITION | ACTION | COMMENTS |
|---|---|---|---|
| Sink/Faucet | - - - D | None | Clip missing on back of faucet<br>hindering the stopper from<br>working properly |

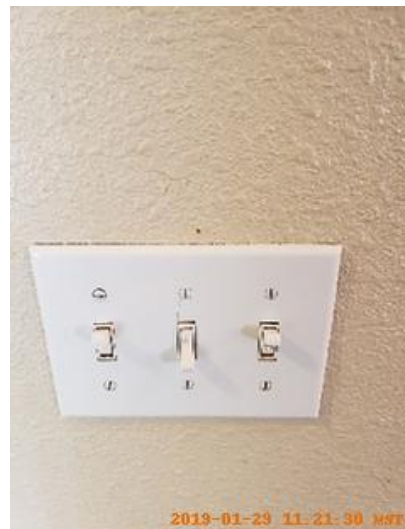
| Bathroom 1: Master Bath #1 | CONDITION | ACTION | COMMENTS |
|---|---|---|---|
| Switch/Outlet | - - - D | None | small crack on outlet cover |

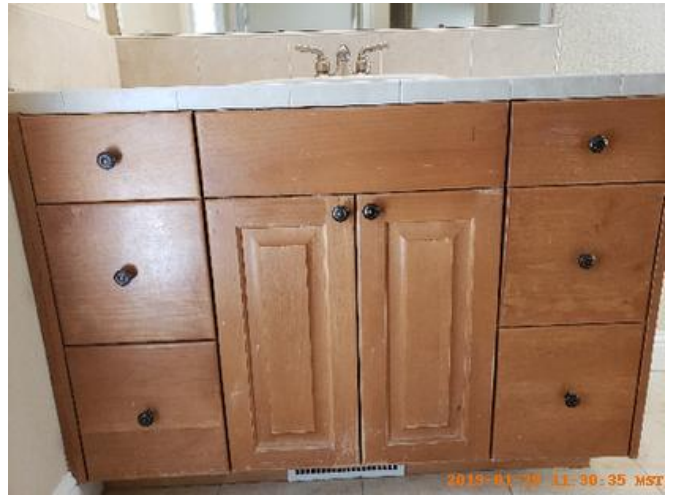
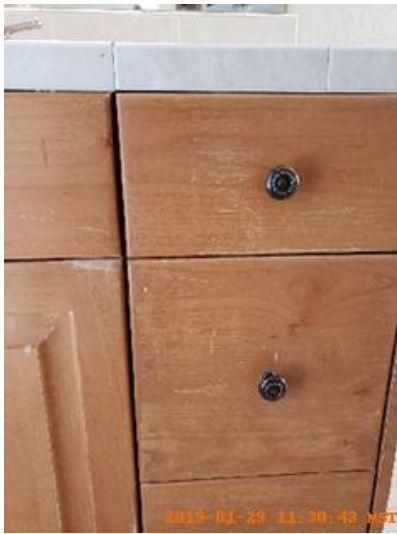
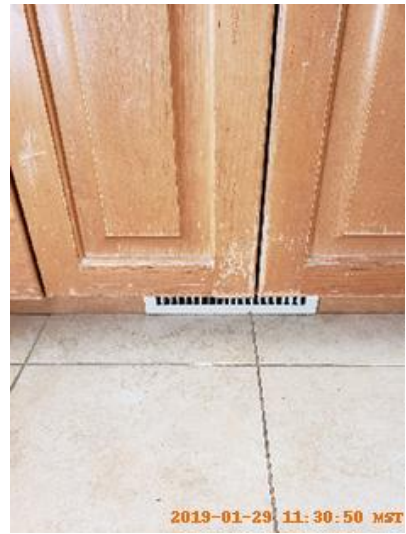
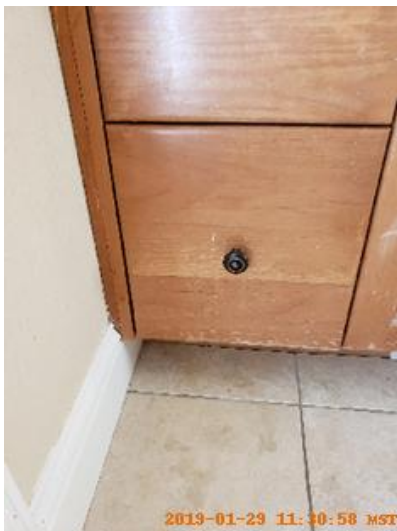
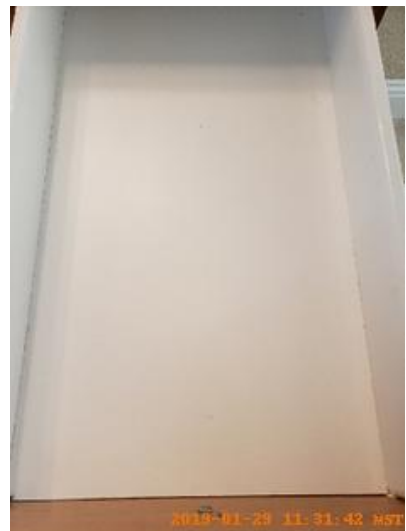
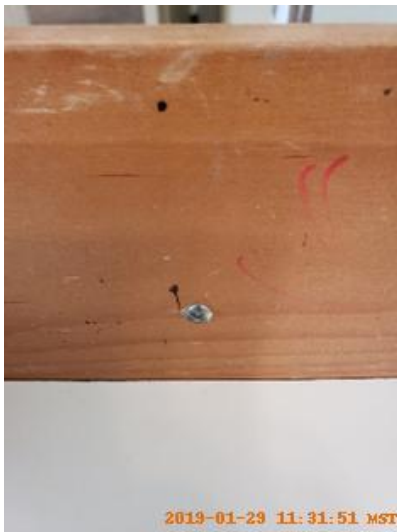
Cabinet/Counter/Shelving  
 Taken on: 2019-01-29 11:30:35  
 Taken at: [43.56522506, -116.60391048](#)  
[Image](#)

| Cabinet/Counter/Shelving | - - - D | None | Bottom shelf has water damage, drawers are dirty, cabinets are worn and scratched |

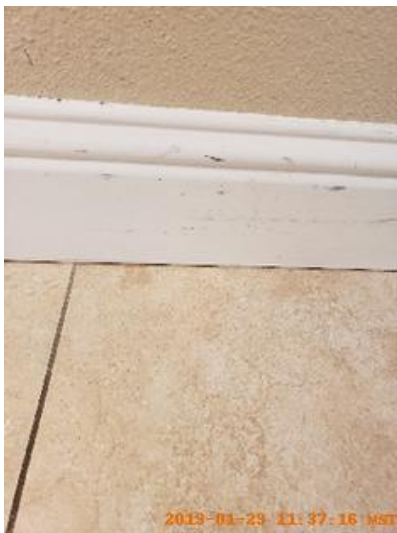
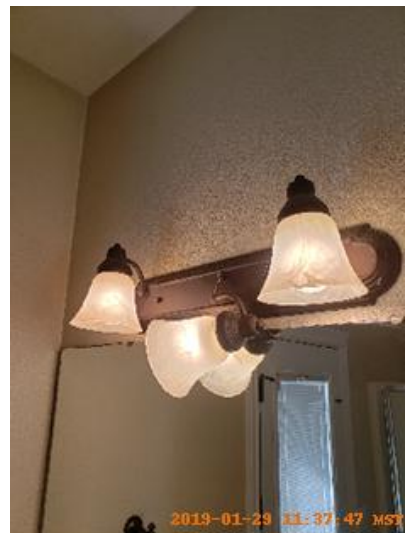
| Flooring/Baseboard | - - - D | None | base board is scratched and damaged, floor grout dirty |

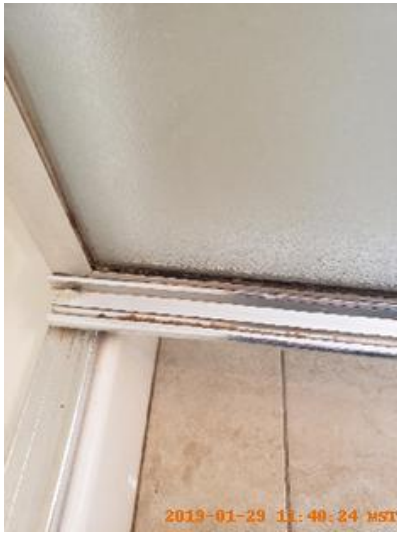
| Shower Door/Rail/Curtain | - - - D | None | hard water stains |

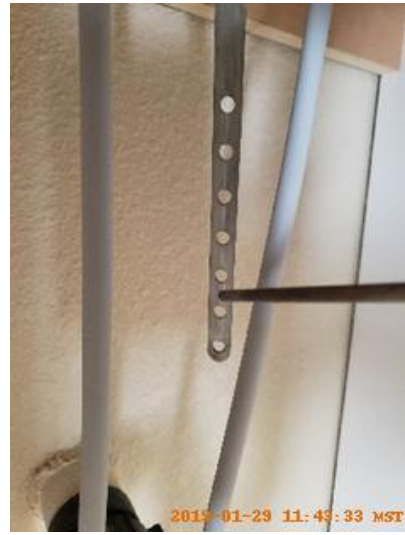
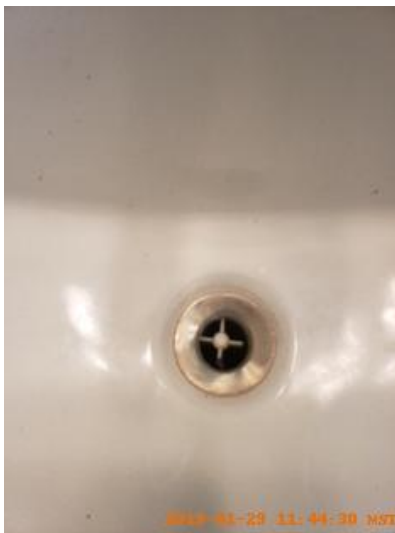
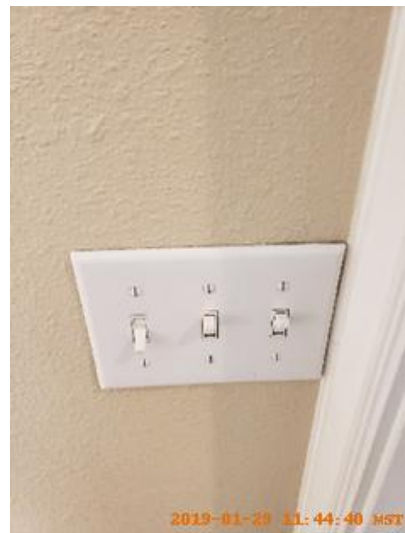
| Sink/Faucet | - - - D | None | grout is chipped and missing in places |

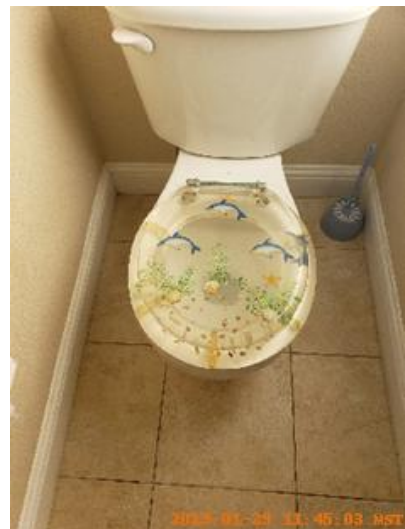
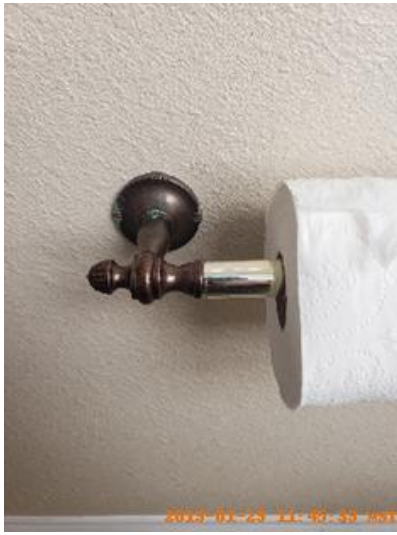
| Toilet | - - - D | None | on bottom of toilet white cap is missing showing exposed screw |

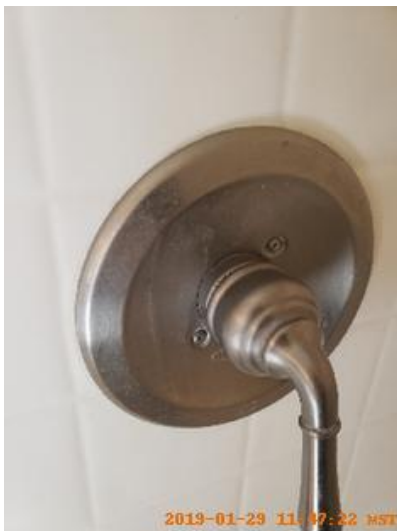
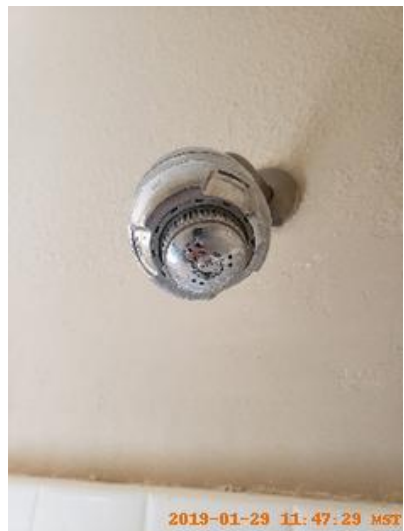
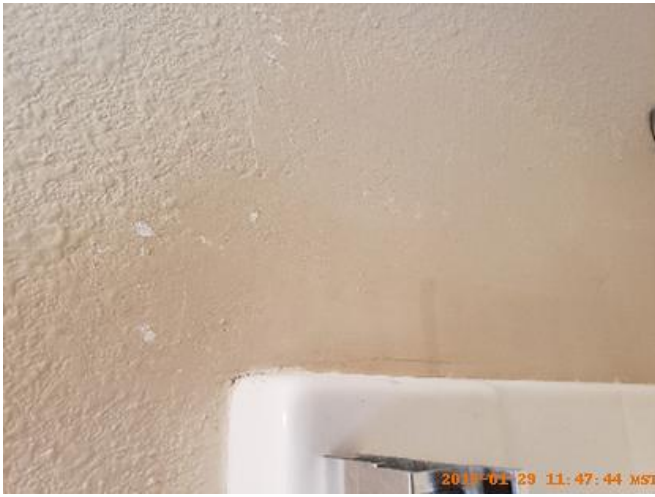
| Tub/Shower | - - - D | None | Tub faucet is separating |

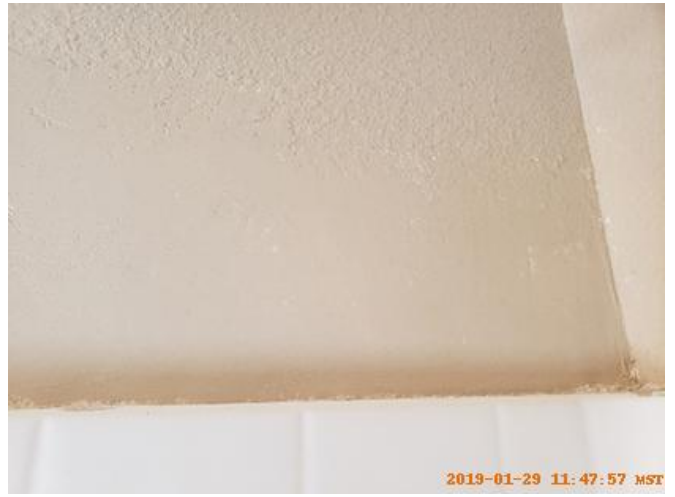
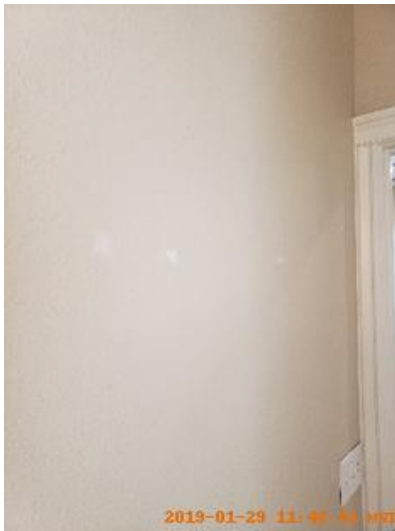
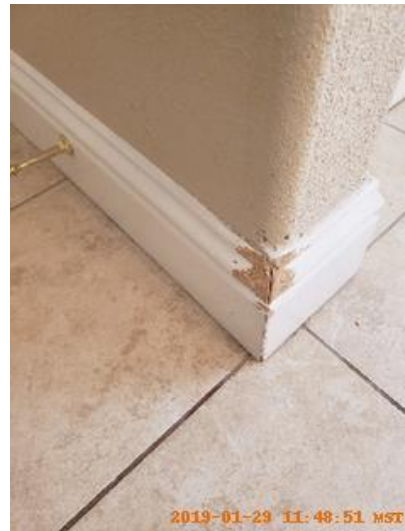
| Wall/Ceiling | - - - D | None | Holes, cracked and peeling paint, dirty |

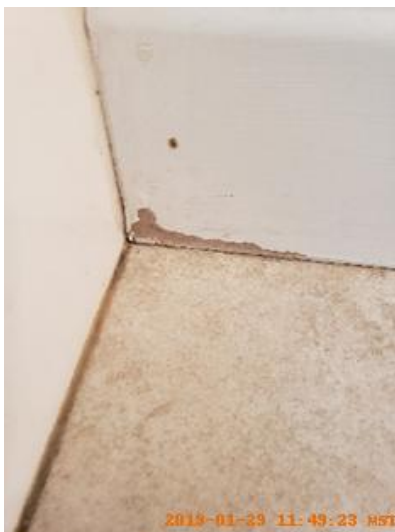
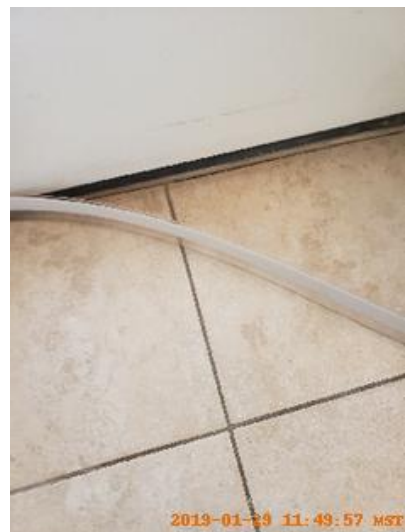
| Flooring/Baseboard | - - - D | None | grout is cracked |

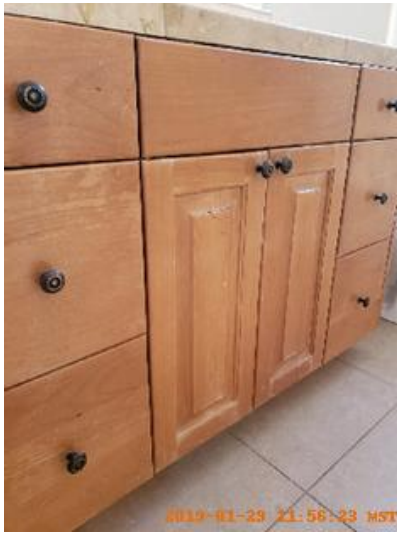
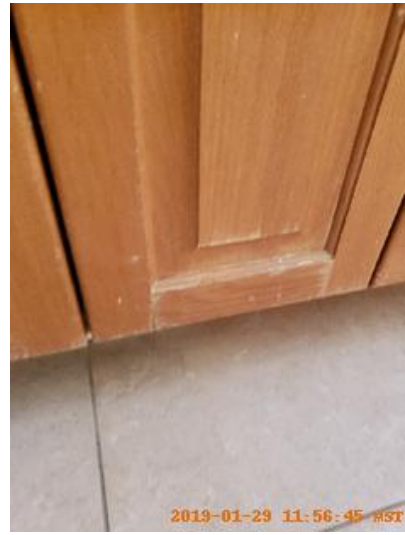
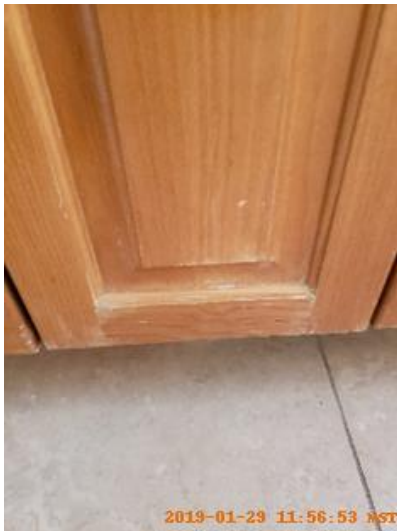
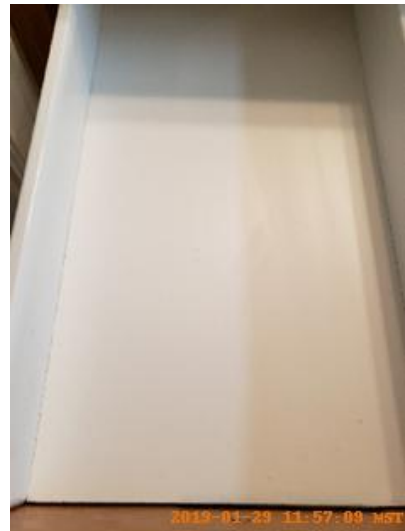
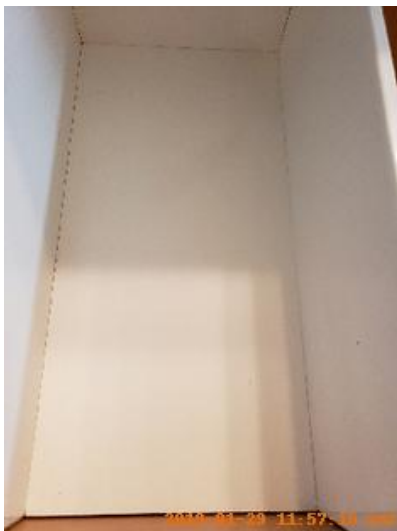
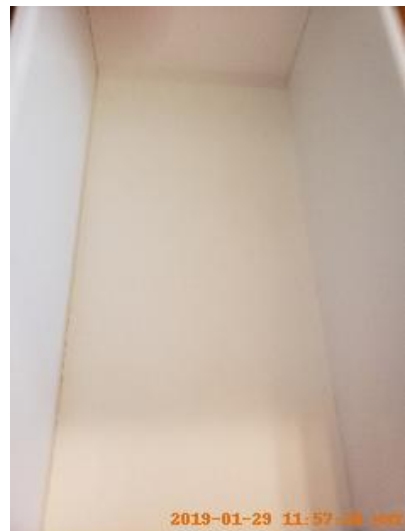
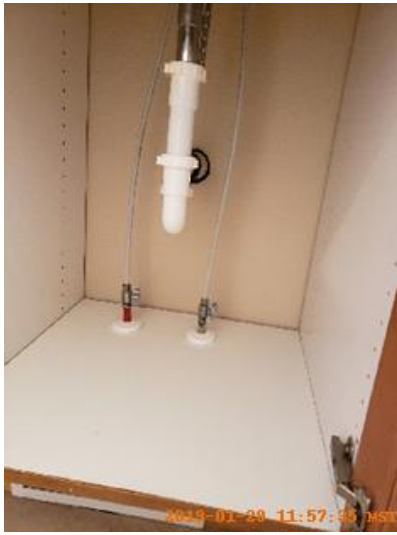
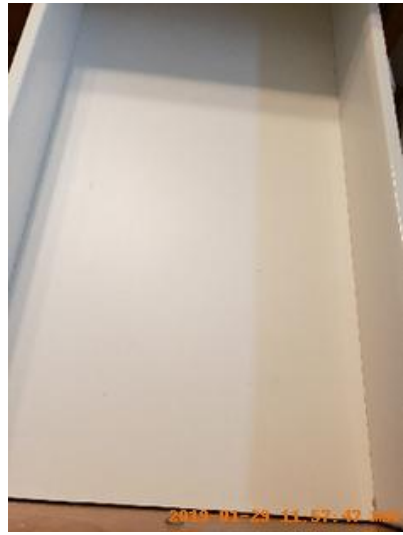
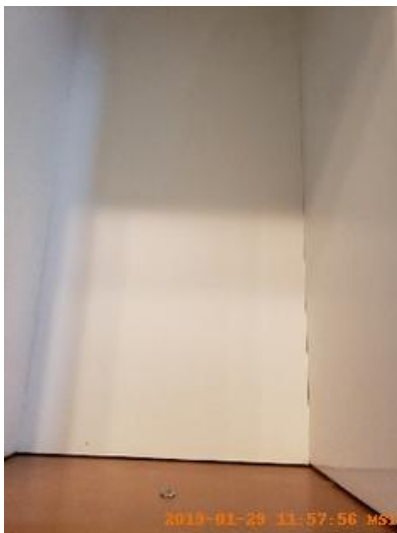
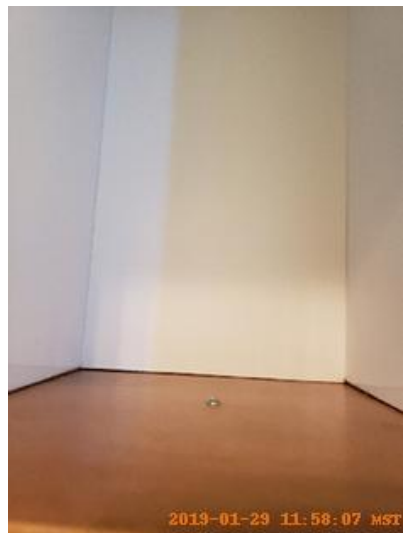
Cabinet/Counter/Shelving  
Taken on: 2019-01-29 11:56:23  
Taken at: [43.56525787, -116.60392187](#)  
[Image](#)

| Cabinet/Counter/Shelving | - - - D | None | cabinets are worn and scratched |

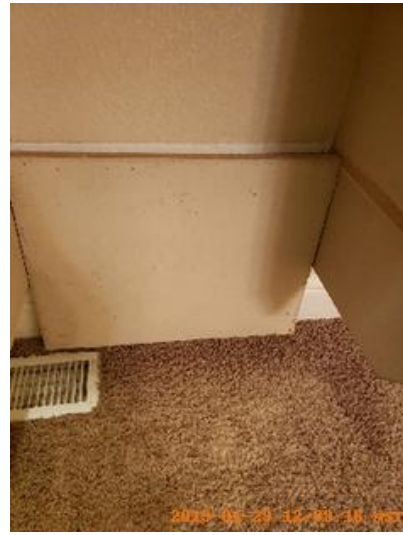
| Bedroom 1: Master Bedroom | CONDITION | ACTION | COMMENTS |
|---|---|---|---|
| Closet/Door/Track/Shelving | - - - D | None | Missing door stop cap, bottom shelf in closet is damaged |

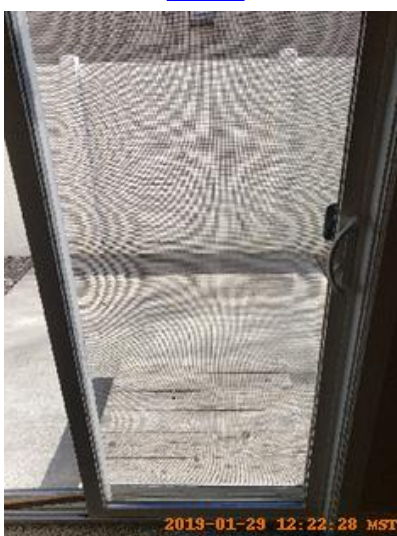
| Bedroom 1: Master Bedroom | CONDITION | ACTION | COMMENTS |
|---|---|---|---|
| Window/Lock/Screen | - - - D | None | Damaged |

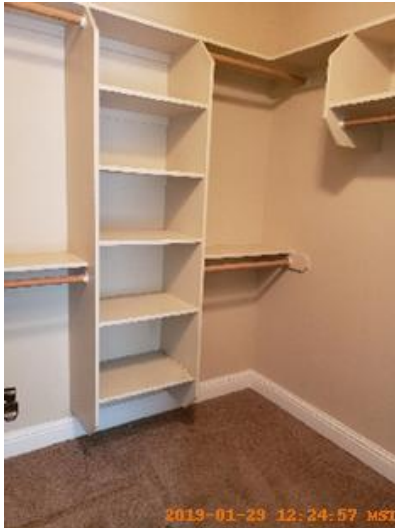
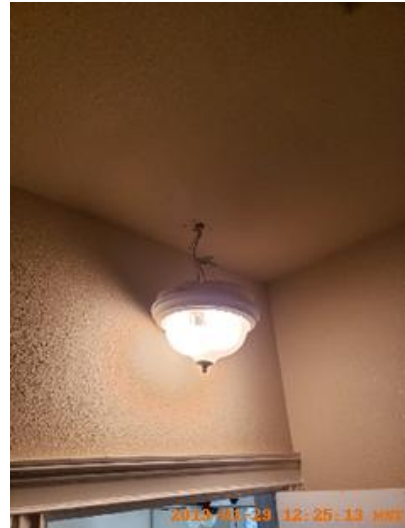
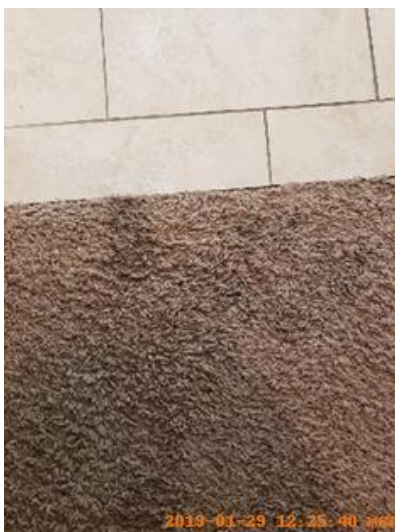
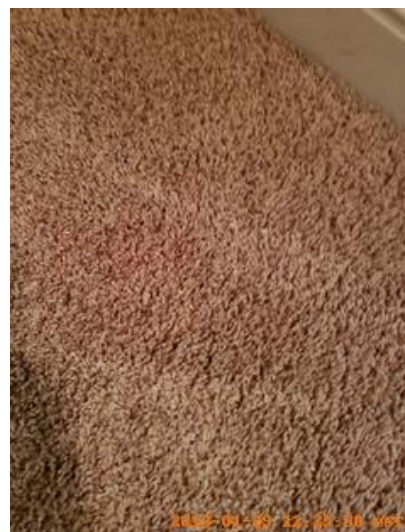
| | CONDITION | ACTION | COMMENTS |
|---|---|---|---|
| Closet/Door/Track/Shelving | - - - D | None | light not attached to ceiling, shelving is broken, carpet is stained, screw holes on back of closet door, door stop missing, closet wall damaged |

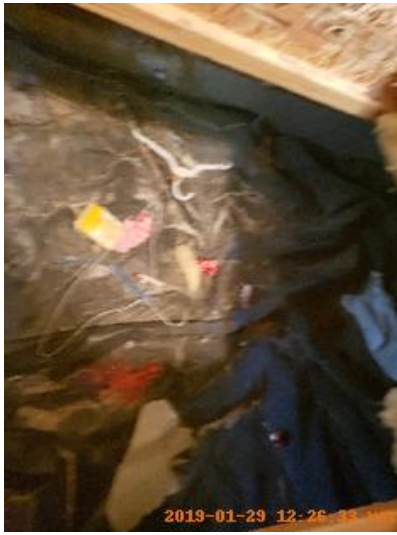
| | CONDITION | ACTION | COMMENTS |
|---|---|---|---|
| Other | - - - D | None | smoke detector not attach to ceiling, trash in crawl space |

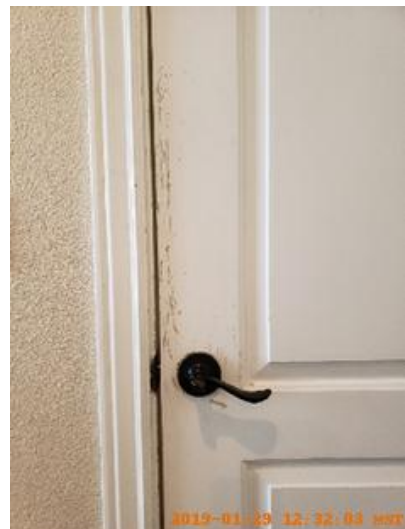
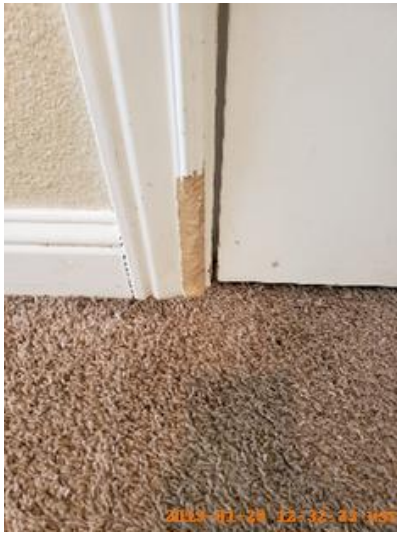
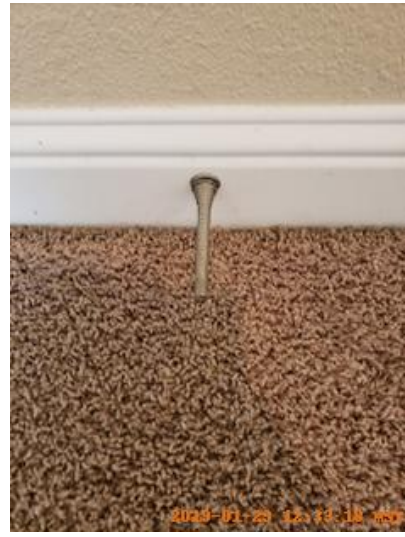
| | CONDITION | ACTION | COMMENTS |
|---|---|---|---|
| Door/Knob/Lock | - - - D | None | parts of door trim missing, door stop cap is missing, door paint is peeling |

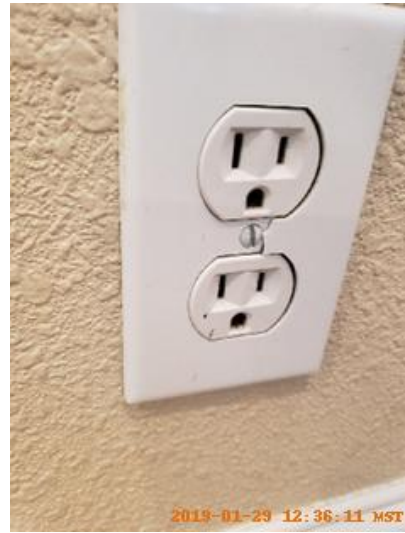
| | CONDITION | ACTION | COMMENTS |
|---|---|---|---|
| Switch/Outlet | - - - D | None | 1 - broken |

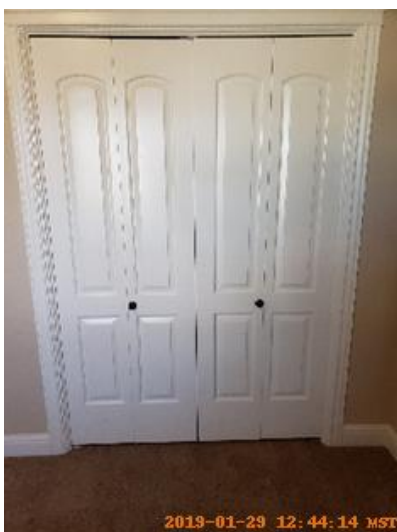
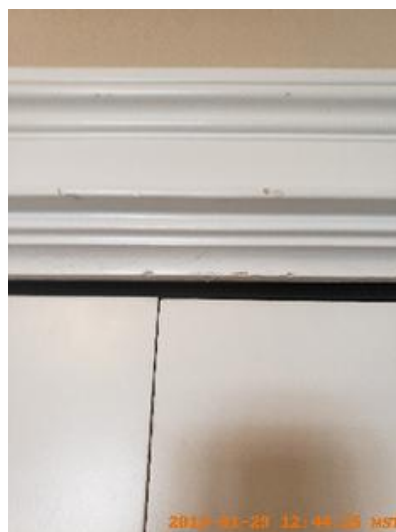
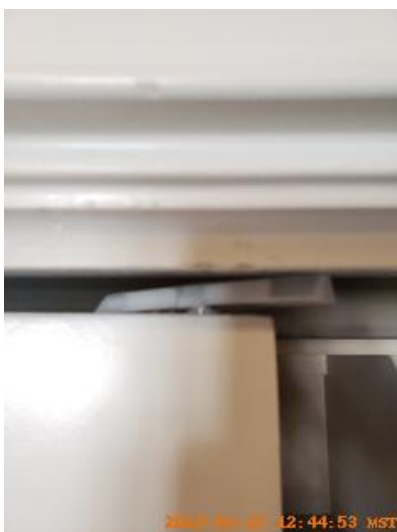
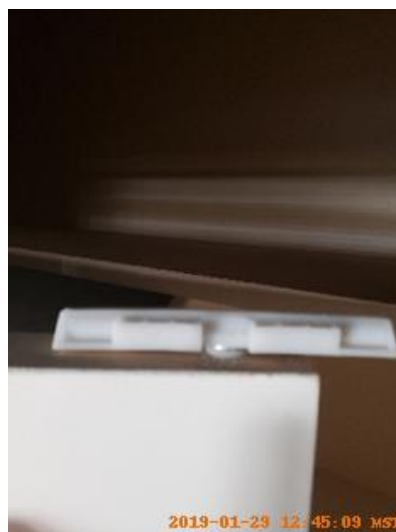
| Bedroom 3: Bedroom 3 | CONDITION | ACTION | COMMENTS |
|---|---|---|---|
| Closet/Door/Track/Shelving | - - - D | None | closet door doesn't stay on track |

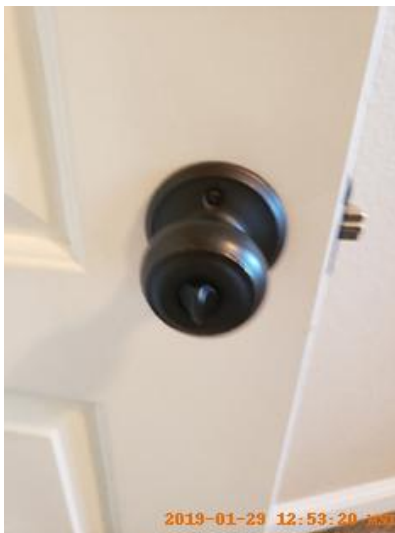
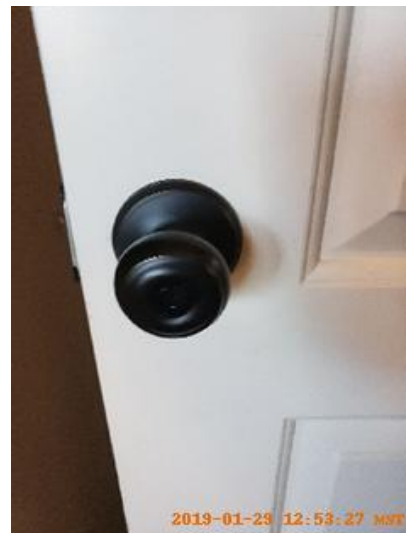
| Door/Knob/Lock | - - D | None | locking door knob - missing key |

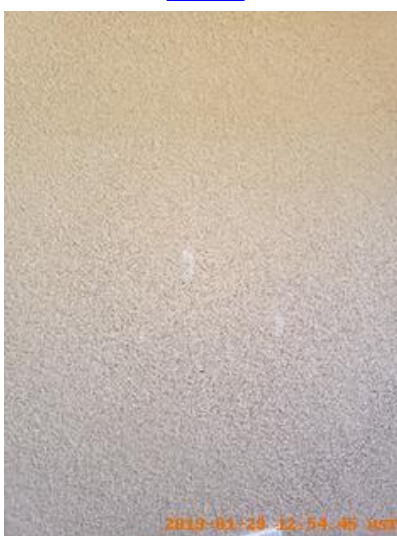
| Wall/Ceiling | - - D | None | holes have been patched |

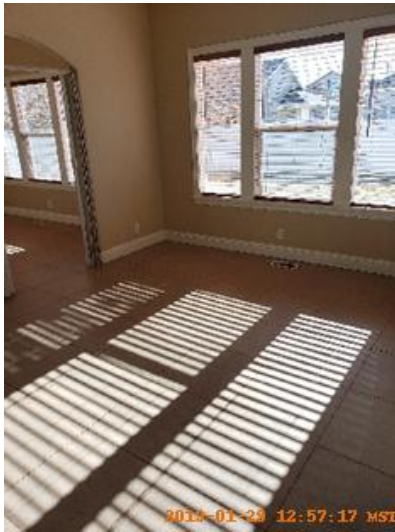
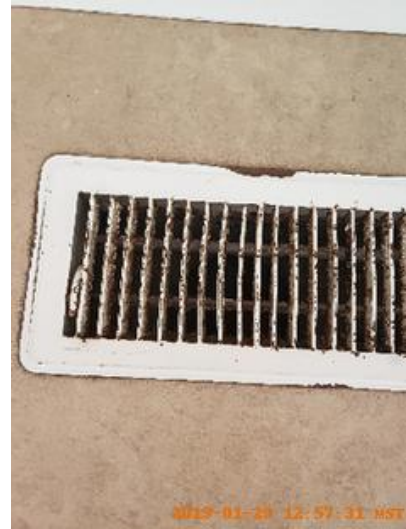
Flooring/Baseboard  
Taken on: 2019-01-29 12:57:31  
Taken at: [43.5653511, -116.60389288](#)  
[Image](#)

| Flooring/Baseboard | - - - D | None | vent cover rusted |

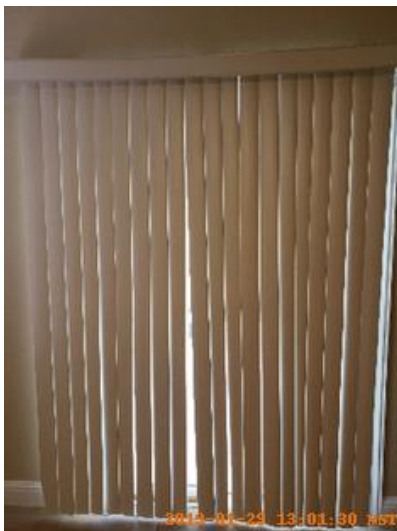
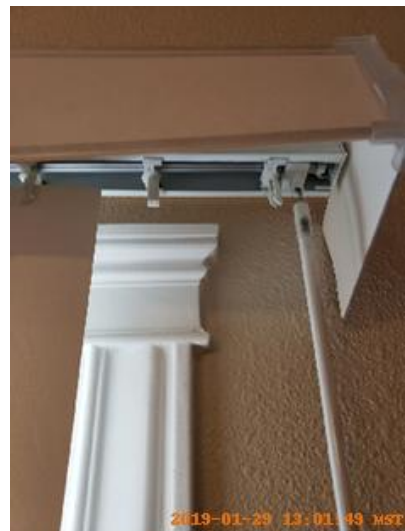
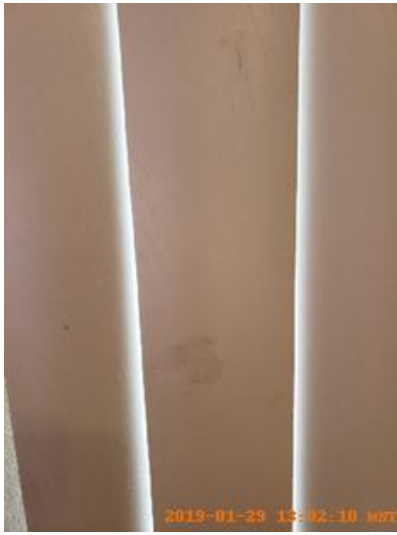
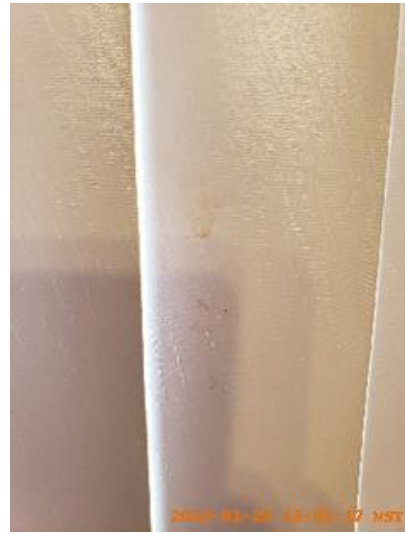
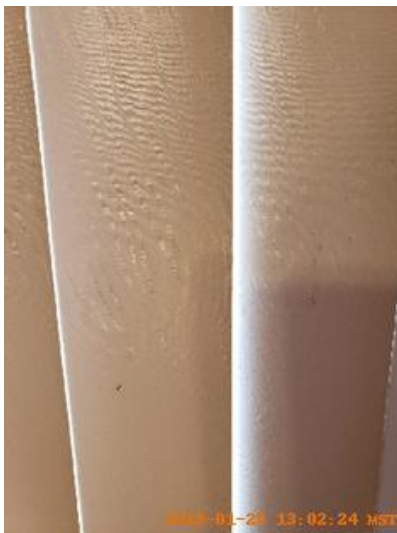
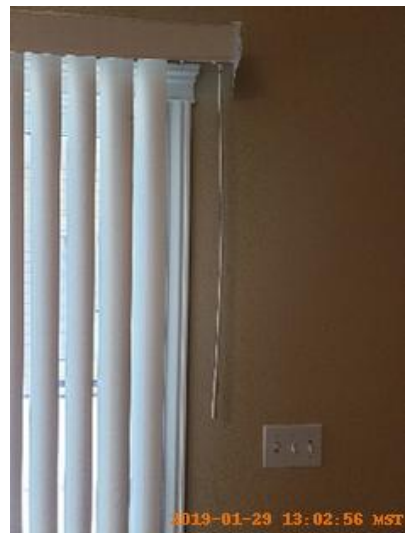
| Window Covering | - - - D | None | Blinding glass door blinds are hard to open, wand is bent, dirty, and missing 2 slats |

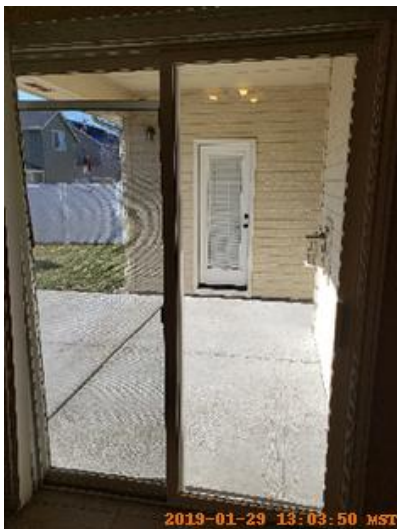
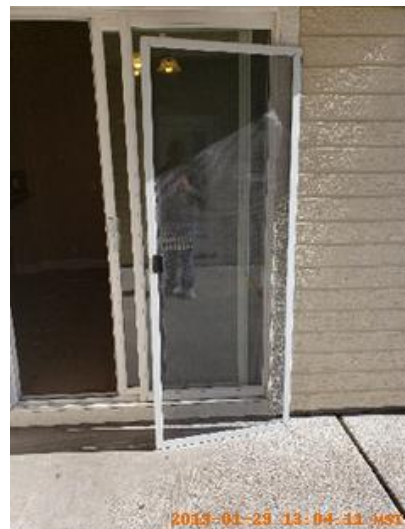
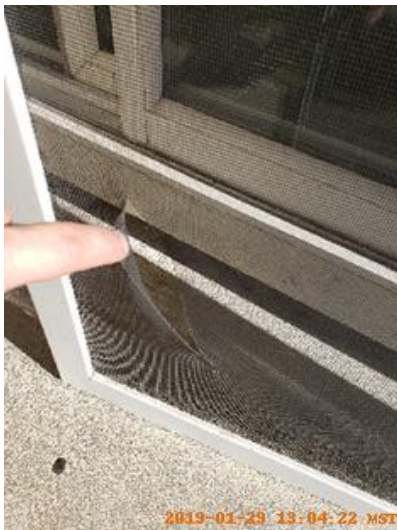
| Window/Lock/Screen | - - - D | None | screen door is leaning against the house, screen is damaged |

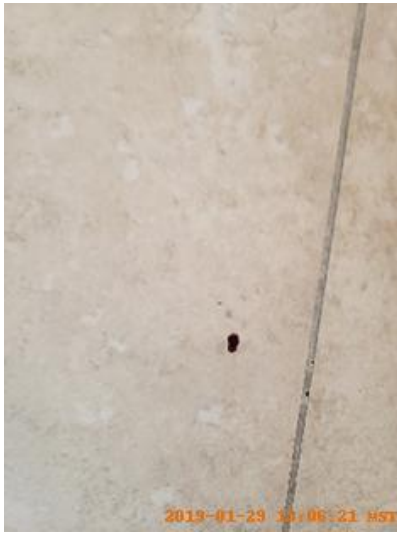
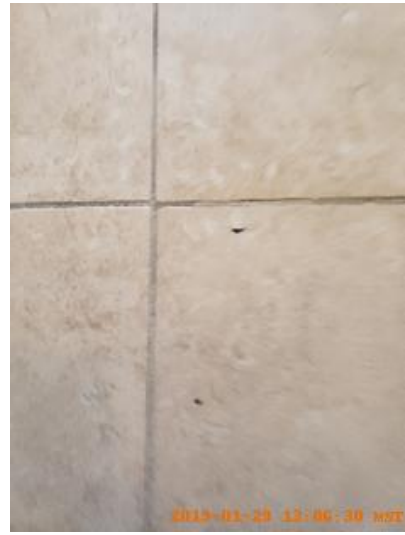
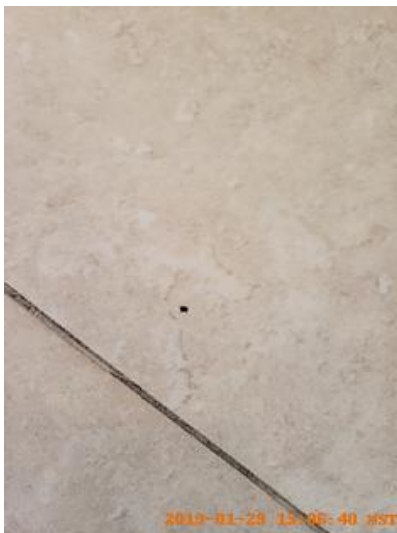
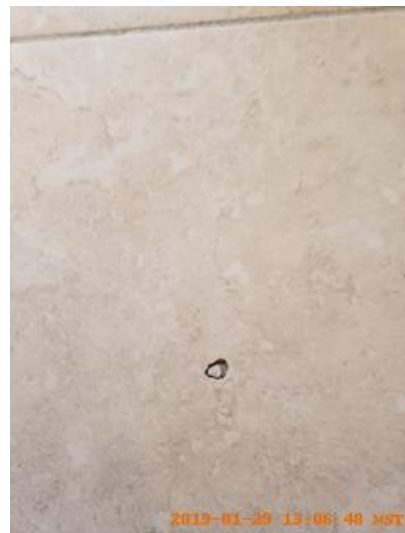
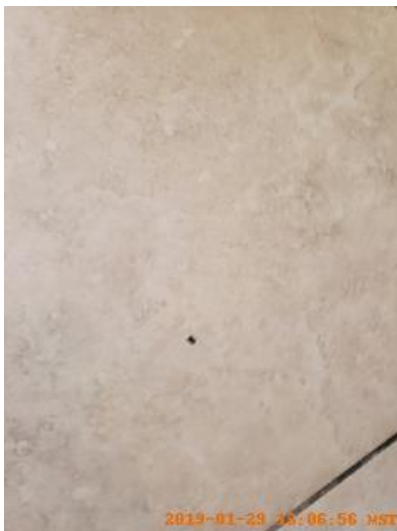
| Family Room: Family | CONDITION | ACTION | COMMENTS |
|---|---|---|---|
| Flooring/Baseboard | - - - D | None | tiles are chipped and broken |

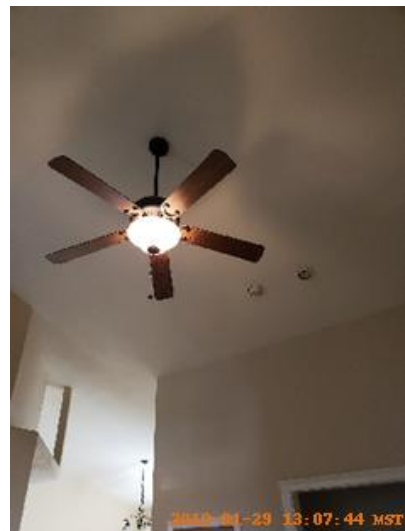
| Family Room: Family | CONDITION | ACTION | COMMENTS |
|---|---|---|---|
| Light Fixture | - - - D | None | light bulb above fireplace is burnt out |

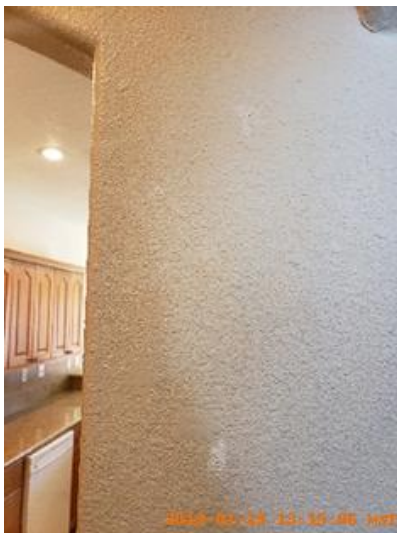
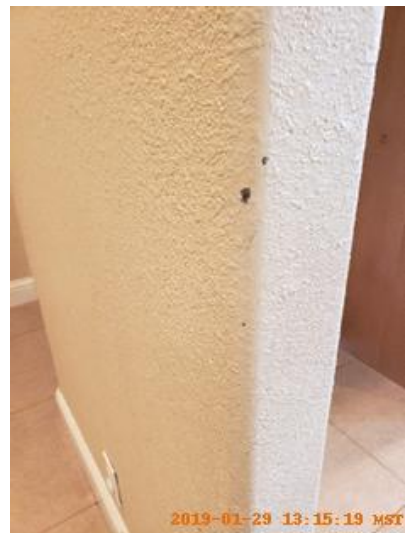
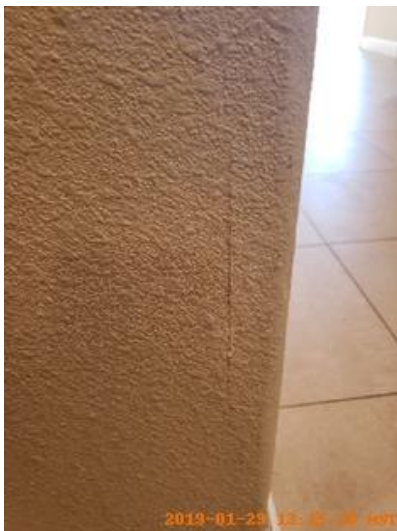
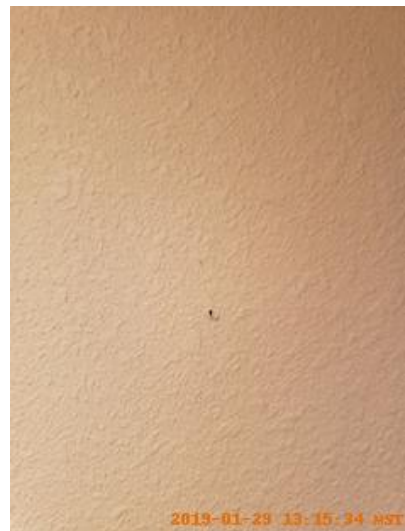
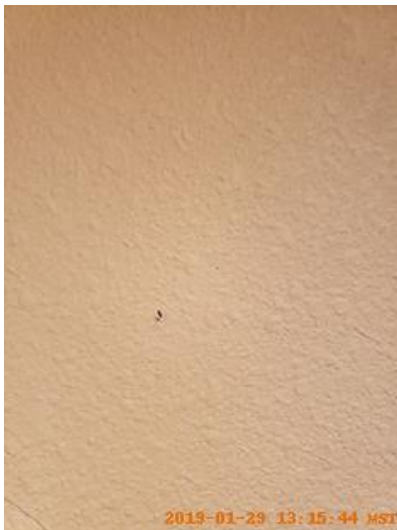
| Wall/Ceiling | - - - D | None | patched but not painted |

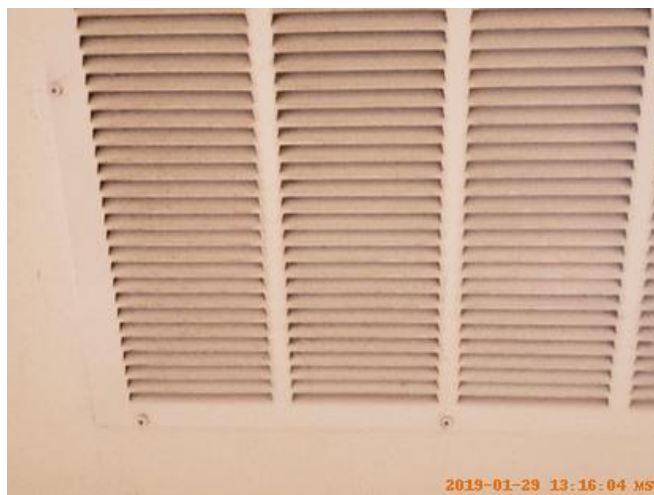
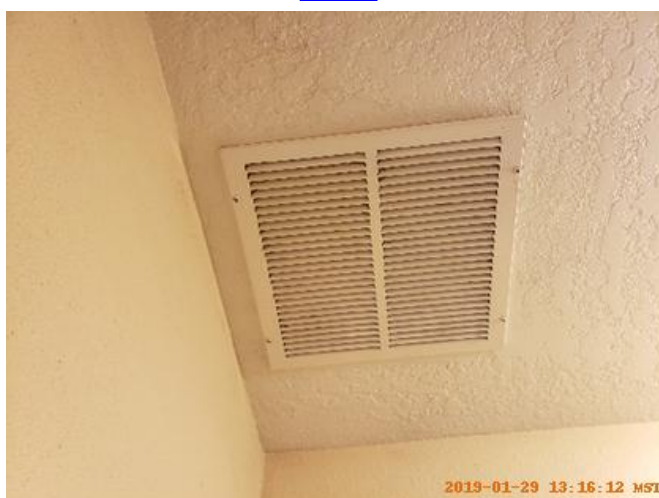
| Other | - - - D | None | Return vents are dirty |

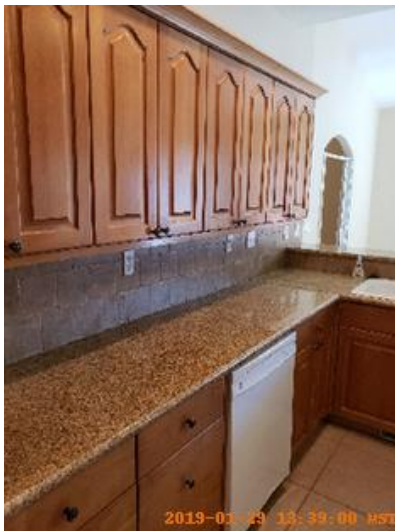
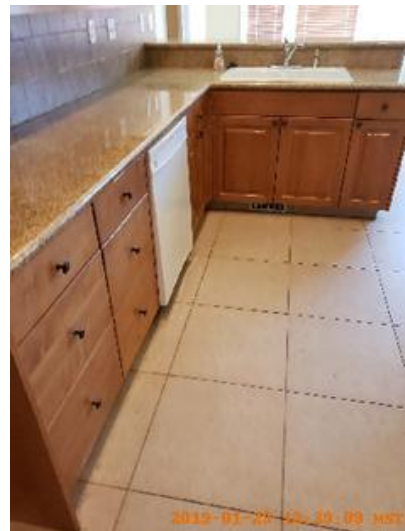
Cabinets/Drawers  
 Taken on: 2019-01-29 13:39:00  
 Taken at: [43.56524173, -116.60380667](#)  
[Image](#)

| Kitchen: Kitchen | CONDITION | ACTION | COMMENTS |
|---|---|---|---|
| Cabinets/Drawers | - - - D | None | dirty |
