# Move Out

1883 W Creek Ct, Nampa, ID 83686, US

2019-01-31

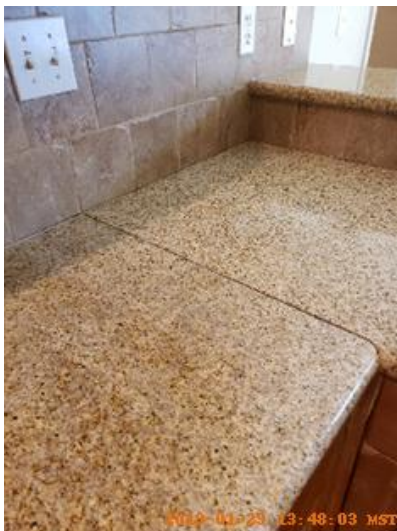
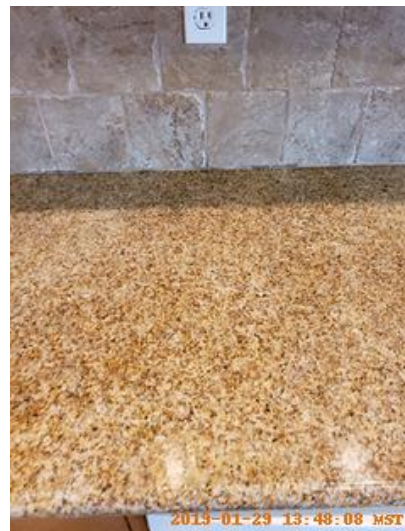
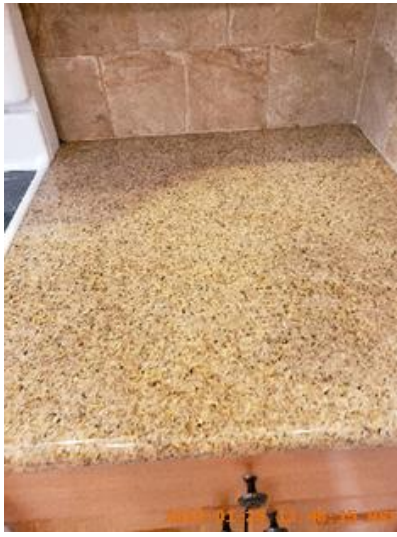
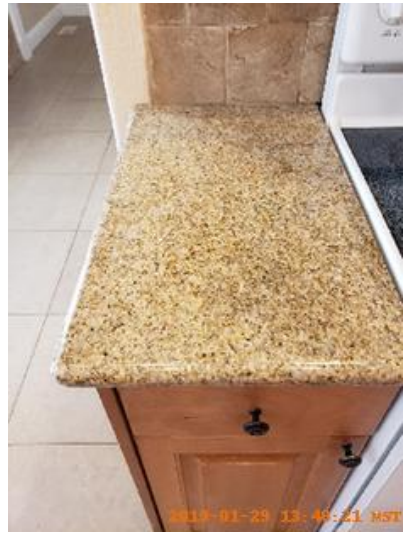
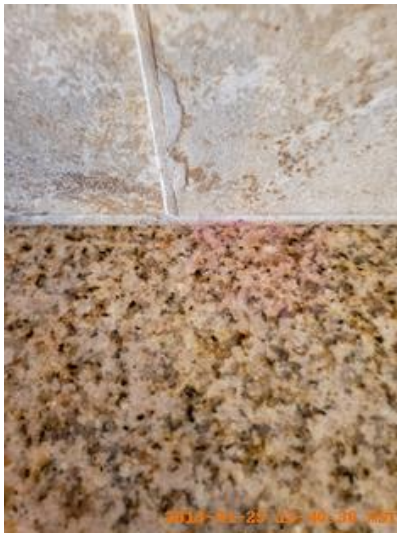
| Kitchen: Kitchen | CONDITION | ACTION | COMMENTS |
|---|---|---|---|
| Counter | - S - - | None | Small stain on counter top by fridge |

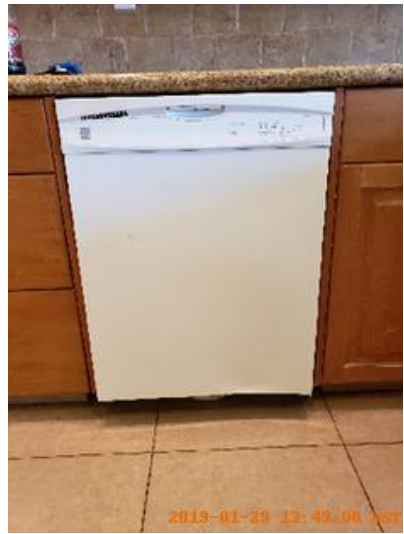
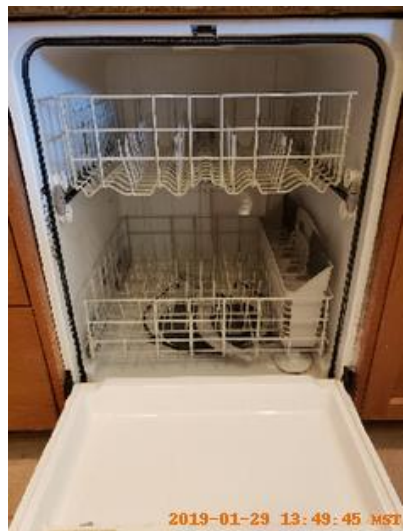
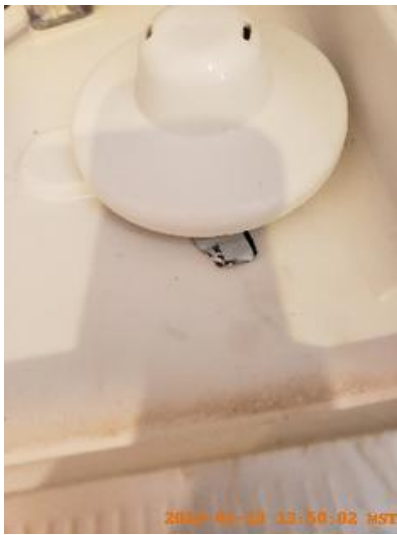
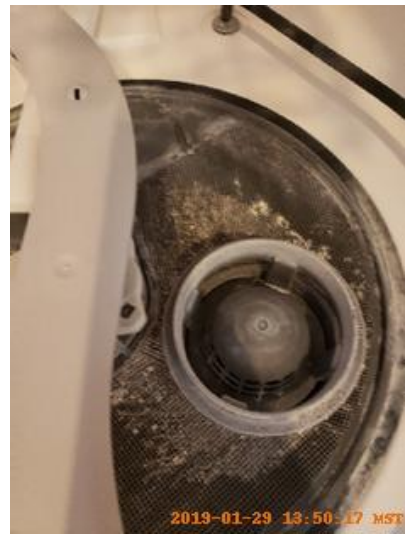
| Kitchen: Kitchen | CONDITION | ACTION | COMMENTS |
|---|---|---|---|
| Dishwasher | - - - D | None | dirty, below dishwasher the kick plate is missing |

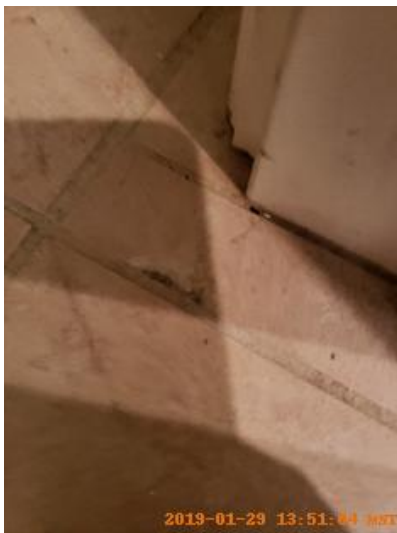
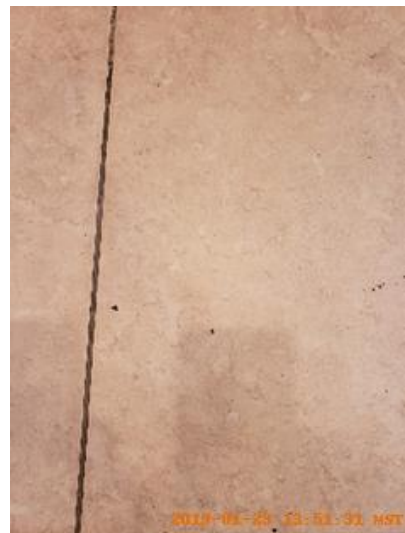
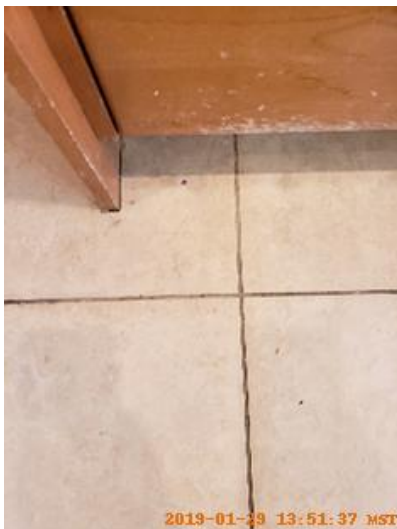
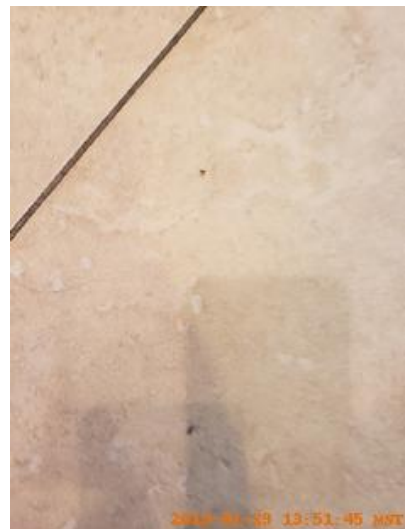
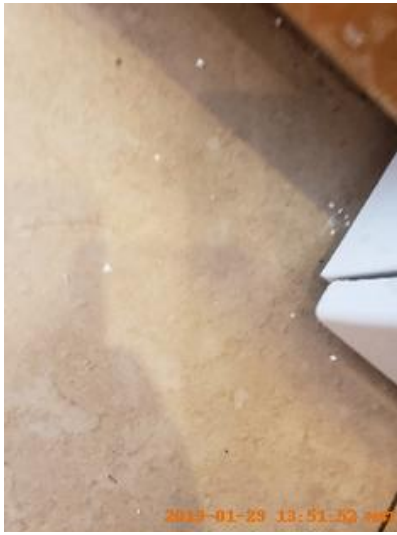
| Kitchen: Kitchen | CONDITION | ACTION | COMMENTS |
|---|---|---|---|
| Flooring/Baseboard | - - - D | None | tile is chipped and broken, dirty |

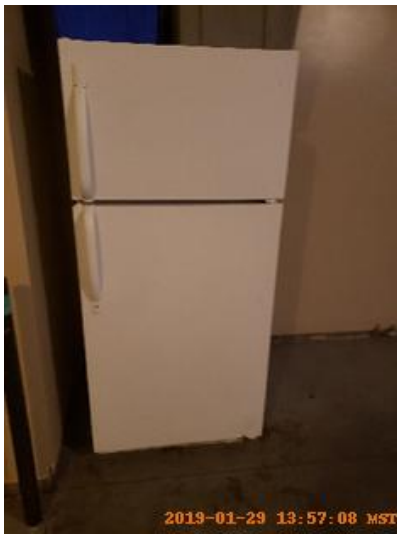
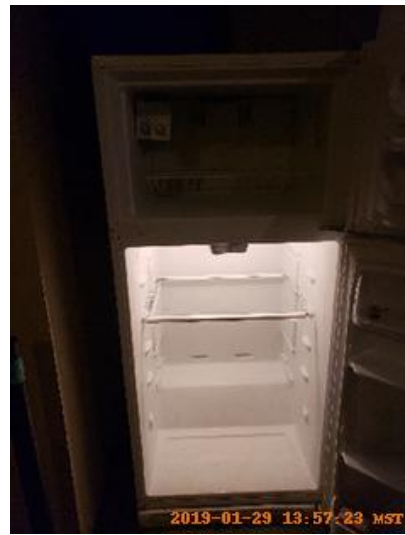
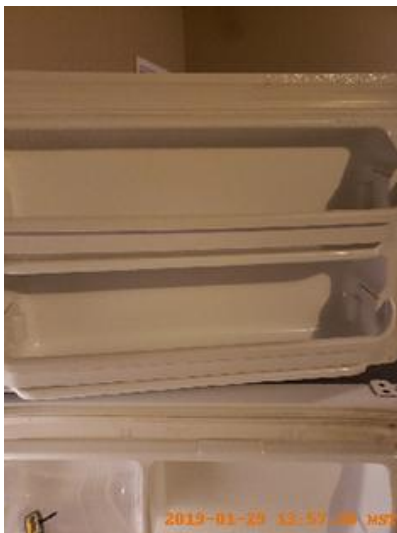
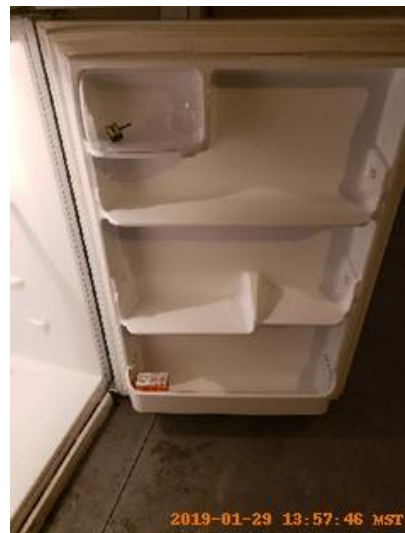
| Kitchen: Kitchen | CONDITION | ACTION | COMMENTS |
|---|---|---|---|
| Refrigerator | - - - D | None | Fridge is in the garage, missing shelf and door bin |

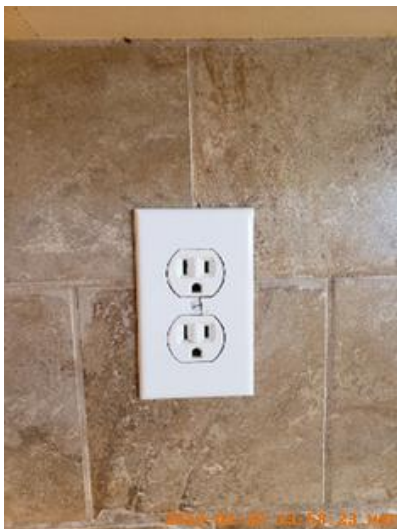
Switch/Outlet

None  
 None  
 None  
 None  
 None  
 1 broken cover

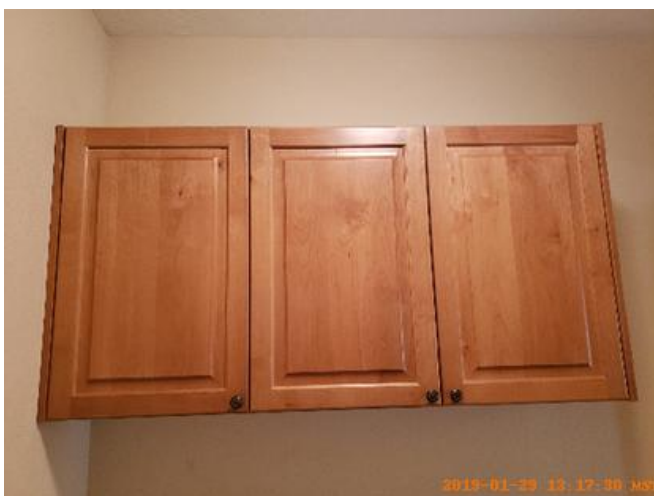
| Cabinet/Counter/Shelving | - - - D | None | door stop is bent and cap is missing |

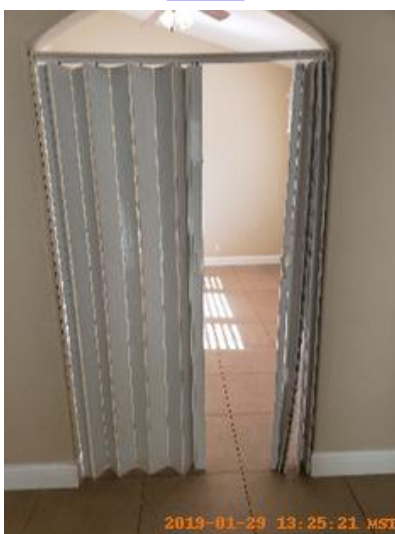
Door/Knob/Lock  
Taken on: 2019-01-29 13:25:21  
Taken at: [43.56527218, -116.60371061](#)  
[Image](#)

| Door/Knob/Lock | - - - D | None | Slider door between dining room and bonus room is split on one panel and slider guides are broken |

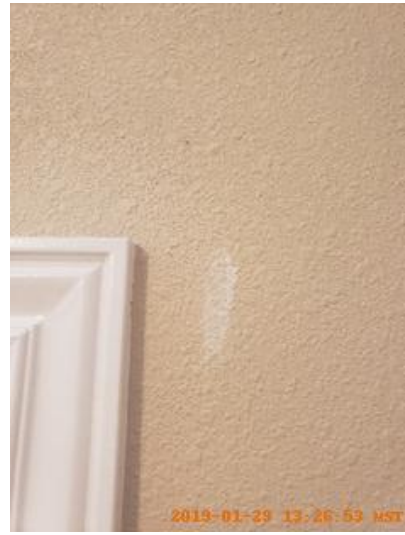
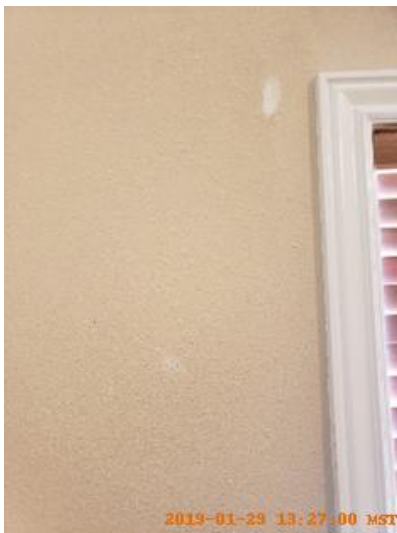
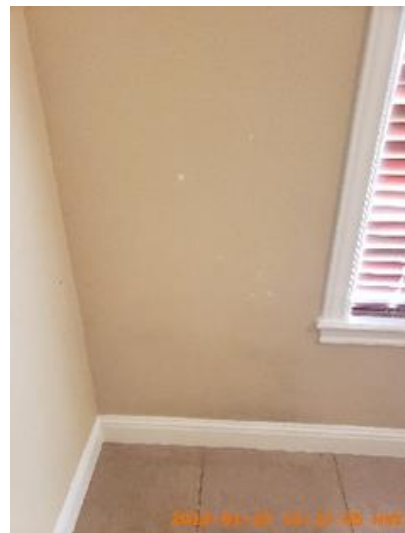
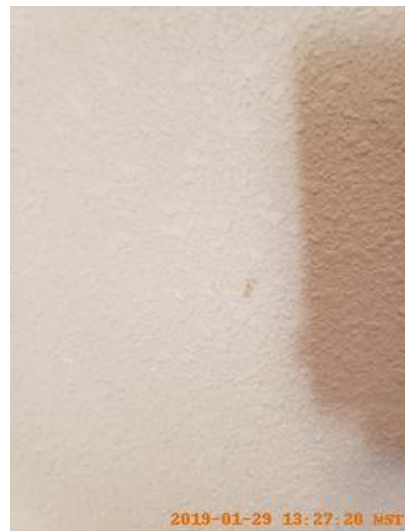
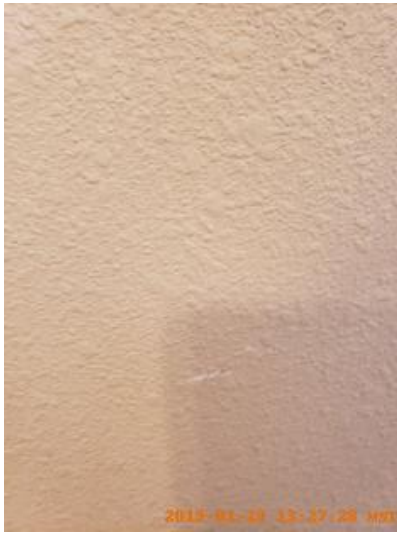
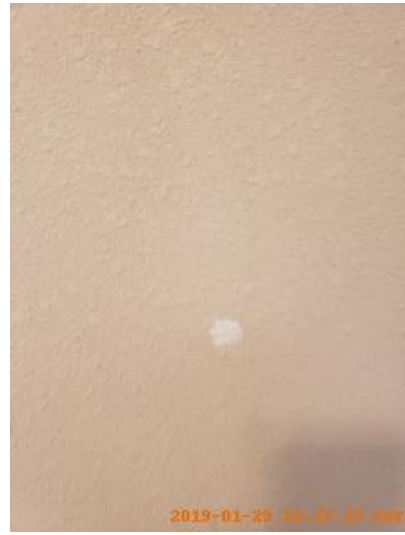
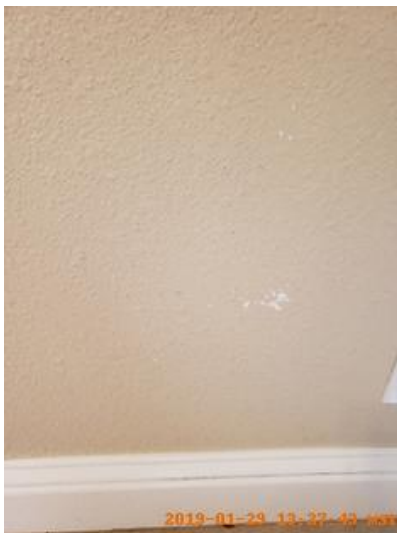
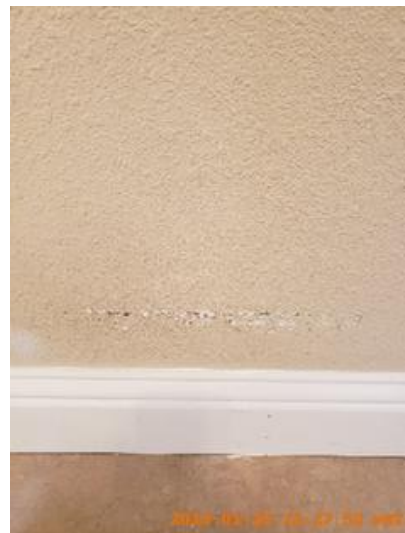
| Wall/Ceiling | - - - D | None | walls have been patched and stickers on ceiling |

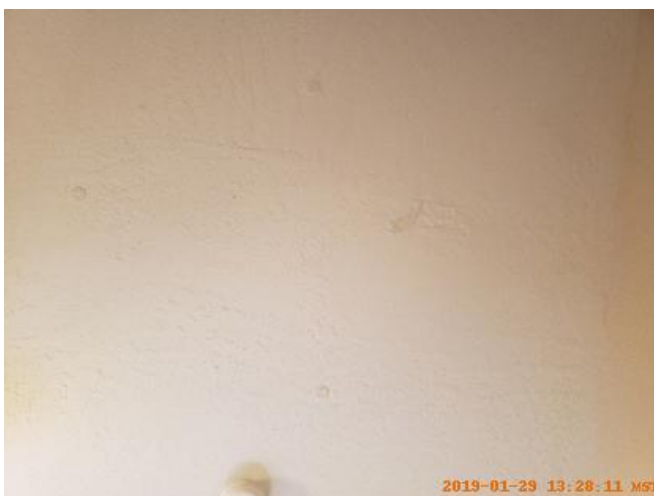
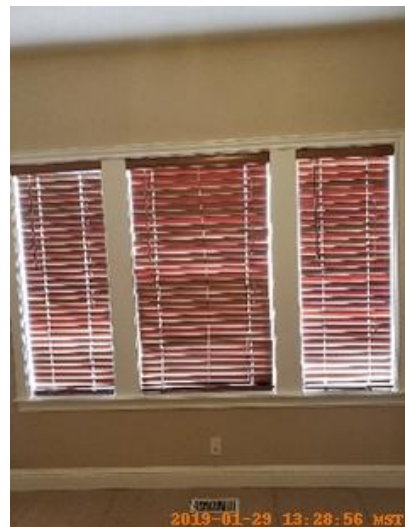
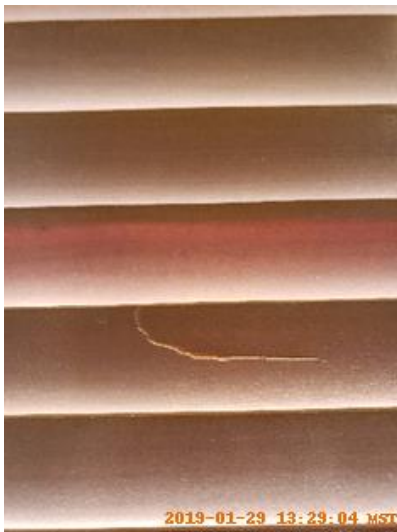
| Window Covering | - - - D | None | caps are missing on all blinds, one blind has a damaged slat |

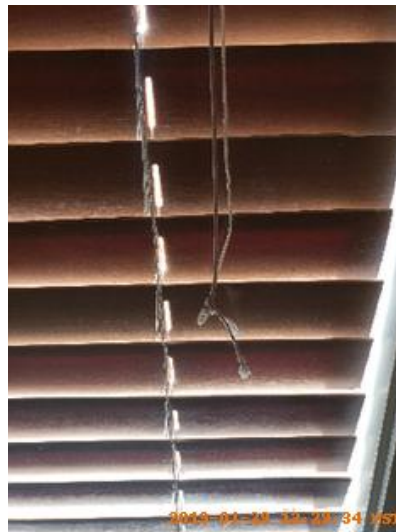
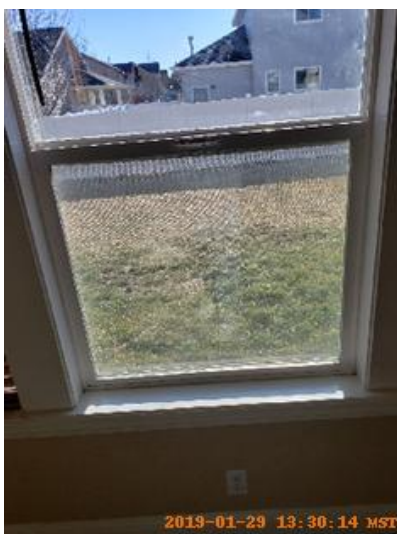
| Window/Lock/Screen | - - - D | None | Window lock is damaged |

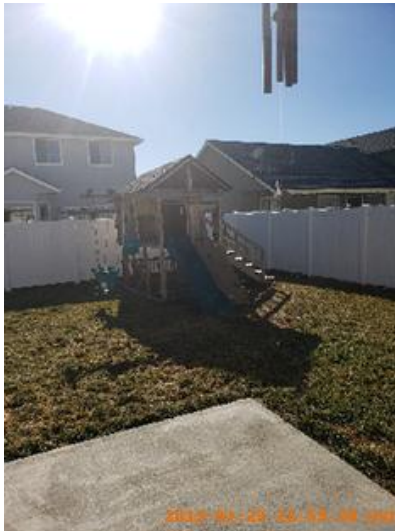
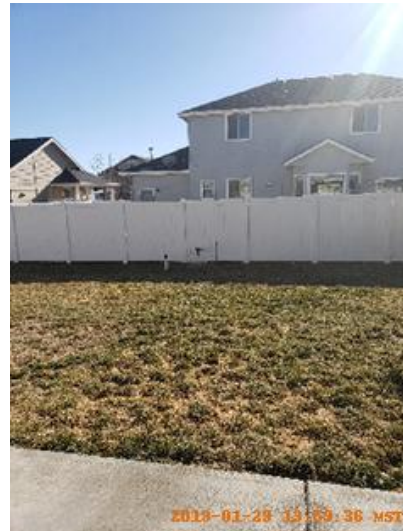
| Other | - - - D | None | Dog feces and holes throughout back yard |

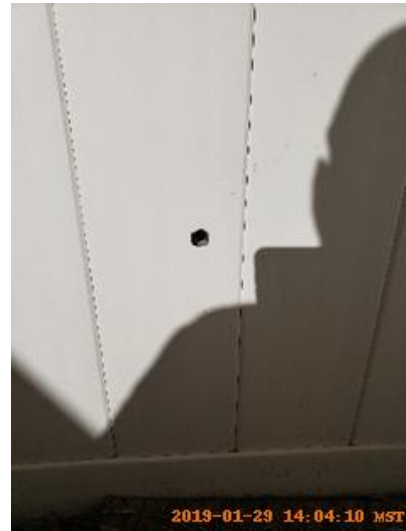
Fence/Gate  
 Taken on: 2019-01-29 14:04:10  
**Taken at: [43.56540357, -116.60399391](#)**  
[Image](#)

| Fence/Gate | - - - D | None | hole in vinyl fence |

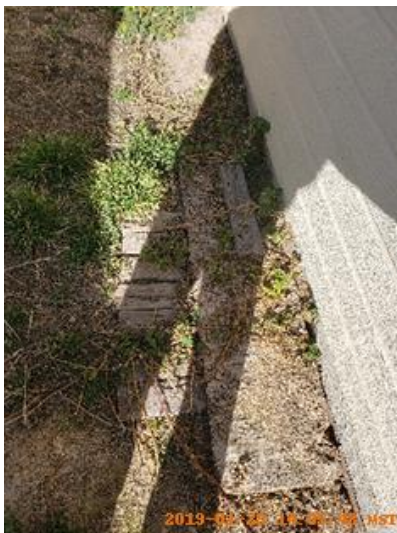
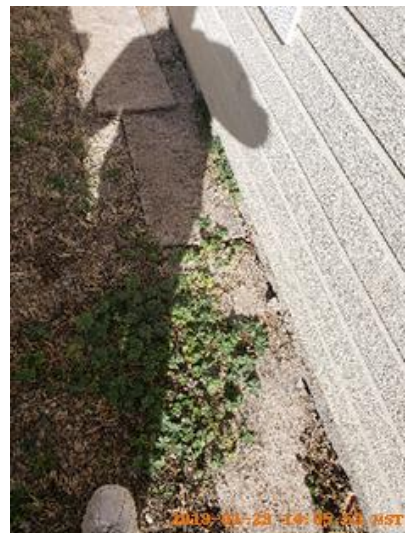
| Other | - - - D | None | Dog feces and holes throughout side yard |

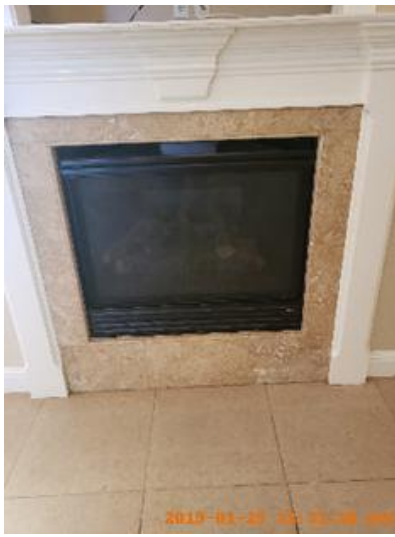
| Fireplace/Chimney: Fireplace | CONDITION | ACTION | COMMENTS |
|---|---|---|---|
| Other | - - - D | None | unknown substance on glass and screen |

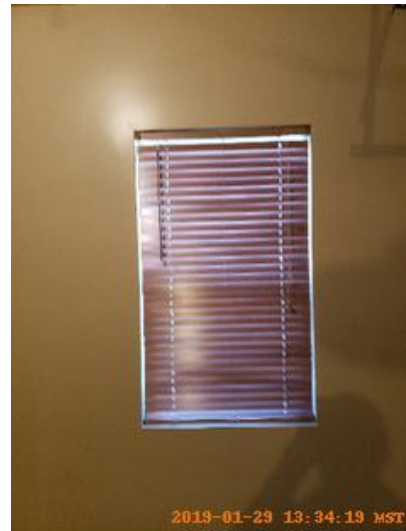
| Garage/Parking: Garage | CONDITION | ACTION | COMMENTS |
|---|---|---|---|
| Window/Lock/Screen | - - - D | None | valance missing on blinds |
