, Meridian, ID 83642 Move Out  
2019-11-01

## Move Out Condition Summary

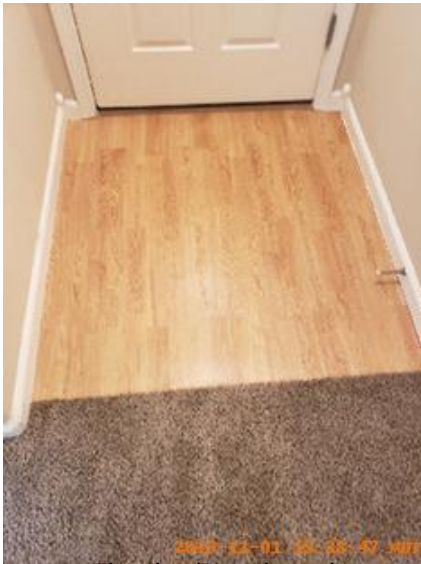
Flooring/Baseboard

| AREA | DETAIL | D | ACTION | COMMENTS | IMAGES |
|---|---|---|---|---|---|
| Entry | Flooring/<br>Baseboard | D | | chip paint on<br>baseboard | <a href="#">Image 1</a><br><a href="#">Image 2</a> |

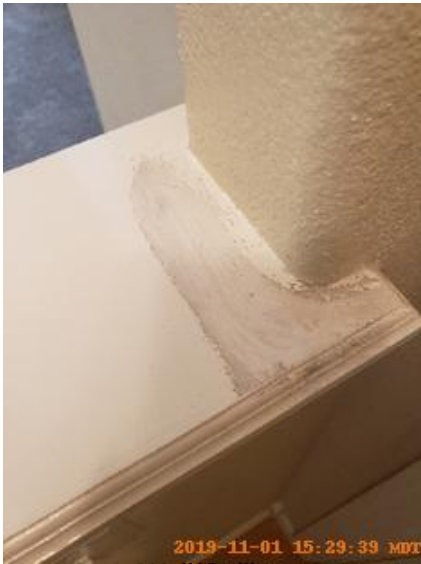
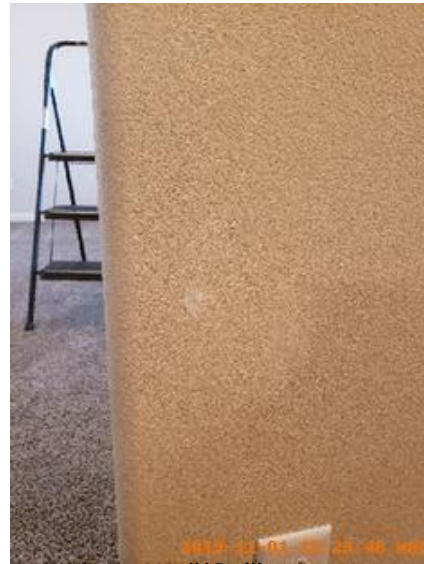
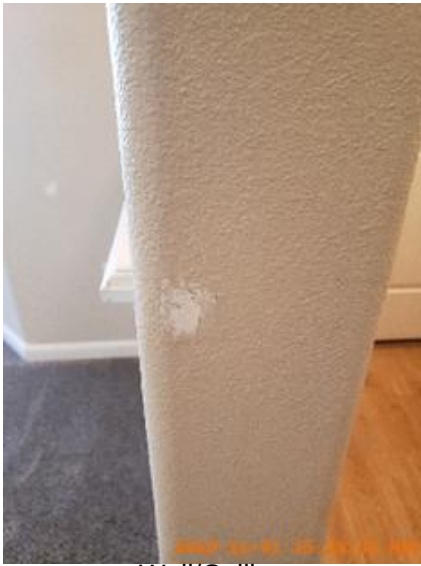
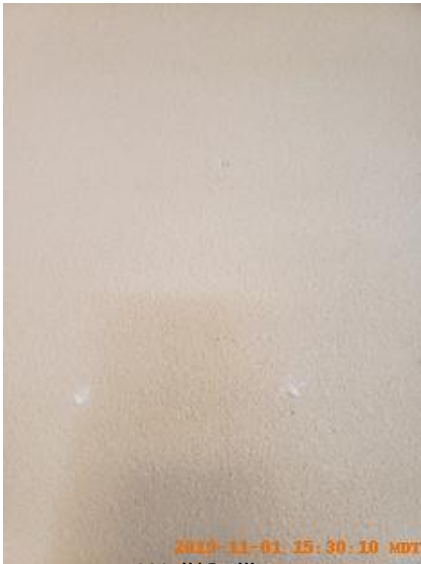
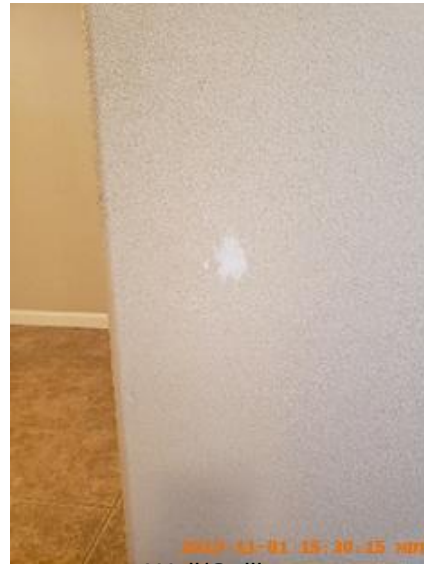
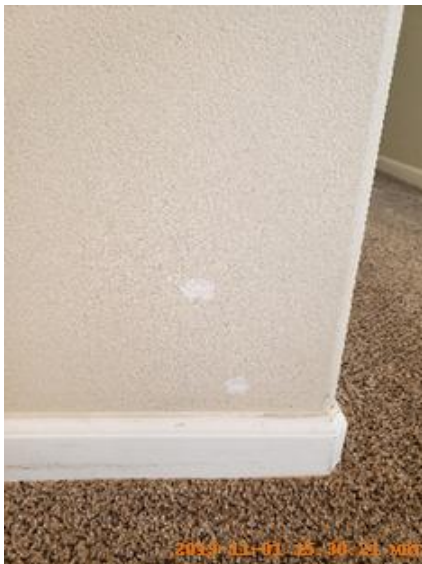
| Entry | CONDITION | ACTION | COMMENTS |
|---|---|---|---|
| Wall/ Ceiling | - - - D | None | patched but not painted or texture holes in wall, banister has paint on it, owner would like the holes texture |

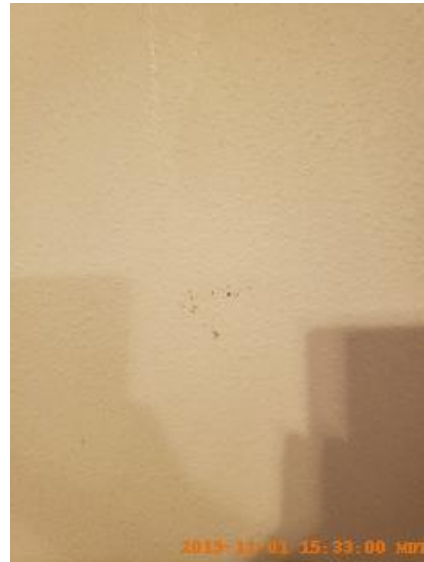
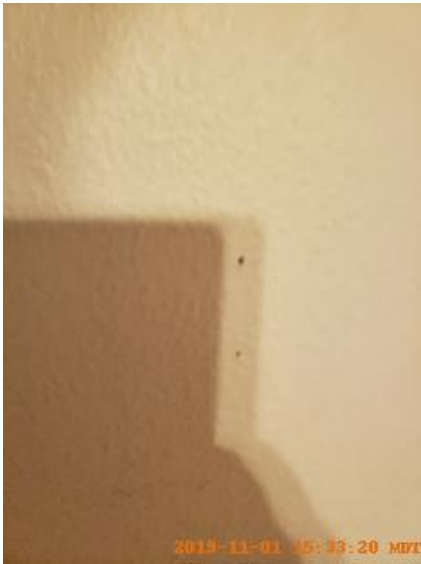
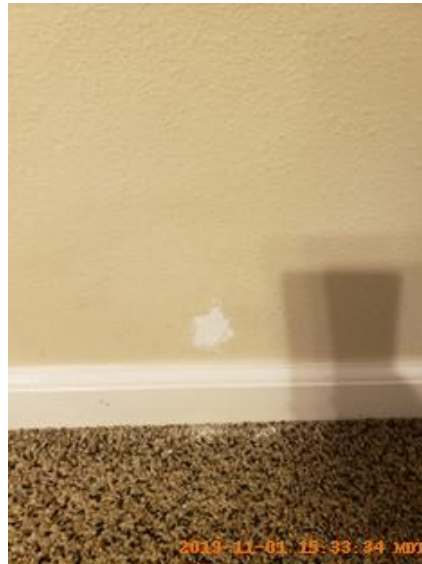
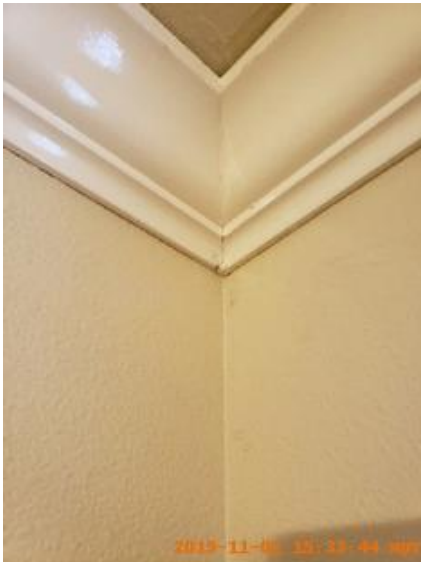
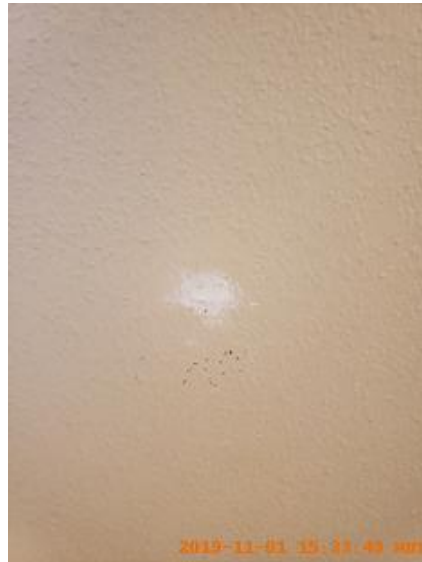
| Family Room | CONDITION | ACTION | COMMENTS |
|---|---|---|---|
| Wall/ Ceiling | - - - D | None | patched but not painted or texture holes in walls, owner would like the holes texture |

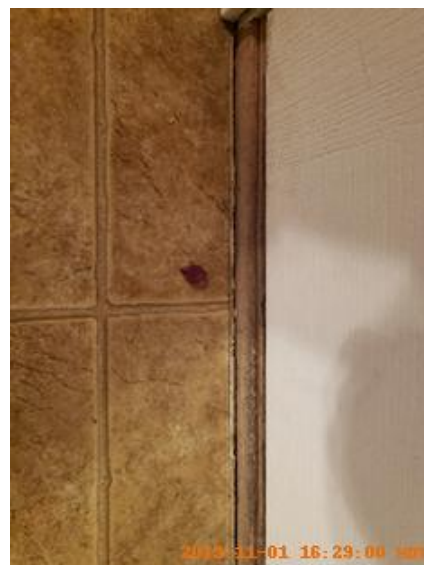
Flooring/Baseboard

| Family Room | CONDITION | ACTION | COMMENTS |
|---|---|---|---|
| Flooring/ Baseboard | - - - D | None | vinyl floor is rolling up by garage door |

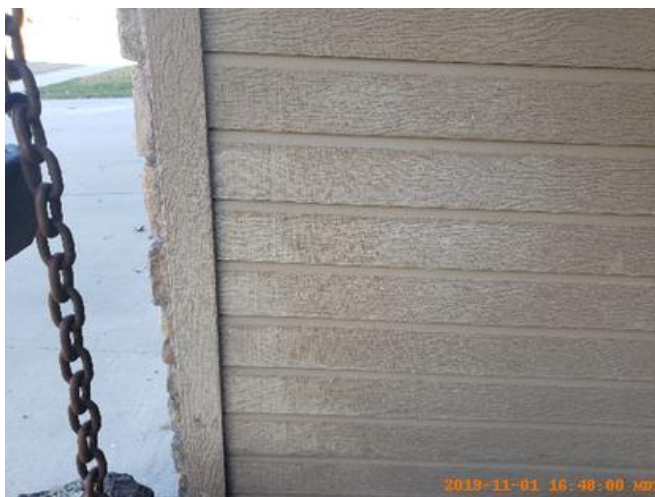
| Front Yard/Exterior | CONDITION | ACTION | COMMENTS |
|---|---|---|---|
| Building Exterior | - - - D | None | paint is fading |

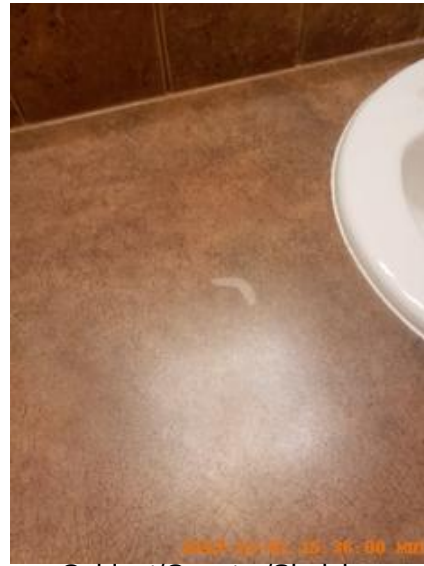
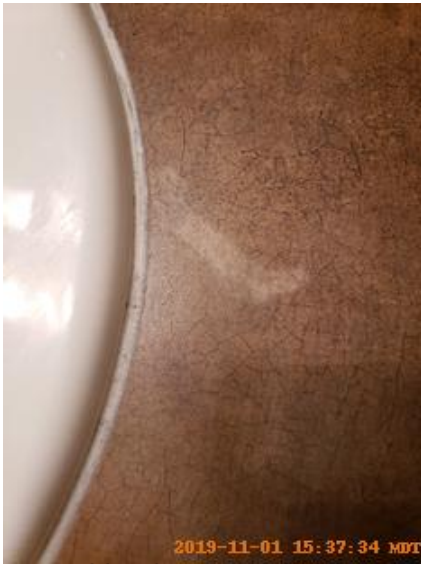
| Bathroom 1: bathroom1 | CONDITION | ACTION | COMMENTS |
|---|---|---|---|
| Cabinet/ Counter/ Shelving | - - - D | None | burn mark on counter top, grout is cracking |

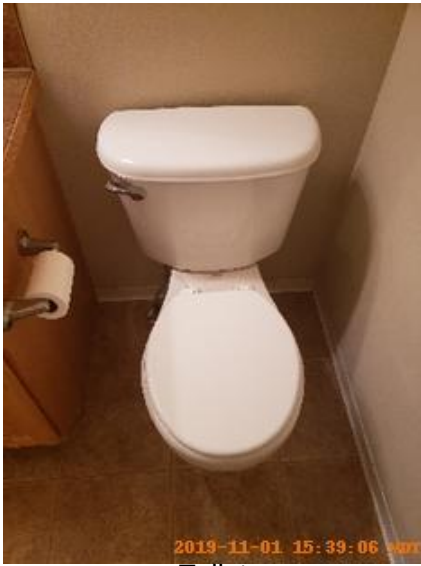
| Bathroom 1 | Toilet | D | | caulking around toilet is cracking and peeling | <a href="#">Image 1</a><br><a href="#">Image 2</a><br><a href="#">Image 3</a> |

| Bathroom 1: bathroom1 | CONDITION | ACTION | COMMENTS |
|---|---|---|---|
| Toilet | - - - D | None | caulking around toilet is cracking and peeling |

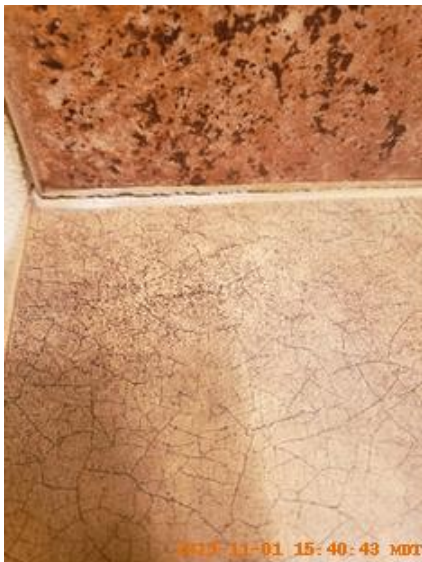
Cabinet/Counter/Shelving

| AREA | DETAIL | D | ACTION | COMMENTS | IMAGES |
|---|---|---|---|---|---|
| Bathroom 1 | Cabinet/ Counter/<br>Shelving | D | | burn mark on<br>counter top, grout<br>is cracking | <a href="#">Image 1</a><br><a href="#">Image 2</a><br><a href="#">Image 3</a> |

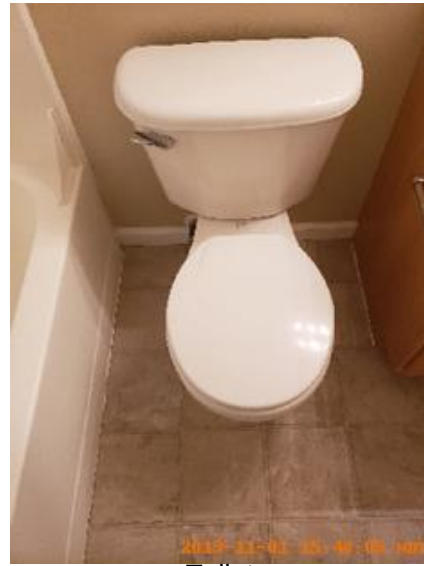
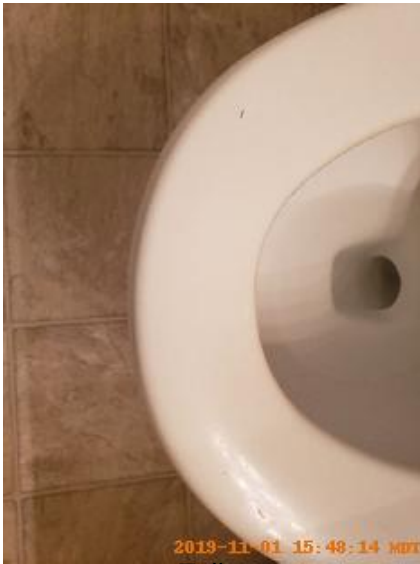
| Bathroom 2 | Toilet | D | | wear marks on toilet seat | <a href="#">Image 1</a><br><a href="#">Image 2</a> |

| Bathroom 2: bathroom2 | CONDITION | ACTION | COMMENTS |
|---|---|---|---|
| Toilet | - - - D | None | wear marks on toilet seat |

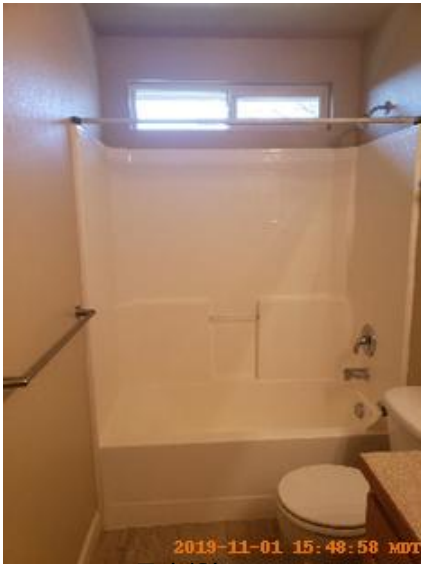
Tub/Shower

| Bathroom 2 | Tub/ Shower | D | | caulking around tub on floor is cracking and peeling | <a href="#">Image 1</a><br><a href="#">Image 2</a> |

| Bathroom 2: bathroom2 | CONDITION | ACTION | COMMENTS |
|---|---|---|---|
| Tub/ Shower | - - - D | None | caulking around tub on floor is cracking and peeling |

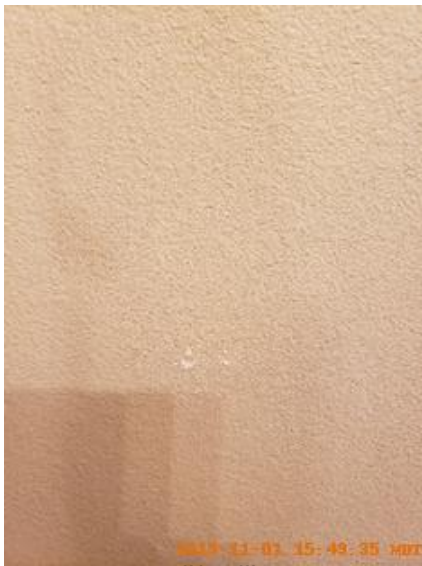
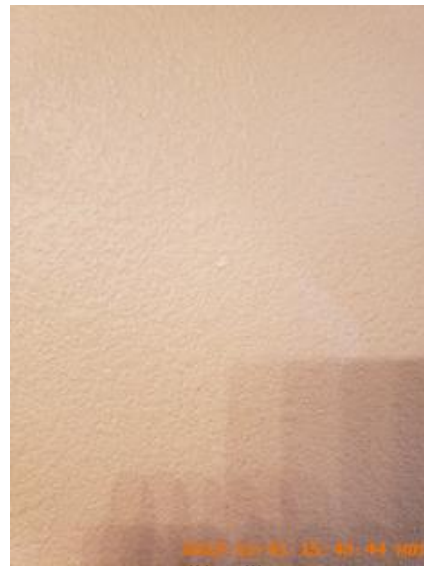
| Bathroom 2: bathroom2 | CONDITION | ACTION | COMMENTS |
|---|---|---|---|
| Wall/ Ceiling | - - - D | None | patched but not painted or texture holes in walls, owner would like the holes texture |

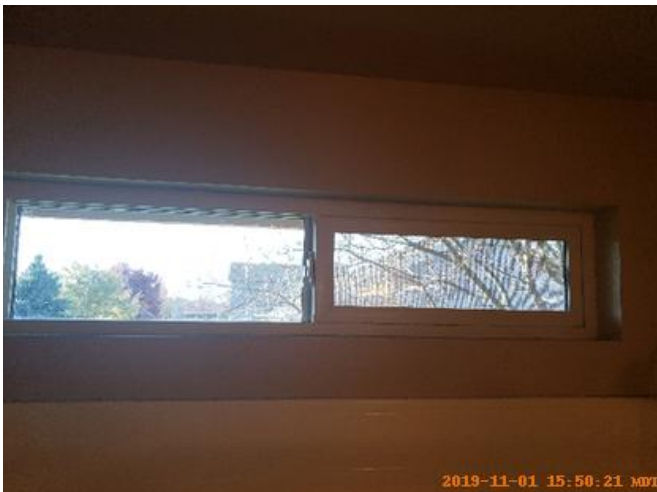
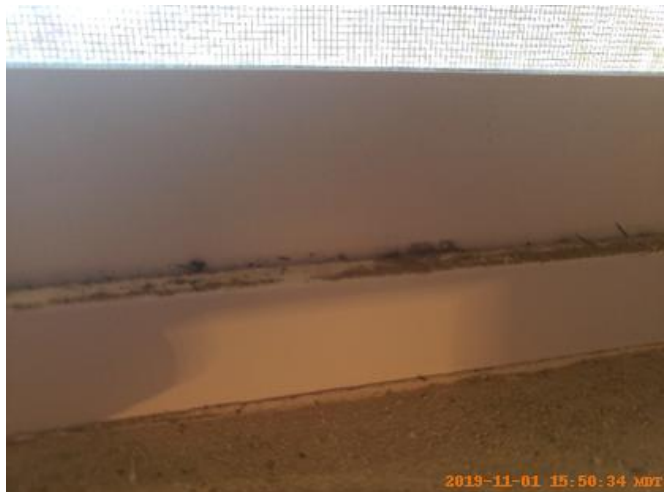
| Bathroom 2: bathroom2 | CONDITION | ACTION | COMMENTS |
|---|---|---|---|
| Window/ Lock/ Screen | - - - D | None | dirty |

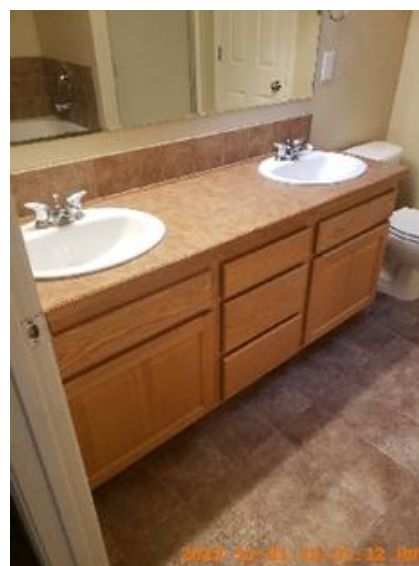
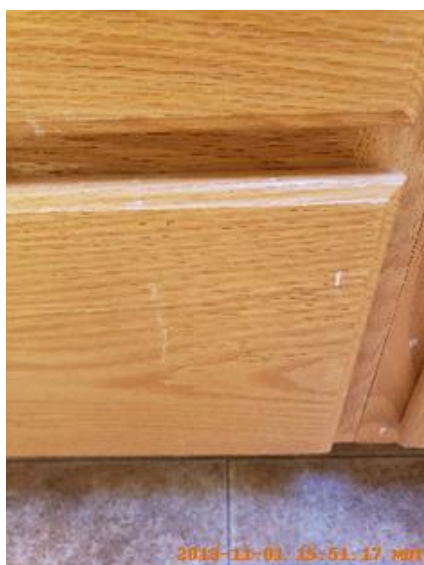
| Bathroom 3: bathroom.5 | CONDITION | ACTION | COMMENTS |
|---|---|---|---|
| Cabinet/ Counter/ Shelving | - - - D | None | cabinet fronts are dirty |

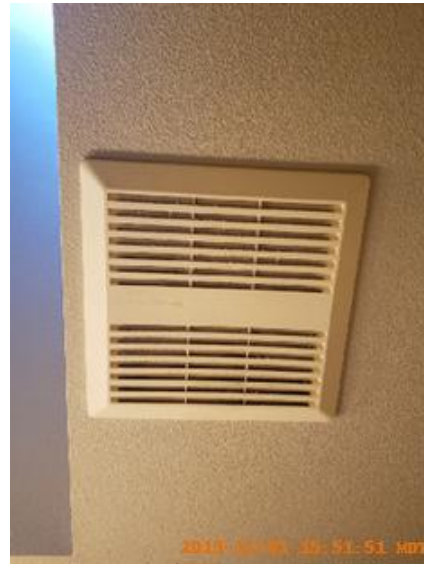
| Bathroom 3: bathroom.5 | CONDITION | ACTION | COMMENTS |
|---|---|---|---|
| Exhaust Fan | - - - D | None | dirty |

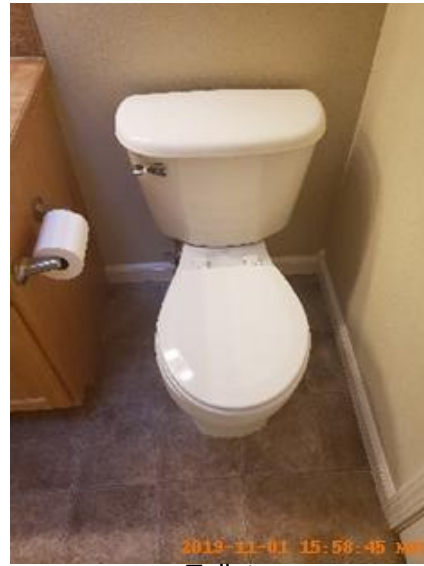
| Toilet | - - - D | None | caulking around toilet is cracking and peeling |

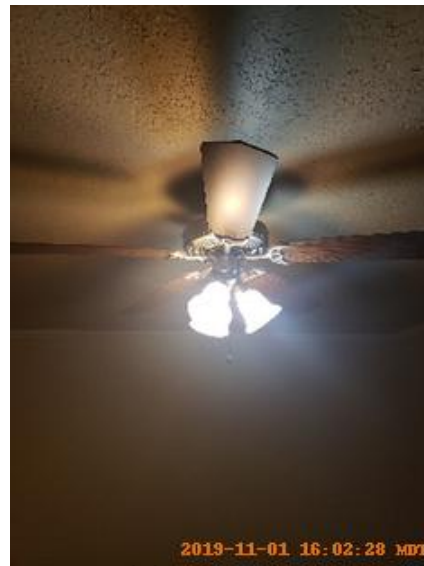
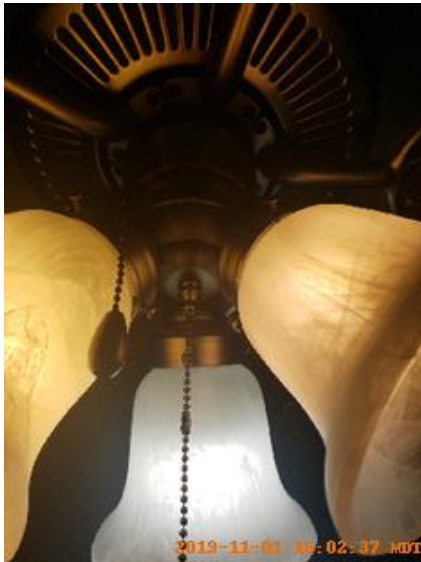
Light Fixture/Fan

| Bedroom 1: bedroom1 | CONDITION | ACTION | COMMENTS |
|---|---|---|---|
| Light Fixture/ Fan | - - - D | None | dirty |

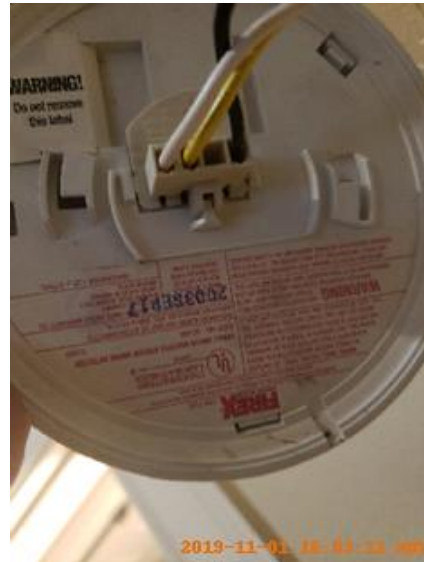
| Bedroom 1: bedroom1 | CONDITION | ACTION | COMMENTS |
|---|---|---|---|
| Smoke / CO detector | - - - D | None | manufactured in 2004 |

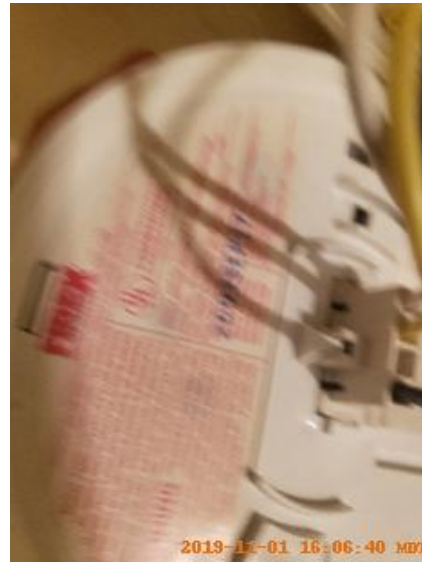
| Bedroom 2: bedroom2 | CONDITION | ACTION | COMMENTS |
|---|---|---|---|
| Smoke / CO detector | - - - D | None | manufactured in 2003 |

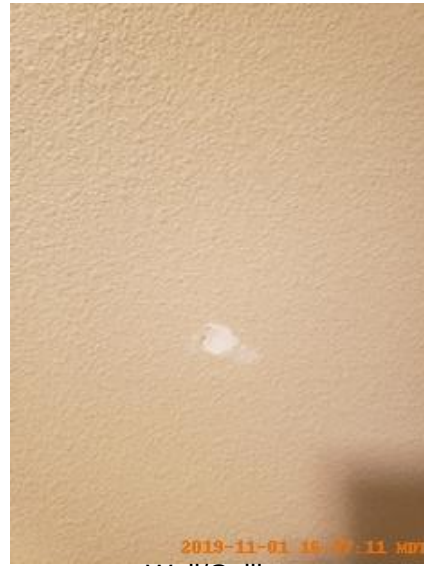
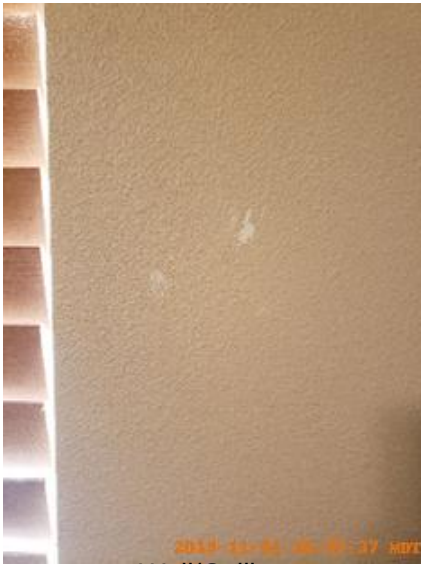
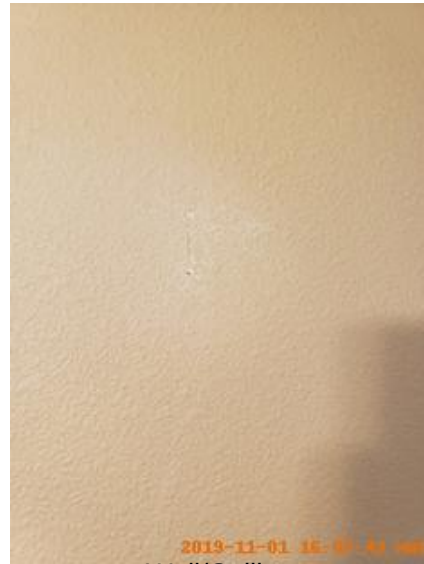
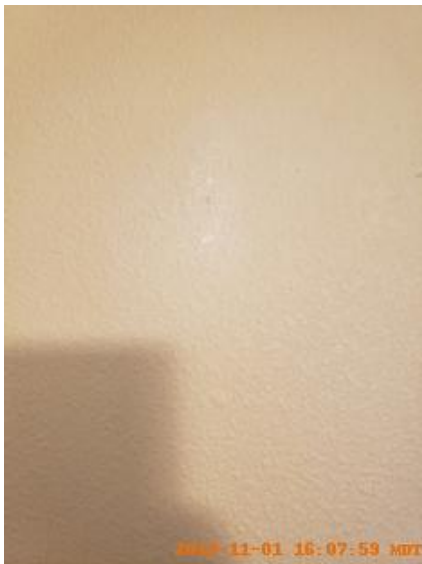
Wall/Ceiling

| Bedroom 2: bedroom2 | CONDITION | ACTION | COMMENTS |
|---|---|---|---|
| Wall/ Ceiling | - - - D | None | patched but not painted or texture holes in walls |

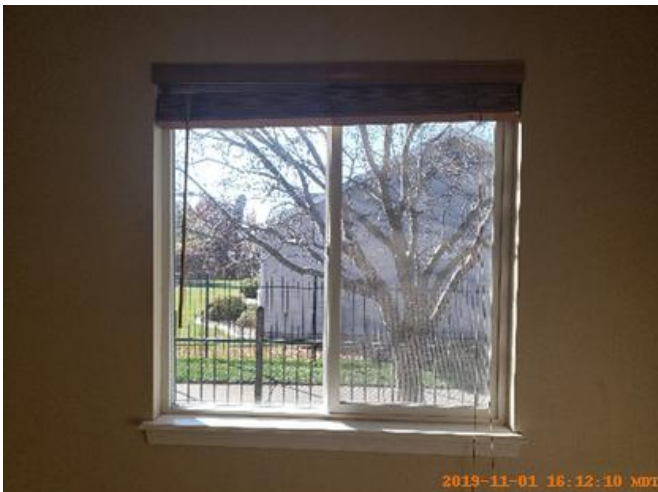
Window/Lock/Screen

| Family Room | CONDITION | ACTION | COMMENTS |
|---|---|---|---|
| Window/ Lock/ Screen | - - - D | None | screen is worn |

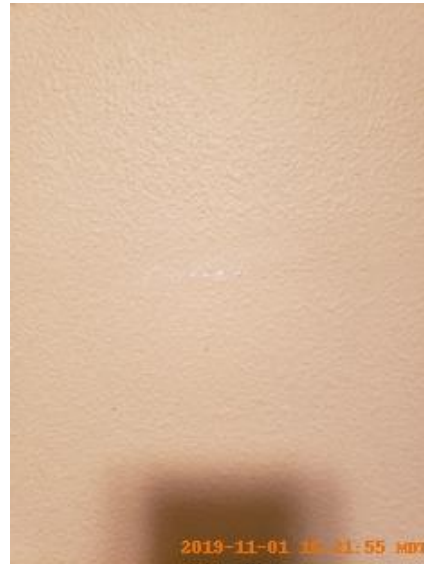
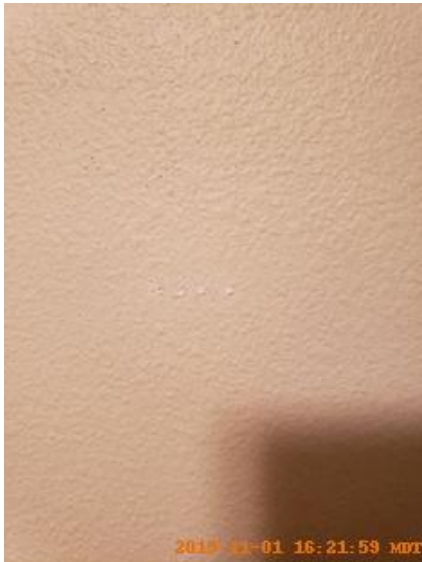
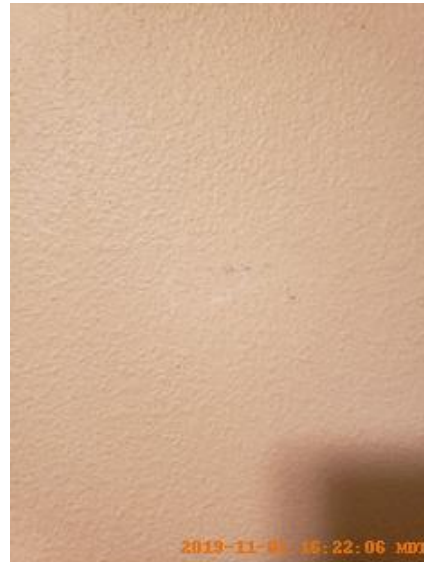
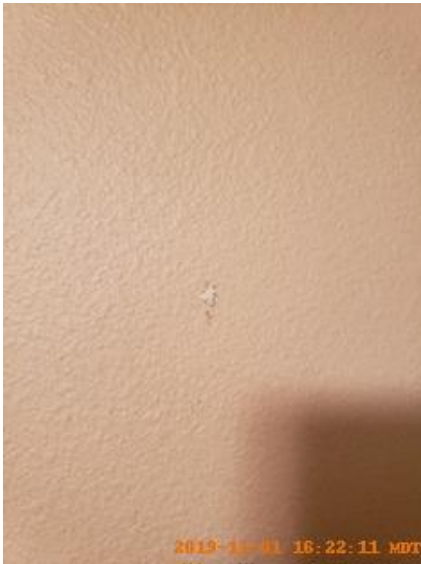
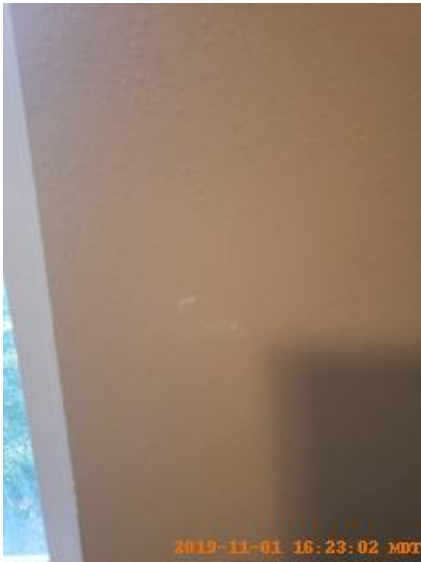
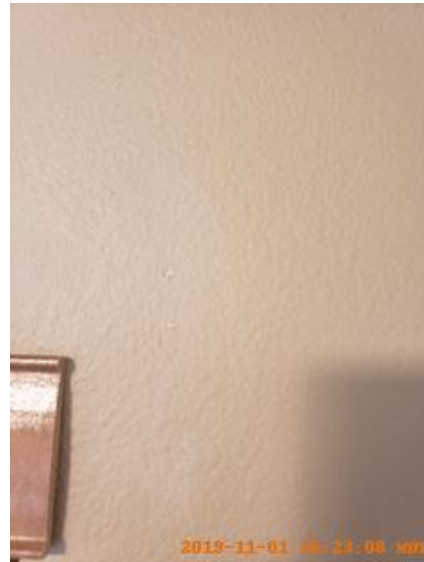
Wall/Ceiling

| Wall/ Ceiling | - - - D | None | patched but not painted or texture holes in walls, owner would like the holes texture |

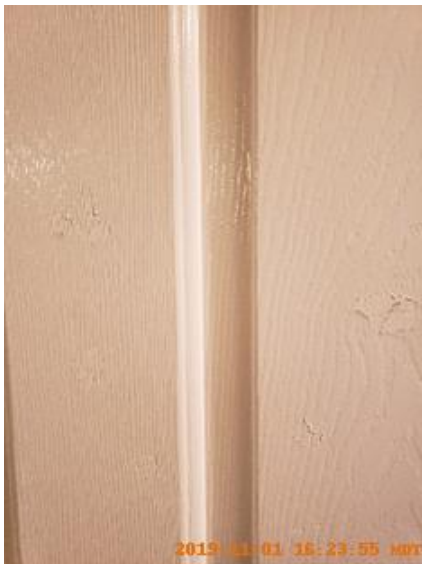
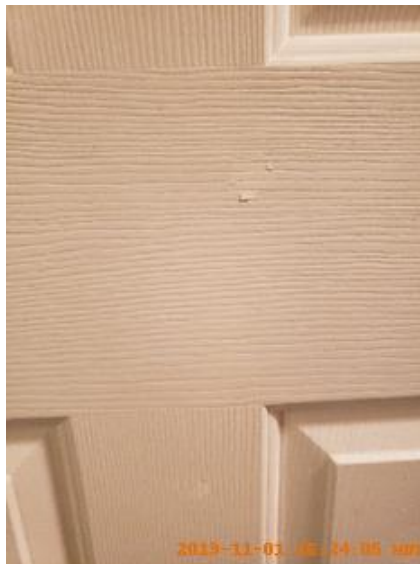
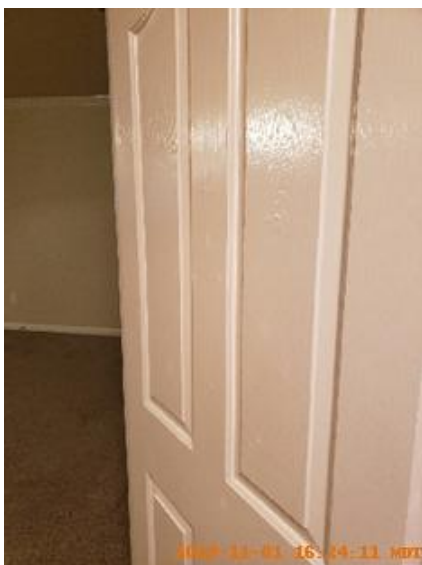
Door/Knob/Lock

| Door/ Knob/ Lock | - - - D | None | chip paint on door |

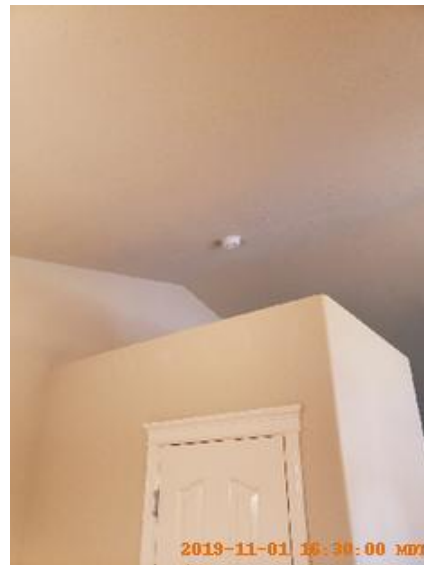
Smoke/CO Detector

| Smoke/ CO Detector | - - - D | None | to high to reach |

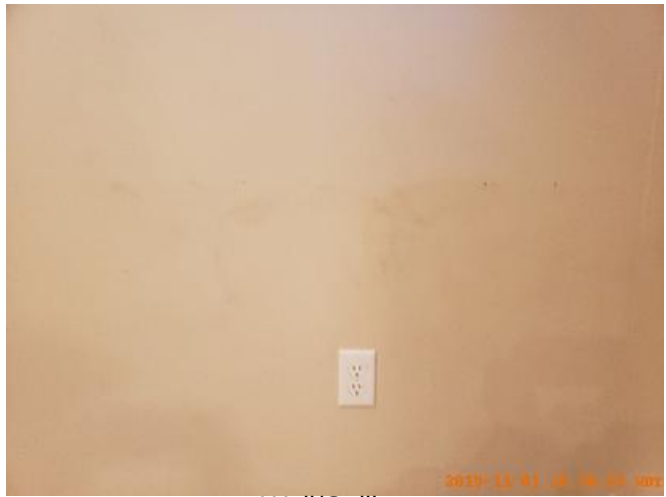
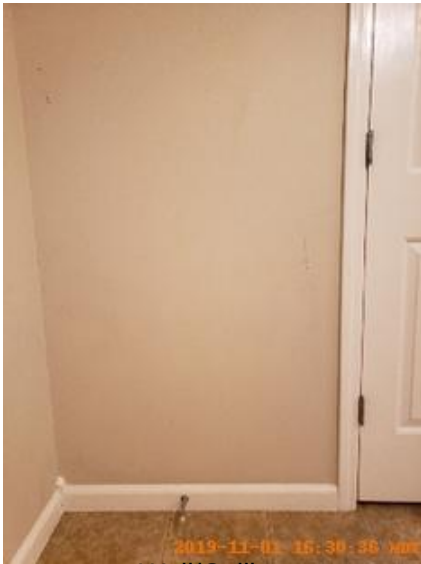
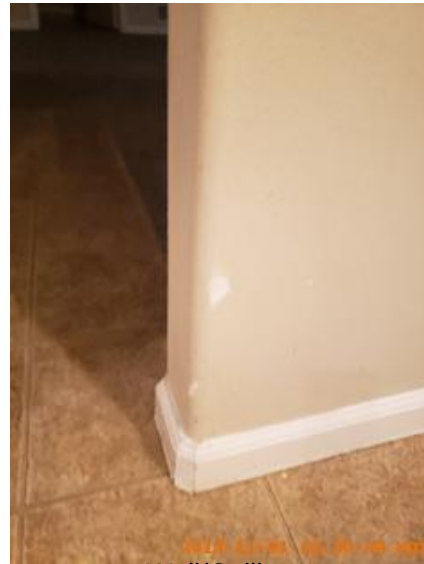
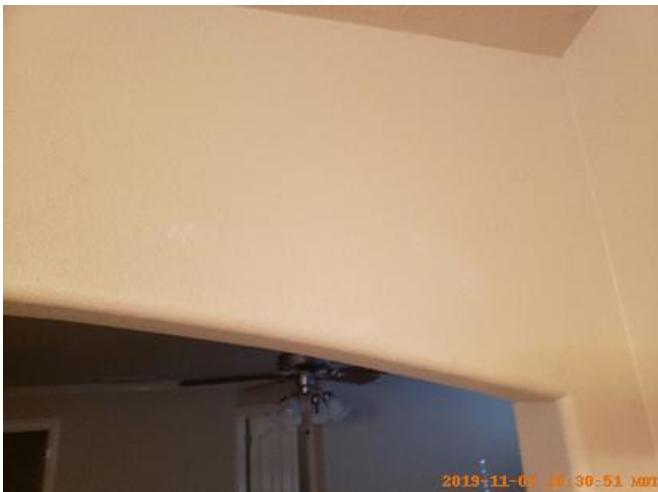
Wall/Ceiling

| Wall/ Ceiling | - - - D | None | dirty, patched but not painted or texture holes in walls, owner would like the holes texture |

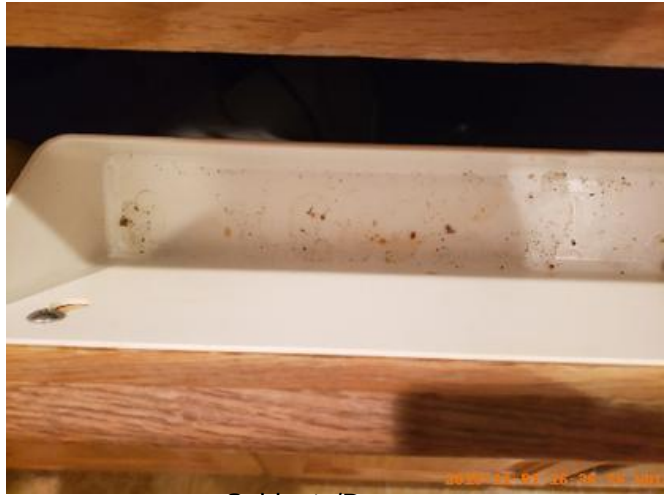
Cabinets/Drawers

| Kitchen | CONDITION | ACTION | COMMENTS |
|---|---|---|---|
| Cabinets/ Drawers | - - - D | None | dirty |

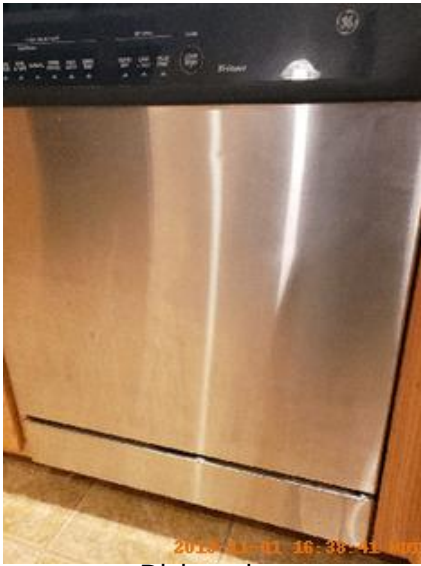
| Kitchen | CONDITION | ACTION | COMMENTS |
|---|---|---|---|
| Dishwasher | - - - D | None | filter on bootom of dishwasher is cracking, dirty front |

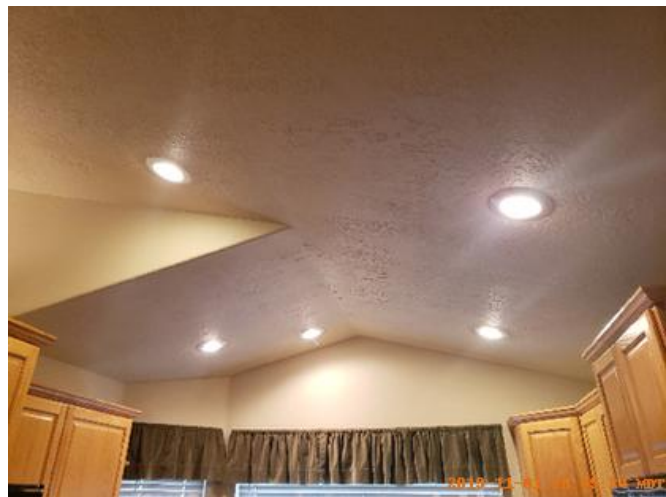
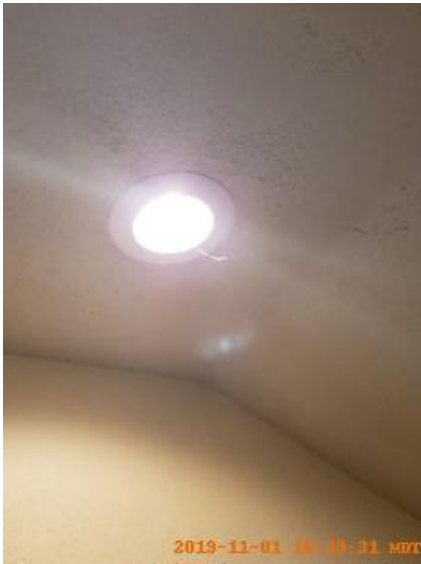
| Kitchen | CONDITION | ACTION | COMMENTS |
|---|---|---|---|
| Light Fixture | - - - D | None | dirty |

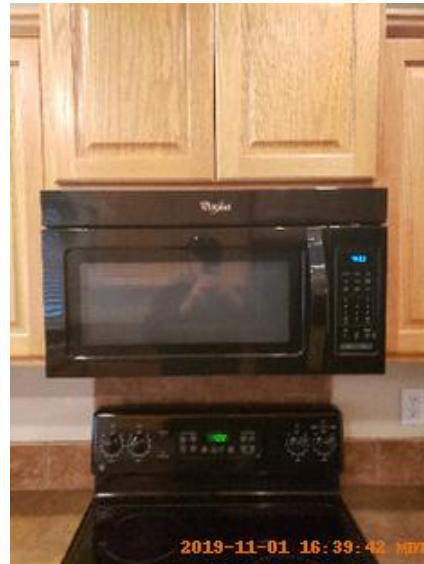
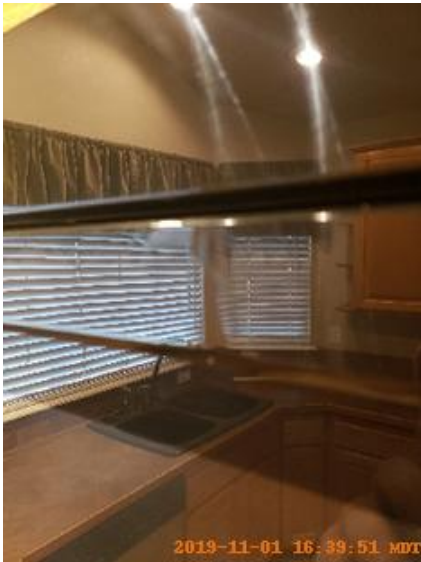
| Kitchen | CONDITION | ACTION | COMMENTS |
|---|---|---|---|
| Microwave | - - - D | None | cracks on microwave door |

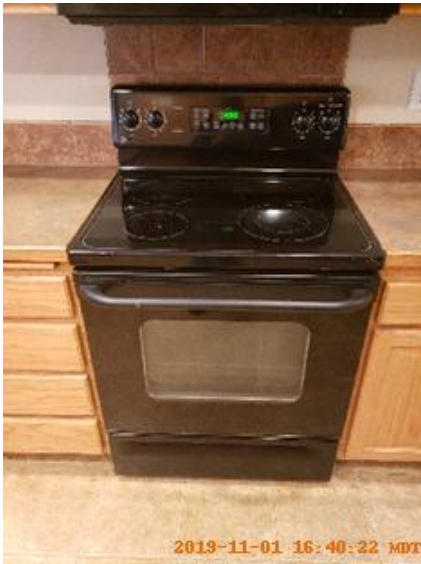
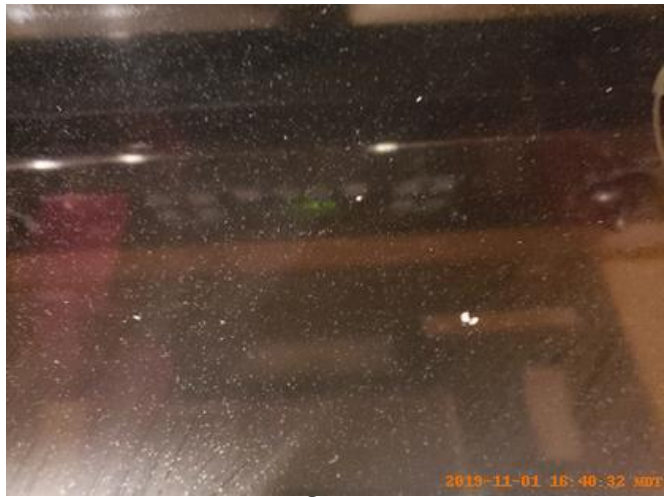
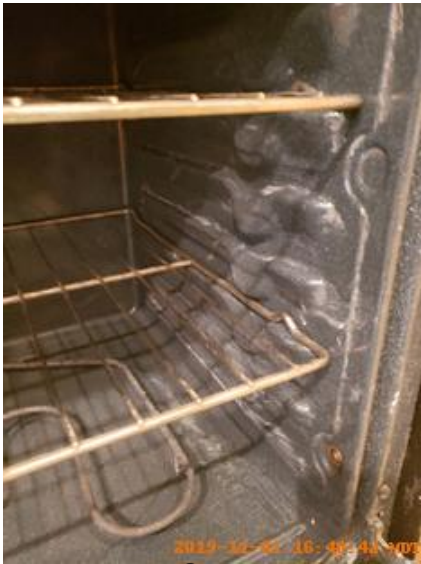
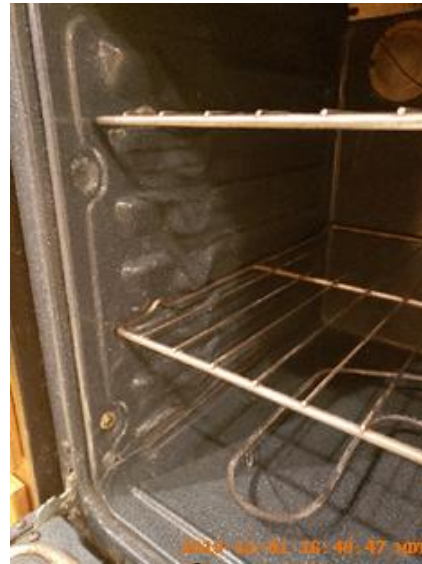
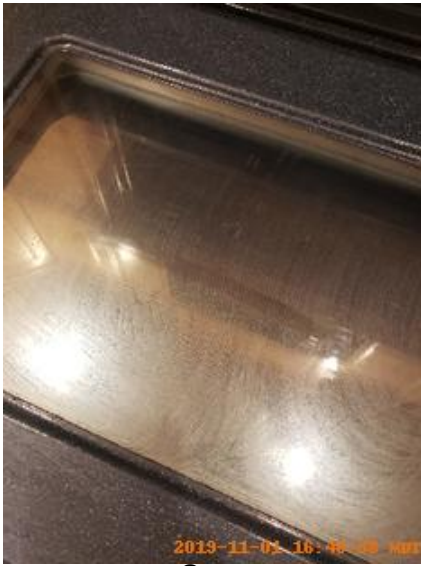
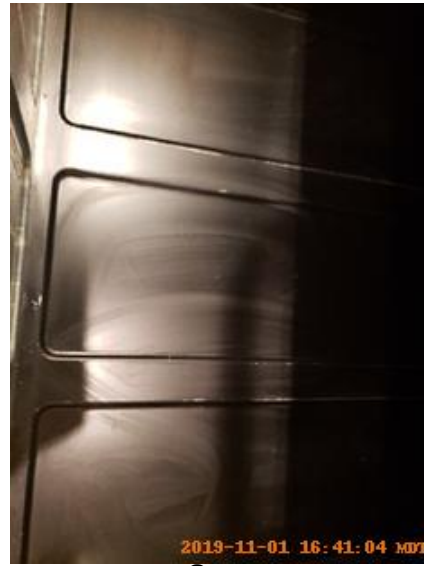
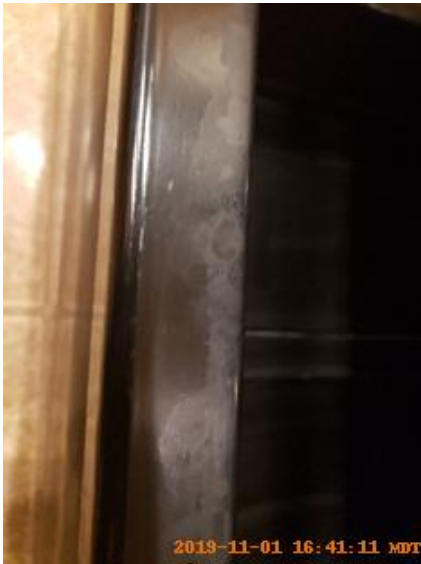
| Kitchen | CONDITION | ACTION | COMMENTS |
|---|---|---|---|
| Oven | - - - D | None | dirty |

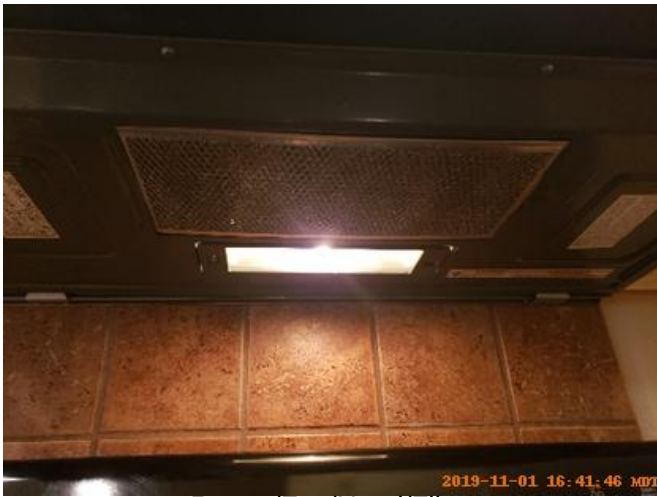
Range/Fan/Hood/Filter

| Kitchen | CONDITION | ACTION | COMMENTS |
|---|---|---|---|
| Range/ Fan/ Hood/ Filter | - - - D | None | dirty |

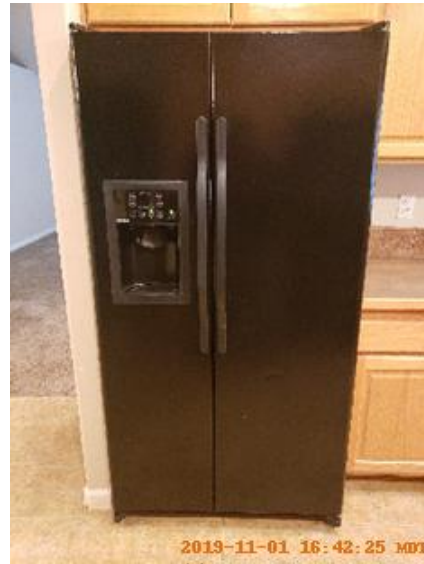
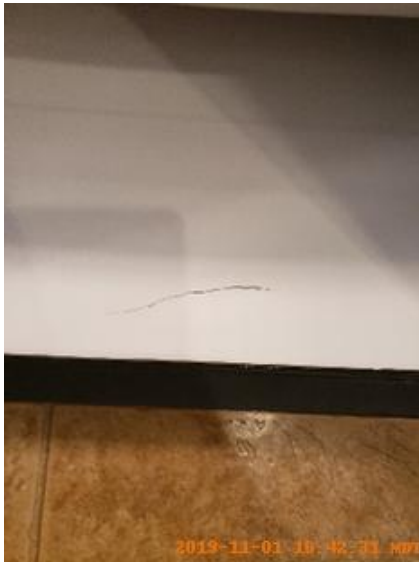
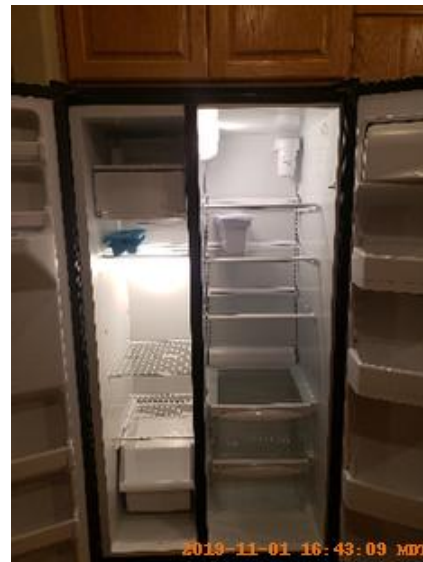
| Kitchen | CONDITION | ACTION | COMMENTS |
|---|---|---|---|
| Refrigerator | - - - D | None | crack on fridge bottom |

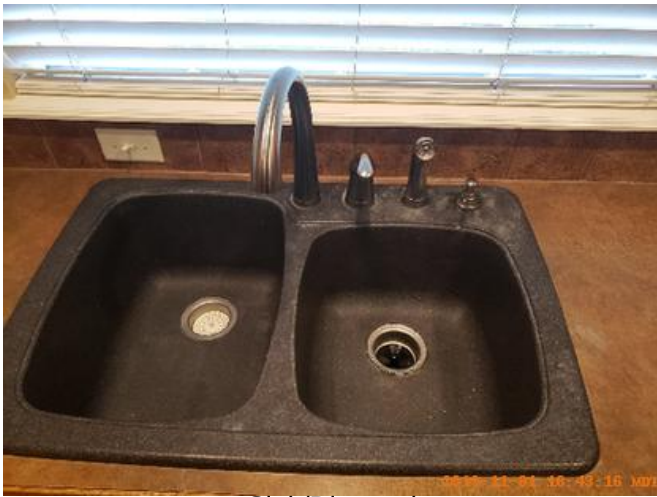
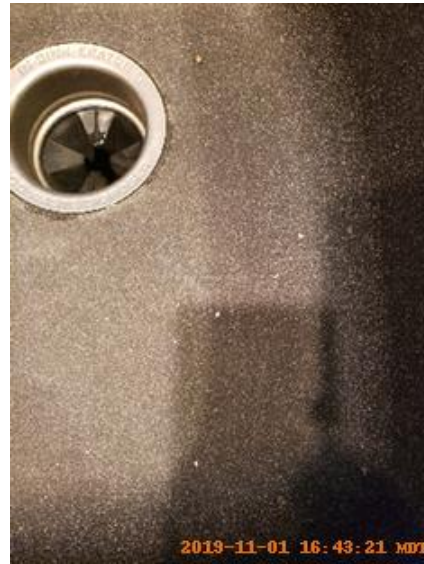
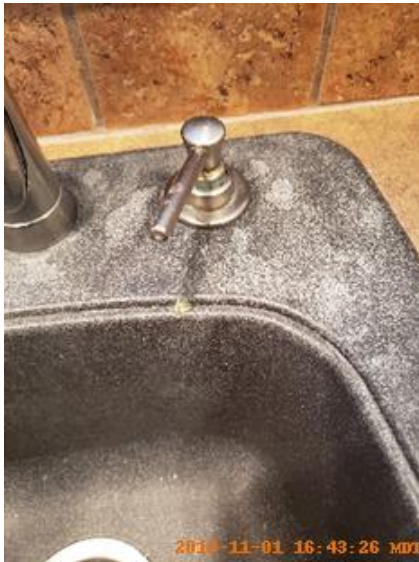
Sink/Disposal

| Kitchen | CONDITION | ACTION | COMMENTS |
|---|---|---|---|
| Sink/ Disposal | - - - D | None | dirty |

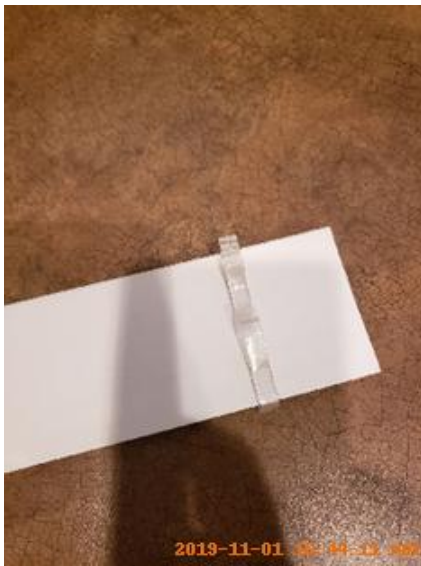
| Kitchen | CONDITION | ACTION | COMMENTS |
|---|---|---|---|
| Window Covering | - - - D | None | broken valance clips |

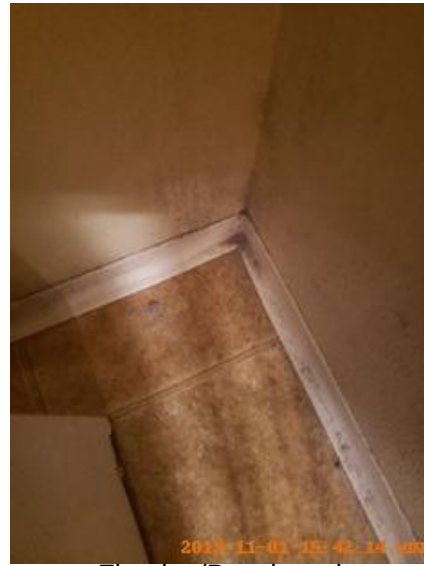
Flooring/Baseboard

| Laundry Room | CONDITION | ACTION | COMMENTS |
|---|---|---|---|
| Flooring/ Baseboard | - - - D | None | dirty |

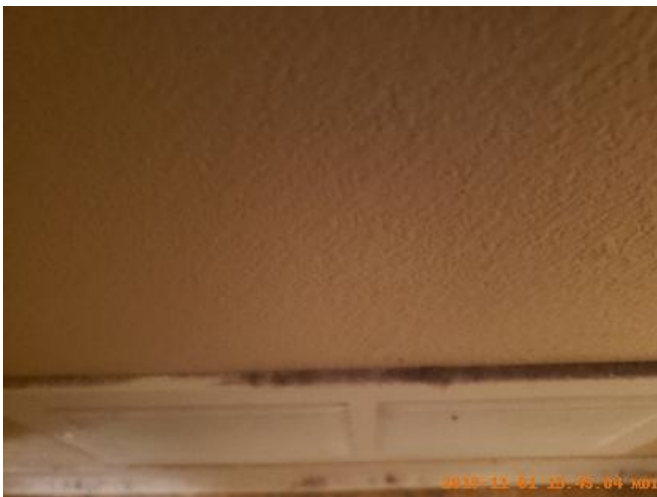
Wall/Ceiling

| Laundry Room | CONDITION | ACTION | COMMENTS |
|---|---|---|---|
| Wall/ Ceiling | - - - D | None | dirty |

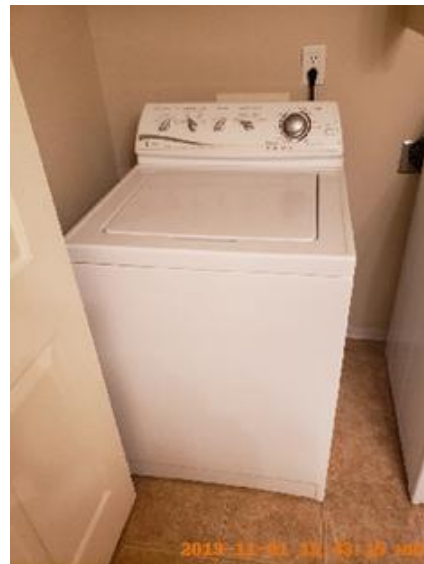
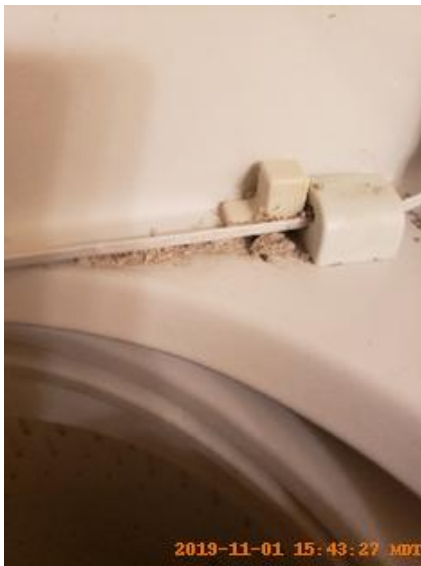
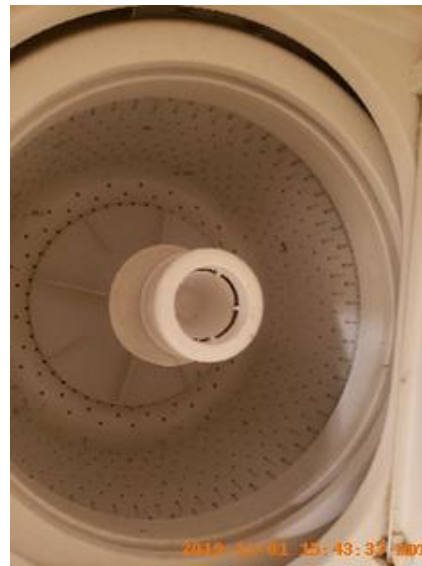
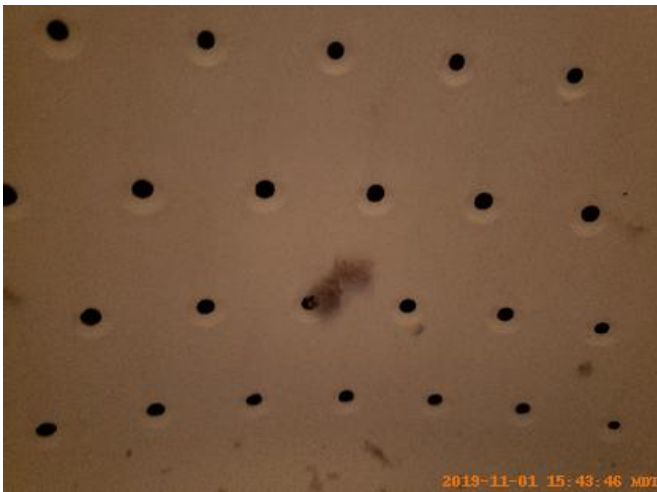
| Laundry Room | CONDITION | ACTION | COMMENTS |
|---|---|---|---|
| Washer | - - - D | None | dirty |

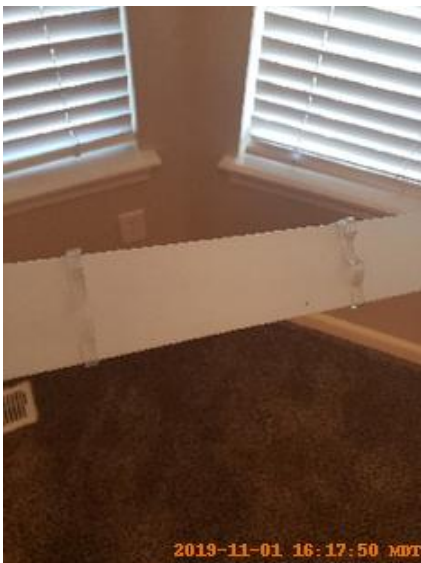
| Living Room | CONDITION | ACTION | COMMENTS |
|---|---|---|---|
| Window Covering | - - - D | None | broken valance clips |
