, Meridian, ID 83642 Move Out  
2019-11-01

## Move Out Condition Summary

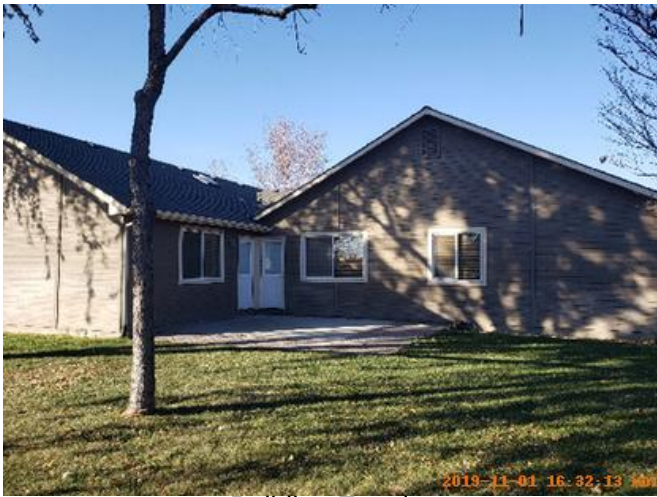
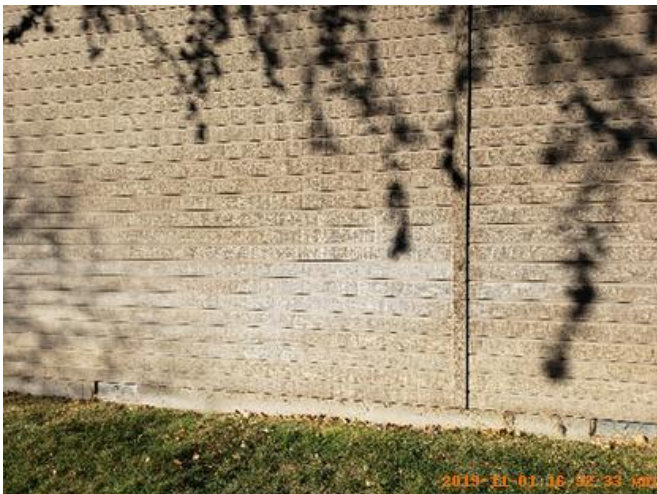
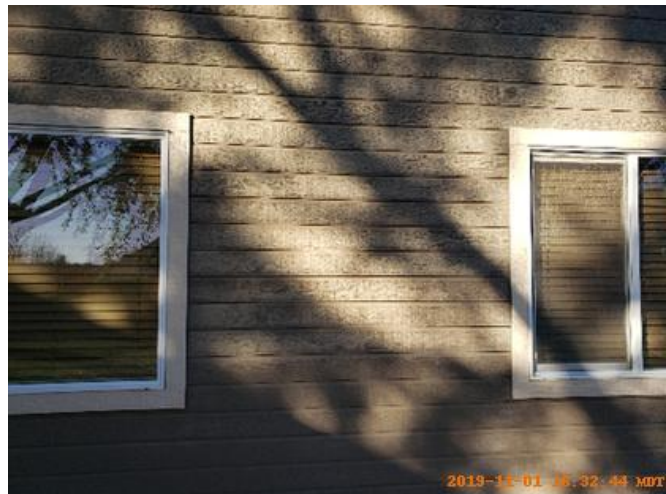
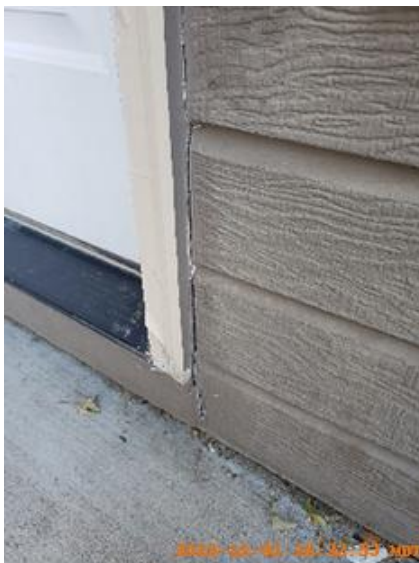
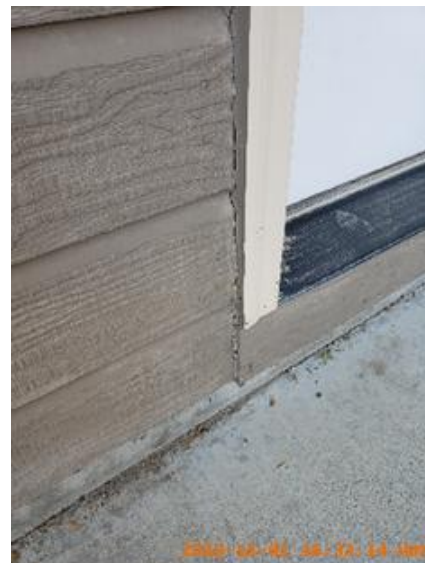
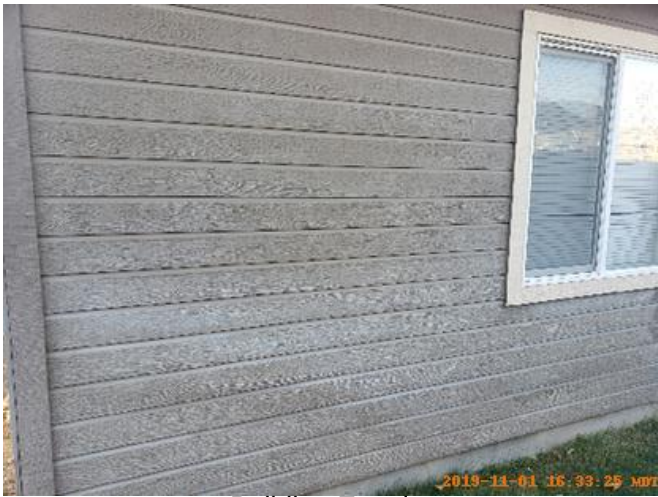
| Back Yard/Exterior | CONDITION | ACTION | COMMENTS |
|---|---|---|---|
| Building Exterior | - - - D | None | paint is fading, gaps in siding, owner would like them caulk |

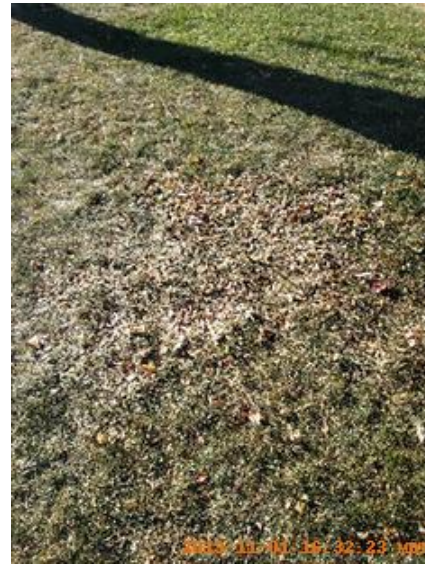
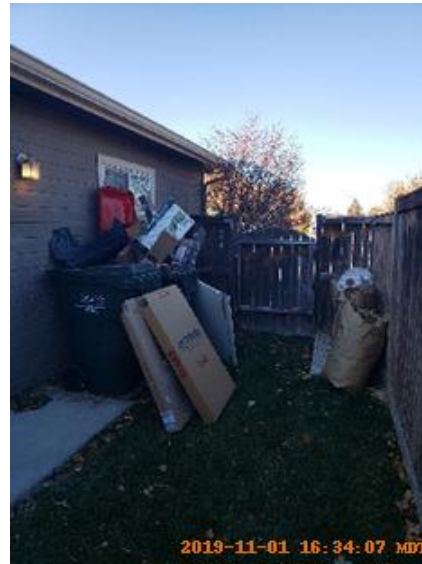
| Back Yard/Exterior | CONDITION | ACTION | COMMENTS |
|---|---|---|---|
| Landscaping | - - - D | None | debris on side of house |

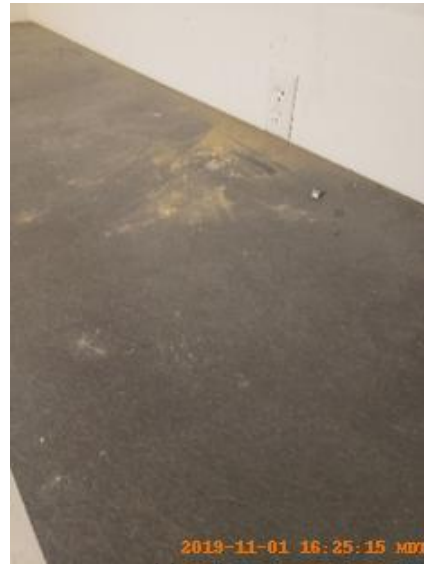
Cabinet/Counter

| Garage/Parking | CONDITION | ACTION | COMMENTS |
|---|---|---|---|
| Cabinet/ Counter | - - - D | None | dirty |

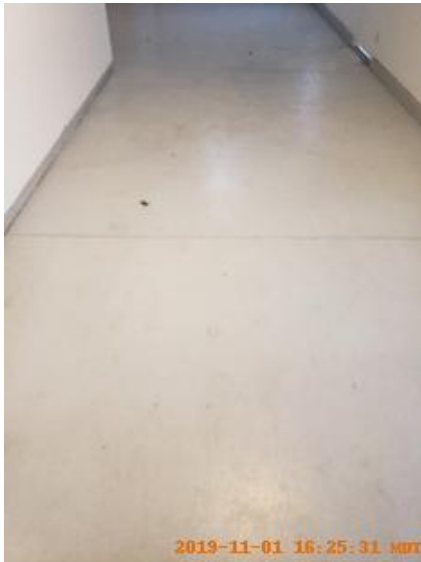
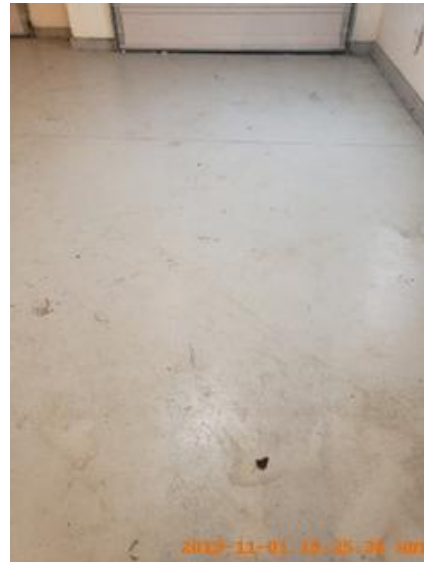
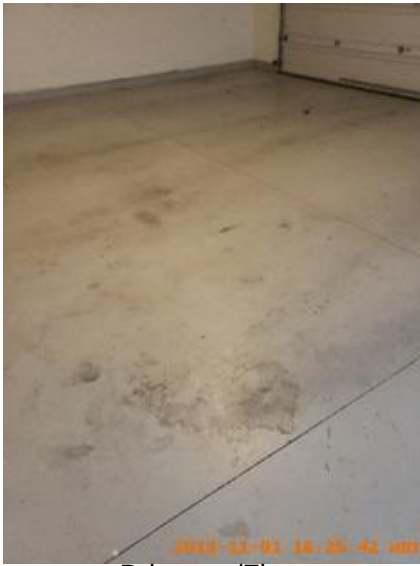
| Garage/ Parking | Driveway/ Floor | <b>D</b> | | dirty and stained | <a href="#">Image 1</a><br><a href="#">Image 2</a><br><a href="#">Image 3</a> |

| Garage/Parking | CONDITION | ACTION | COMMENTS |
|---|---|---|---|
| Driveway/ Floor | - - - D | None | dirty and stained |

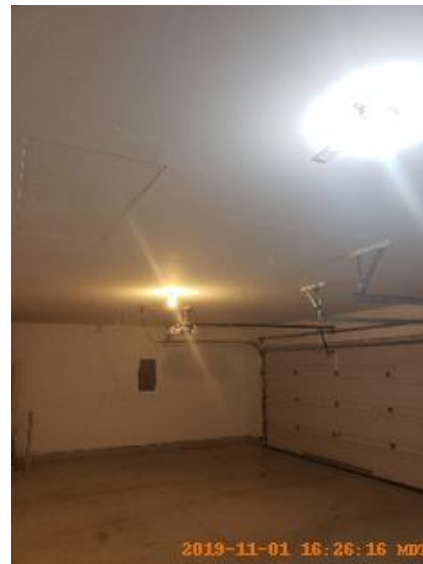
| Garage/ Parking | Light Fixture | <b>D</b> | | burnt out bulb | <a href="#">Image 1</a> |

| Garage/Parking | CONDITION | ACTION | COMMENTS |
|---|---|---|---|
| Light Fixture | - - - D | None | burnt out bulb |

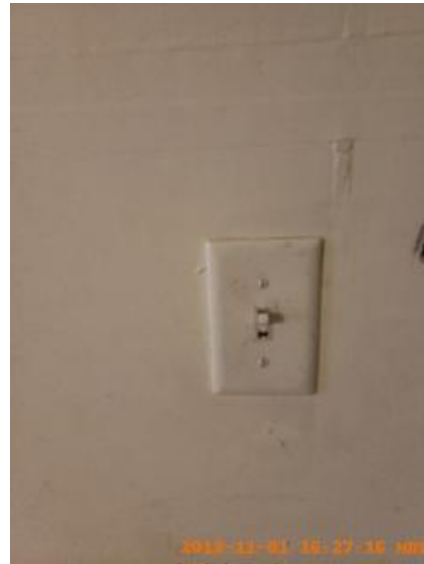
Switch/Outlet

| Garage/Parking | CONDITION | ACTION | COMMENTS |
|---|---|---|---|
| Switch/ Outlet | - - - D | None | dirty |

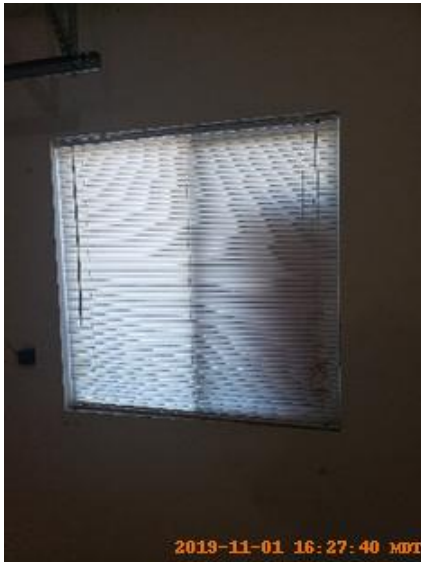
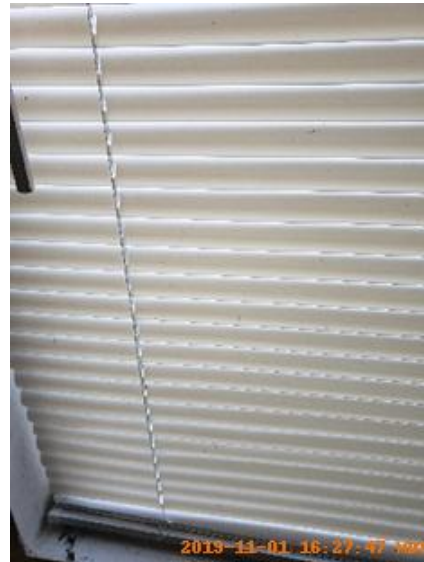
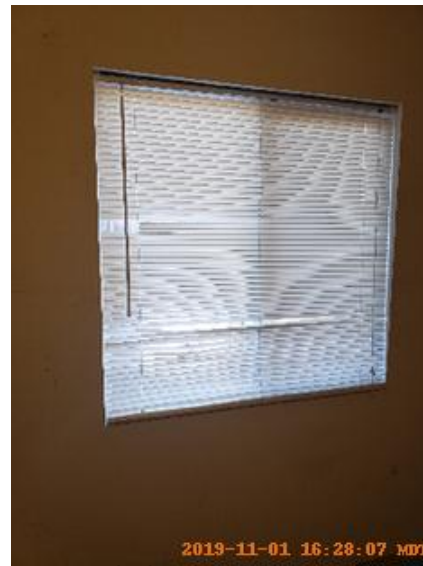
| Garage/ Parking | Window/ Lock/<br>Screen | <b>D</b> | | broken blind, dirty | <a href="#">Image 1</a><br><a href="#">Image 2</a><br><a href="#">Image 3</a><br><a href="#">Image 4</a><br><a href="#">Image 5</a> |

| Garage/Parking | CONDITION | ACTION | COMMENTS |
|---|---|---|---|
| Window/ Lock/ Screen | - - - D | None | broken blind, dirty |
