# Move Out

201 w 1st st, Middleton , ID, US

2019-01-31

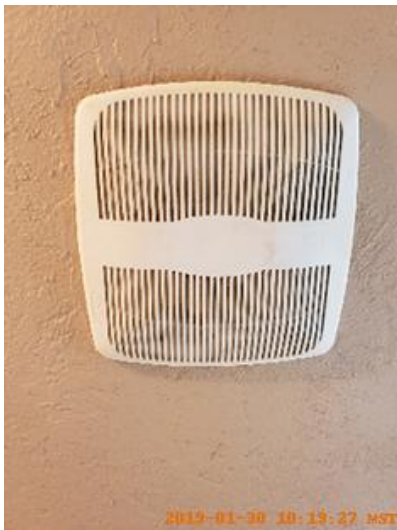
| Bathroom 1: master bath | CONDITION | ACTION | COMMENTS |
|---|---|---|---|
| Exhaust Fan | - - - D | None | dirty |

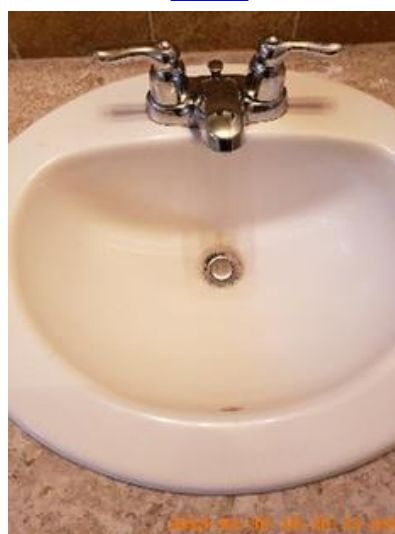
| Bathroom 1: master bath | CONDITION | ACTION | COMMENTS |
|---|---|---|---|
| Sink/Faucet | - - - D | None | Stopper is damaged |

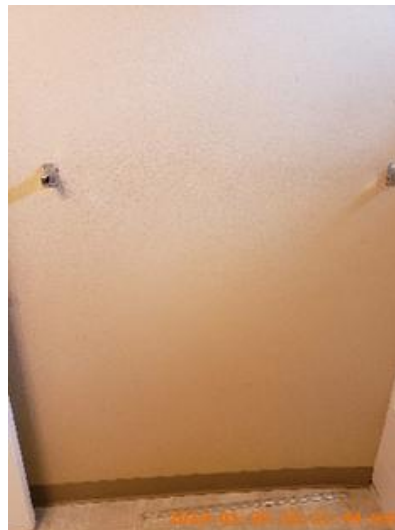
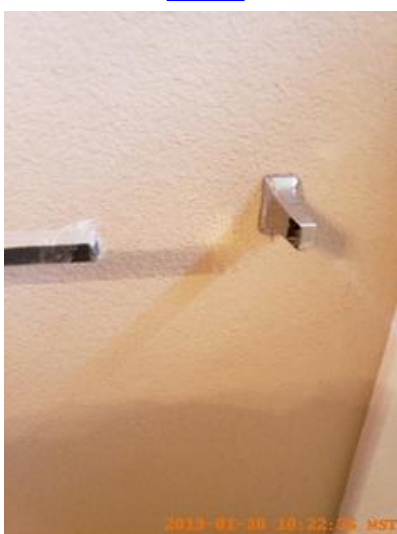
| Bathroom 1: master bath | CONDITION | ACTION | COMMENTS |
|---|---|---|---|
| Towel Rack | - - - D | None | towel bar does not fit in brackets<br>(length or thickness) |

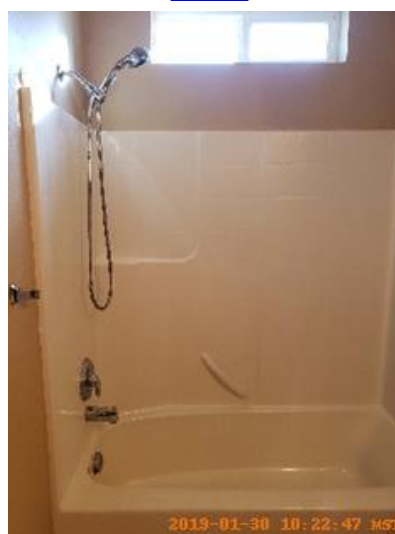
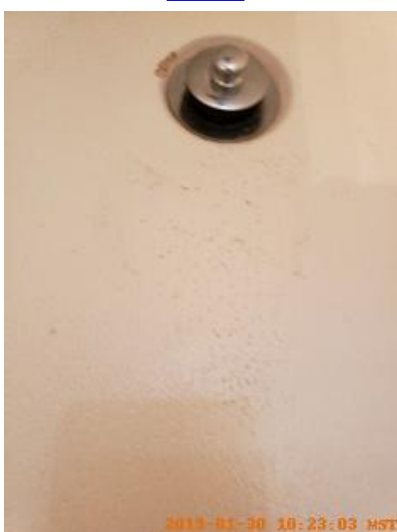
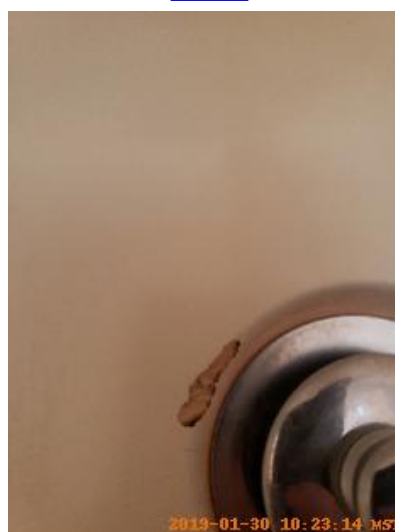
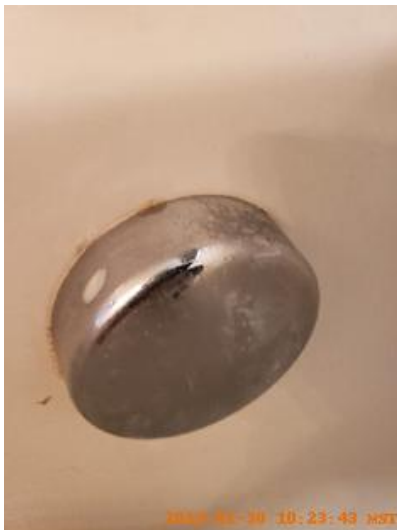
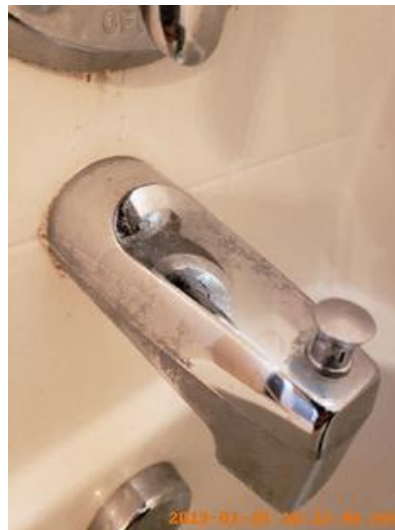
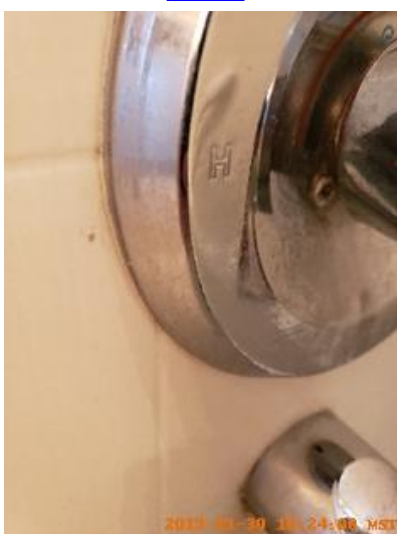
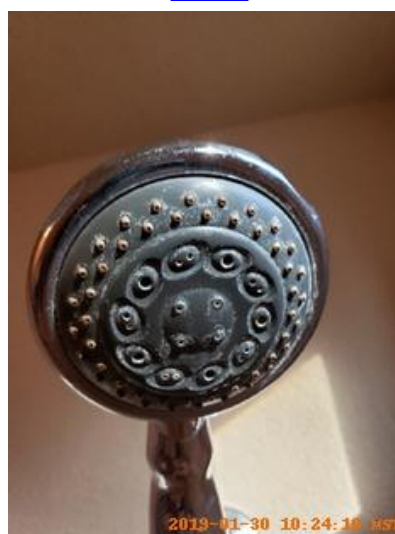
| Bathroom 1: master bath | CONDITION | ACTION | COMMENTS |
|---|---|---|---|
| Tub/Shower | - - - D | None | tub is dirty and chipped |

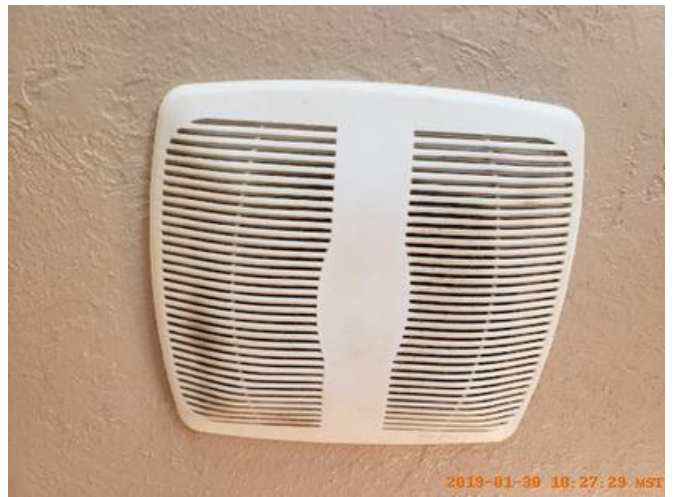
| Bathroom 2: bathroom 2 | CONDITION | ACTION | COMMENTS |
|---|---|---|---|
| Exhaust Fan | - - - D | None | dirty |

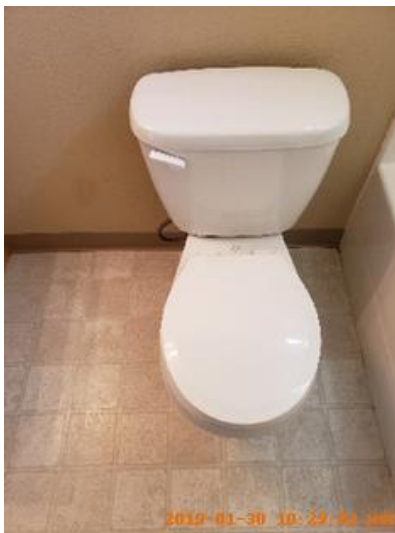
| Bathroom 2: bathroom 2 | CONDITION | ACTION | COMMENTS |
|---|---|---|---|
| Toilet | - - - D | None | caulking is missing around toilet |

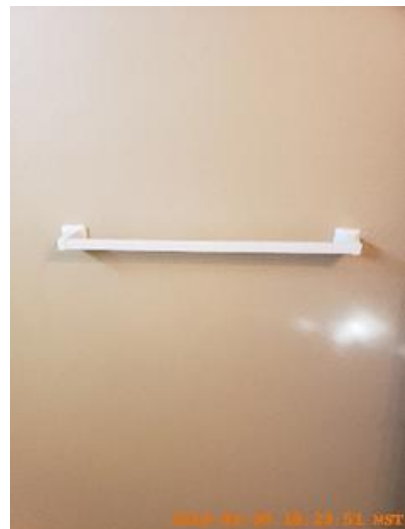
| Bathroom 2: bathroom 2 | CONDITION | ACTION | COMMENTS |
|---|---|---|---|
| Towel Rack | - - - D | None | towel rack is mismatched |

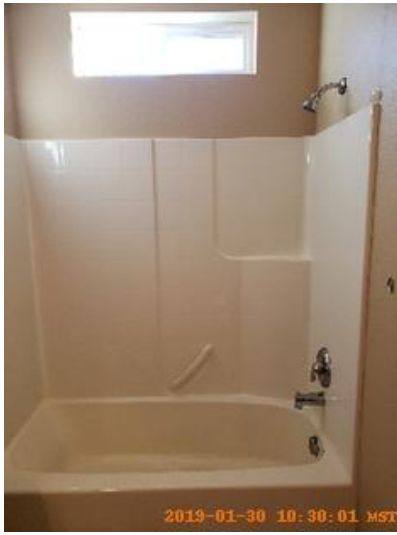
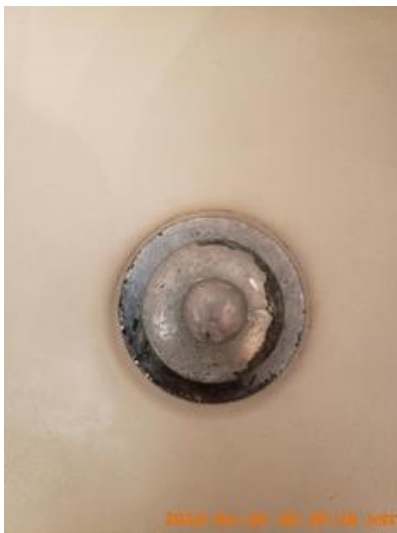
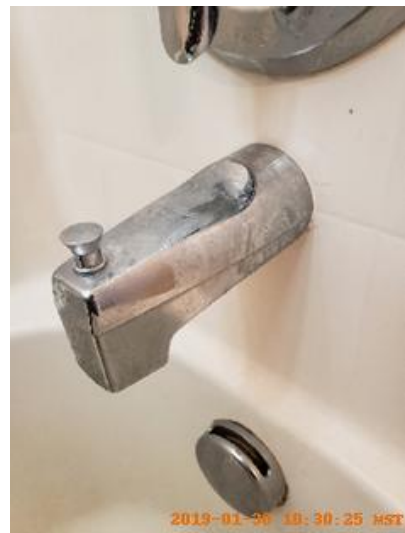
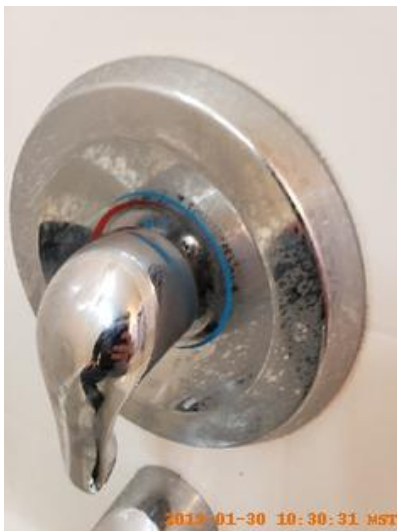
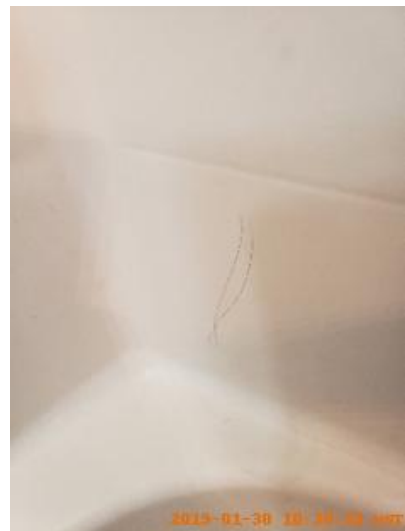
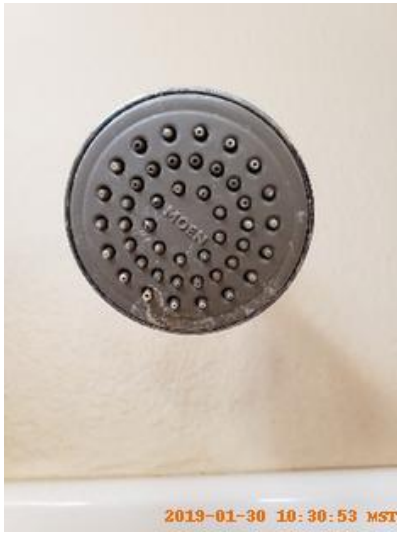
| Bathroom 2: bathroom 2 | CONDITION | ACTION | COMMENTS |
|---|---|---|---|
| Tub/Shower | - - - D | None | dirty |

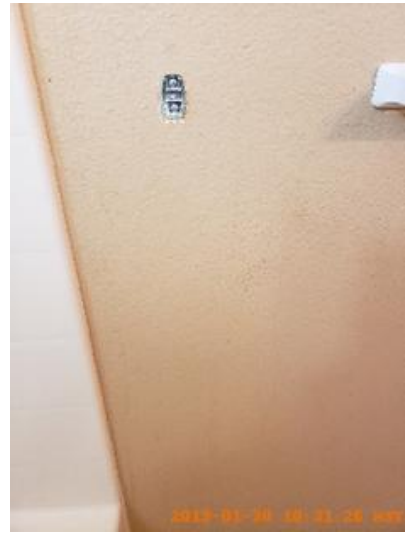
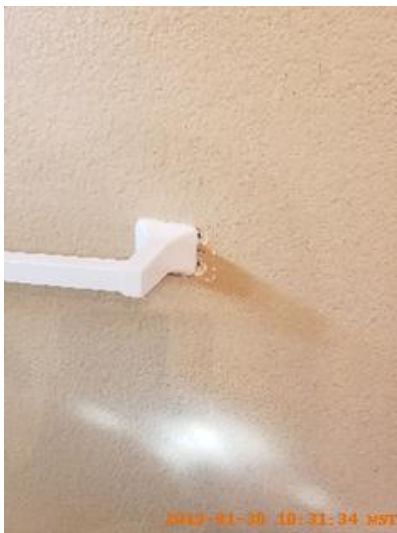
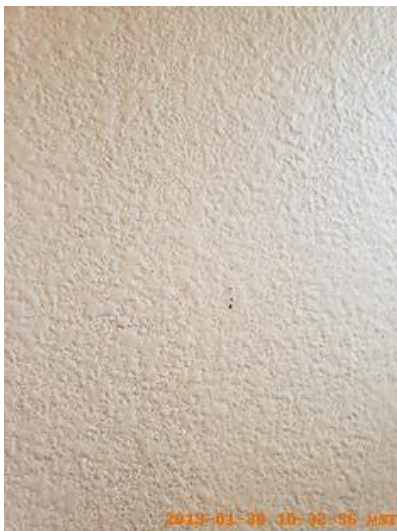
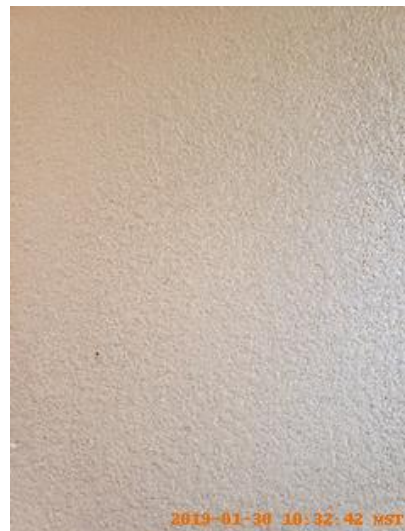
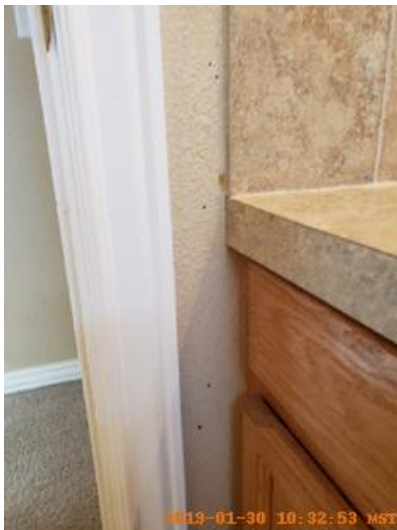
| Bathroom 2: bathroom 2 | CONDITION | ACTION | COMMENTS |
|---|---|---|---|
| Wall/Ceiling | - - - D | None | holes in walls |

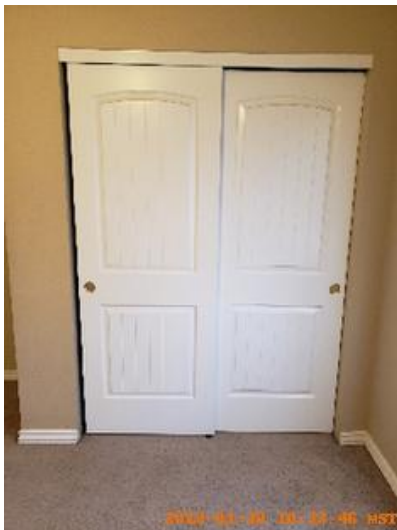
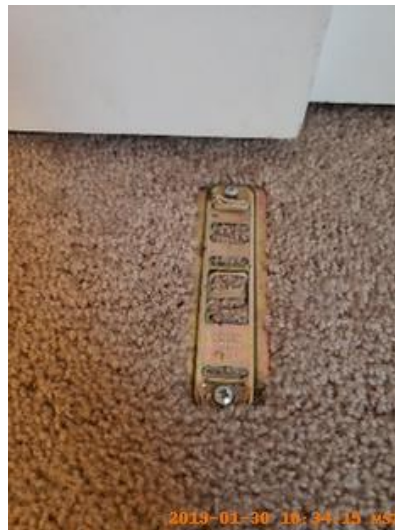
| Bedroom 1: master bedroom | CONDITION | ACTION | COMMENTS |
|---|---|---|---|
| Closet/Door/Track/Shelving | - - - D | None | 27 nails in wood underneath the top shelf, coat rack in closet, closet door guide broken |

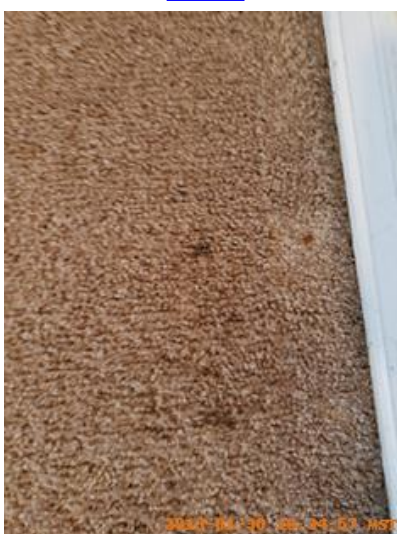
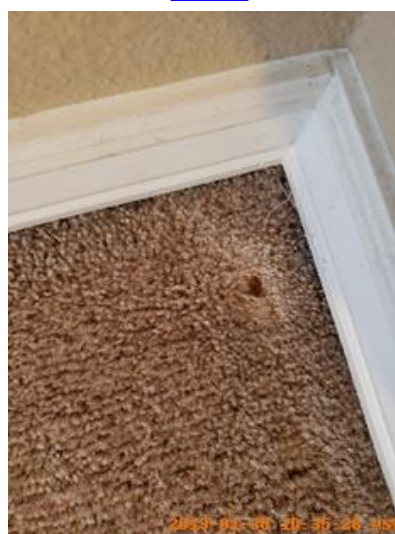
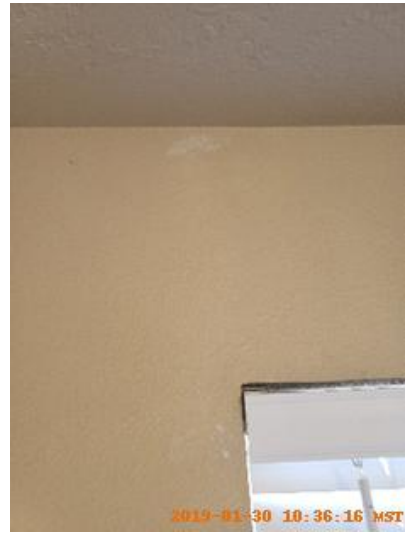
| Bedroom 1: master bedroom | CONDITION | ACTION | COMMENTS |
|---|---|---|---|
| Flooring/Baseboard | - - - D | None | baseboard has missing sections and is dirty |

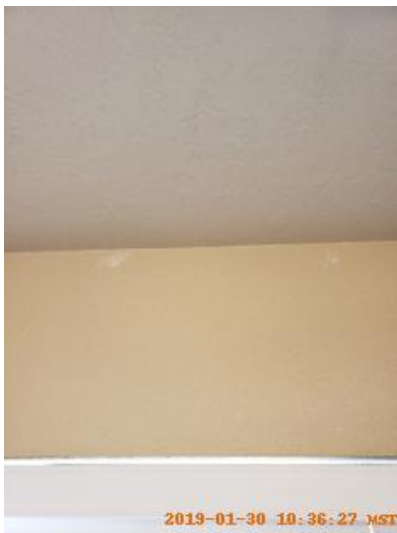
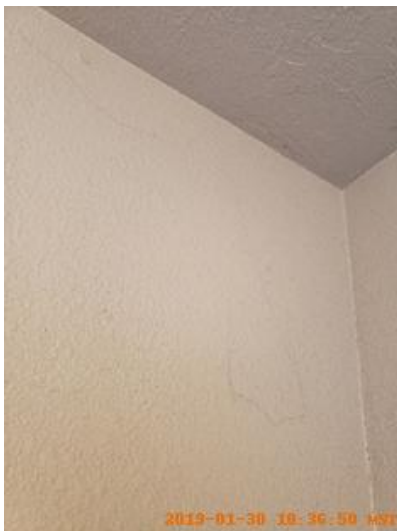
| Bedroom 1: master bedroom | CONDITION | ACTION | COMMENTS |
|---|---|---|---|
| Wall/Ceiling | - - - D | None | mismatch paint, patching but not touch up |

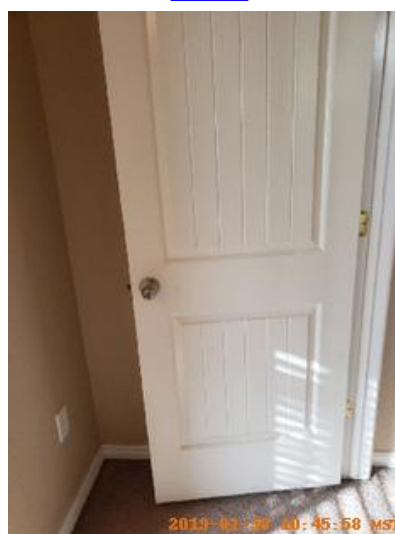
Door/Knob/Lock  
 Taken on: 2019-01-30 10:45:58  
 Taken at: [43.70715838, -116.62558043](#)  
[Image](#)

| Bedroom 2: bedroom 2 | CONDITION | ACTION | COMMENTS |
|---|---|---|---|
| Door/Knob/Lock | - - - D | None | locking door, key not present |

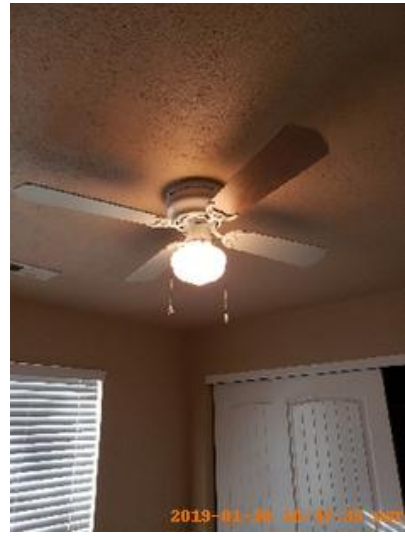
| Bedroom 2: bedroom 2 | CONDITION | ACTION | COMMENTS |
|---|---|---|---|
| Light Fixture/Fan | - - - D | None | fan blade upside down |

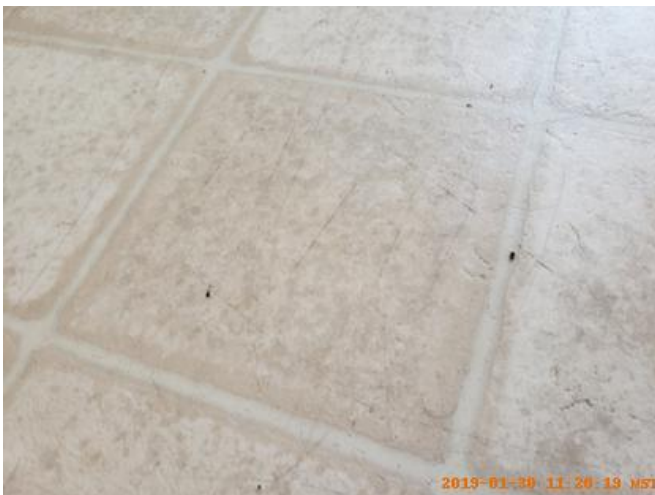
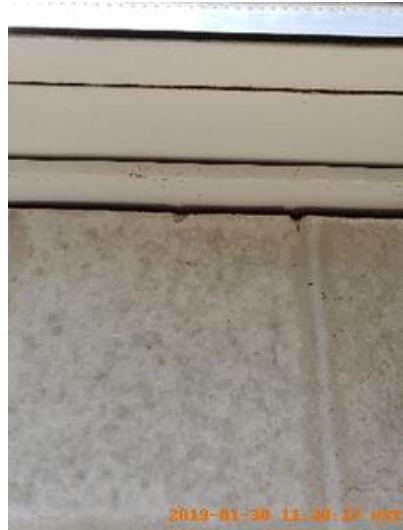
| Dining Room | CONDITION | ACTION | COMMENTS |
|---|---|---|---|
| Flooring/Baseboard | - - - D | None | scratches on floor, floor pulling up next to sliding glass door |

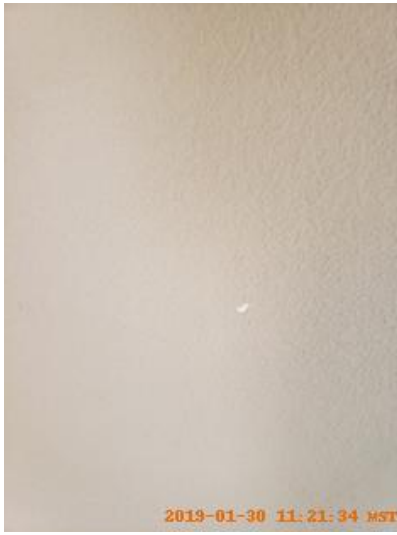
| Dining Room | CONDITION | ACTION | COMMENTS |
|---|---|---|---|
| Wall/Ceiling | - - - D | None | some walls have patched but not painted |

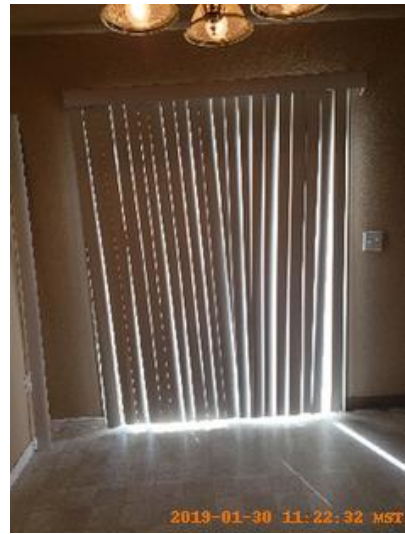
| Dining Room | CONDITION | ACTION | COMMENTS |
|---|---|---|---|
| Window Covering | - - - D | None | blind are stuck in close position |

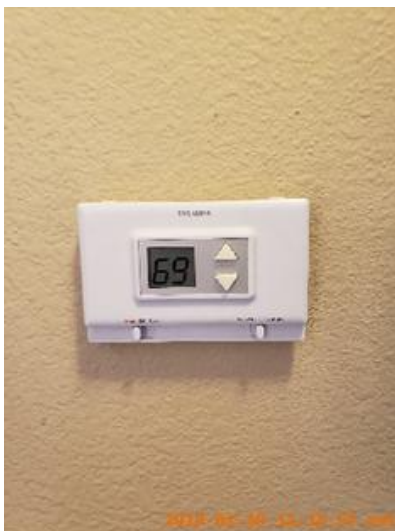
Other  
 Taken on: 2019-01-30 11:18:57  
**Taken at:** [43.70728131, -116.6255936](#)  
[Image](#)

| Other | - - D | None | filter is dirty |

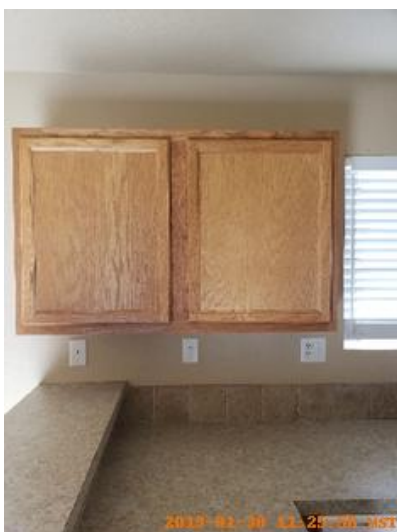
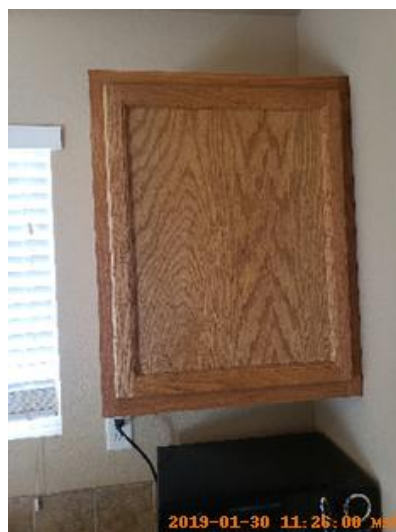
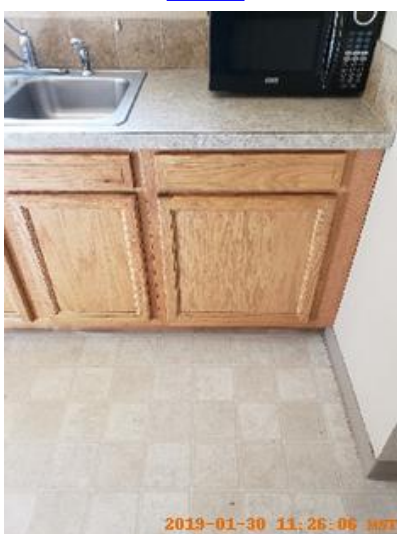
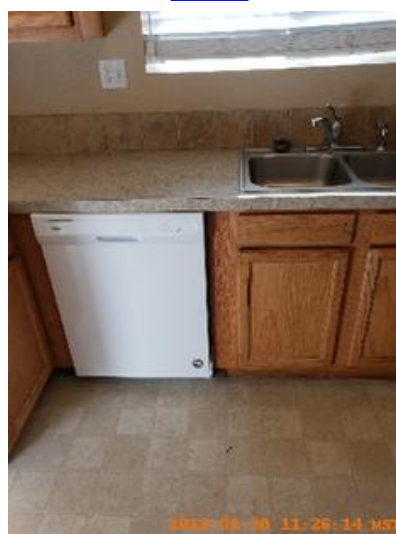
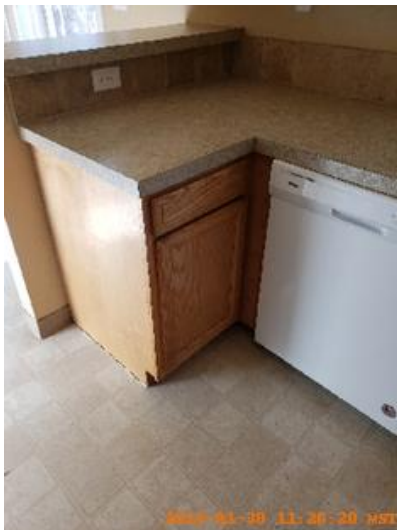
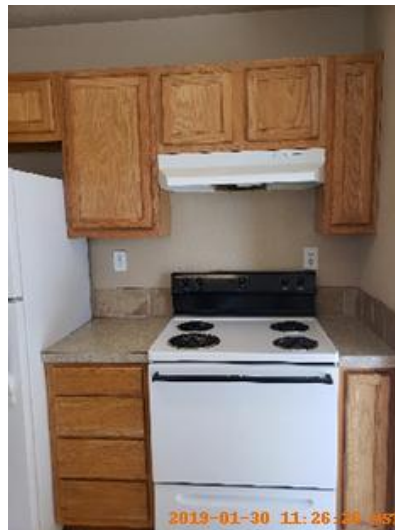
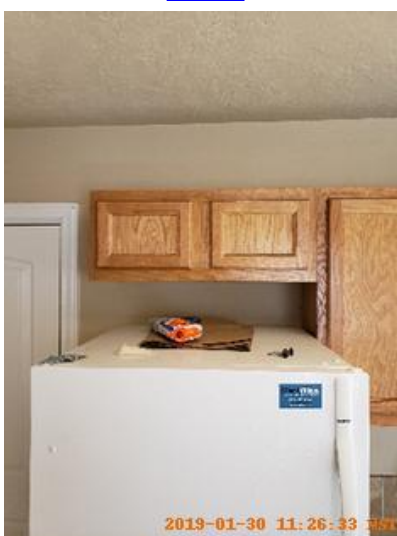
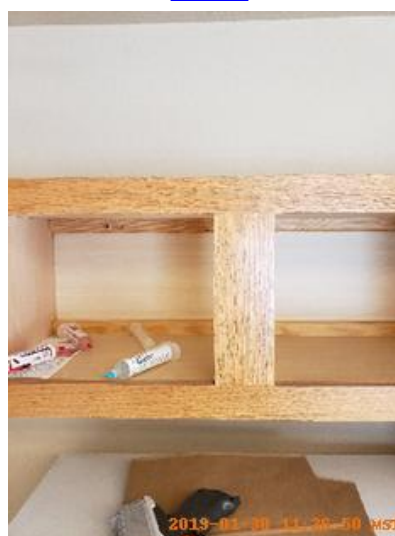
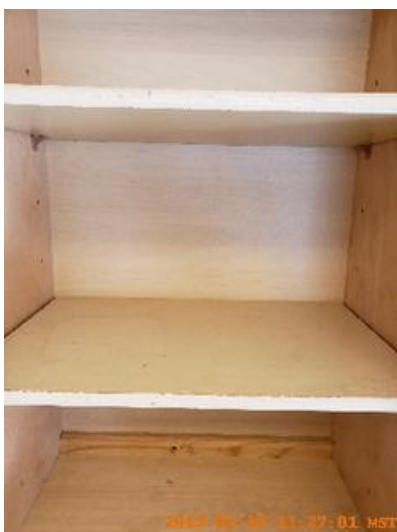
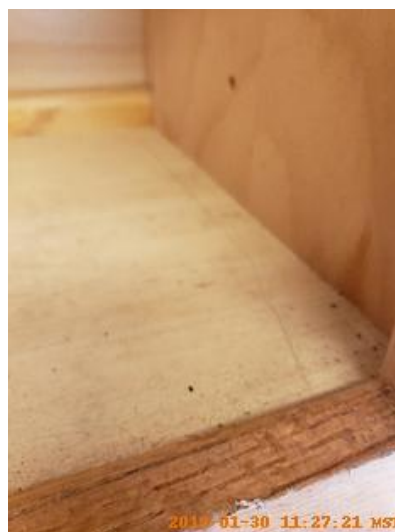
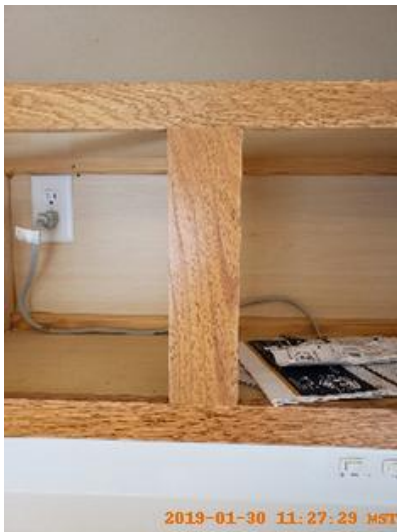
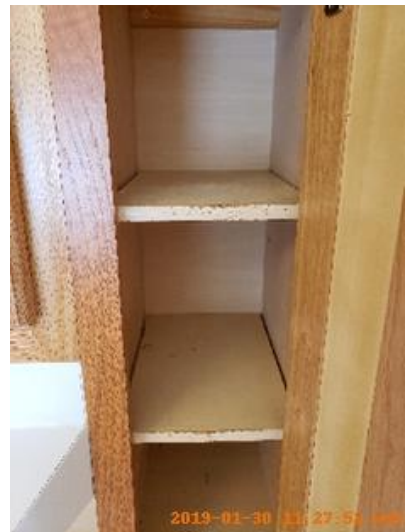
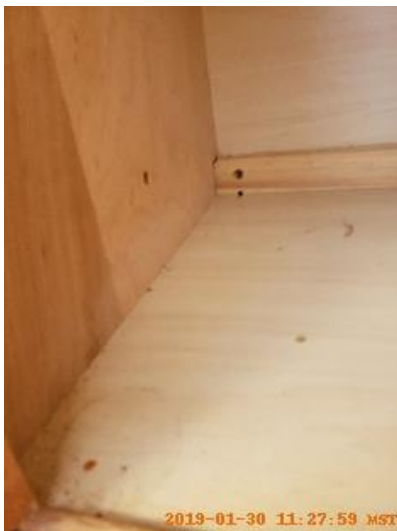
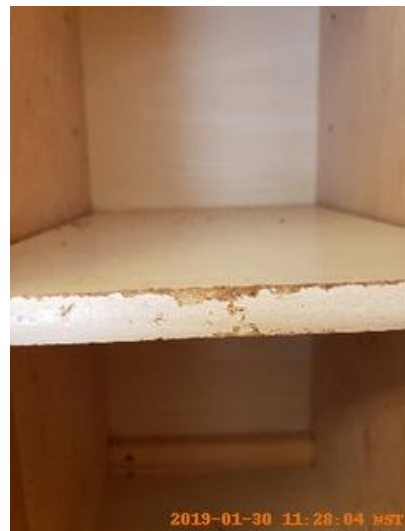
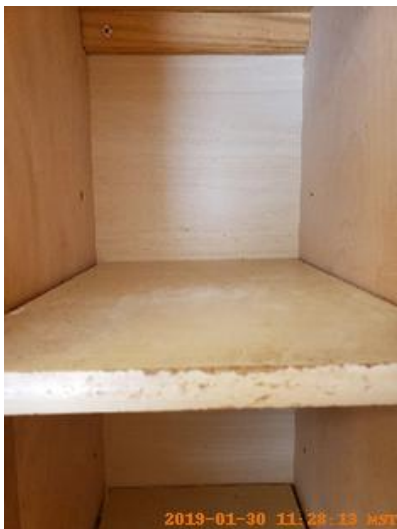
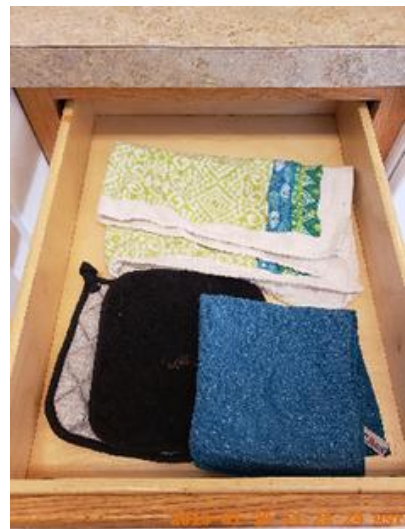
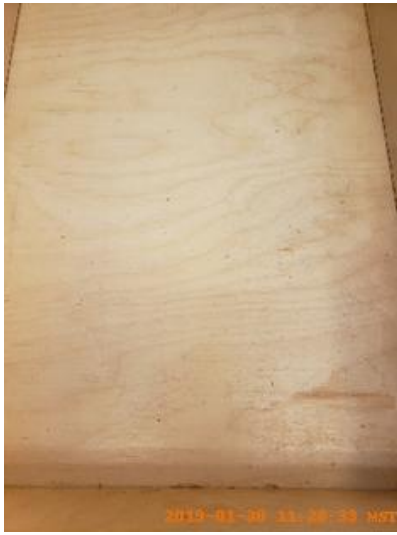
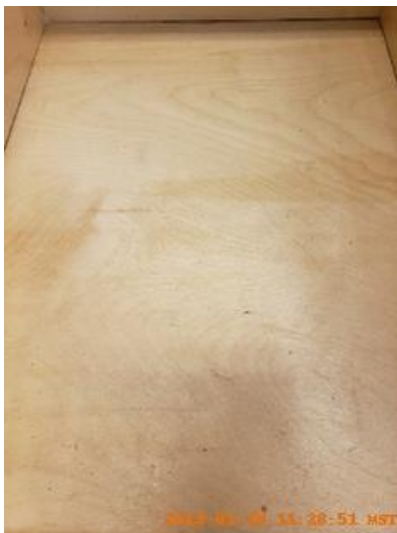
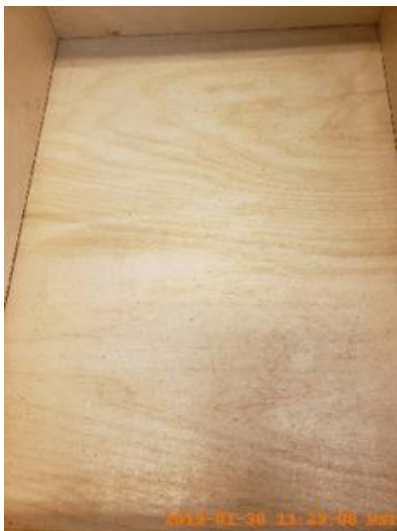
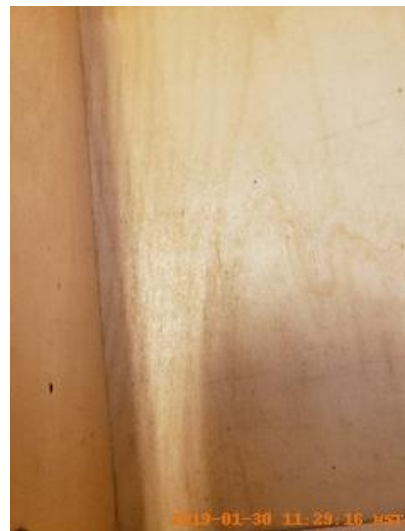
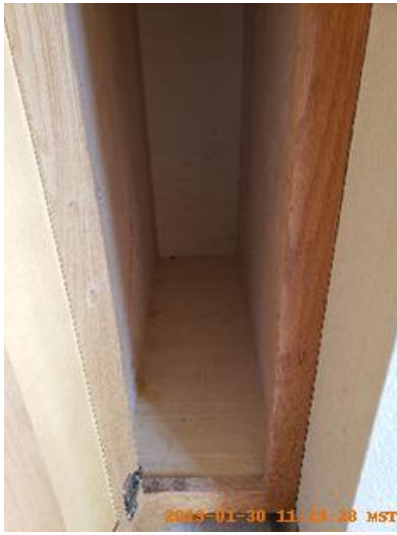
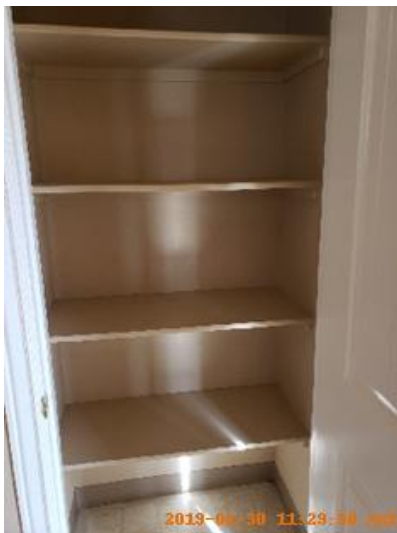
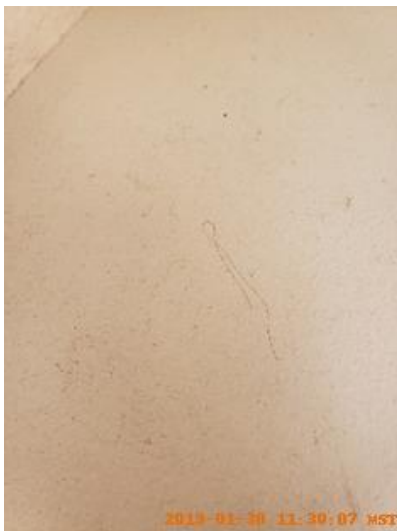
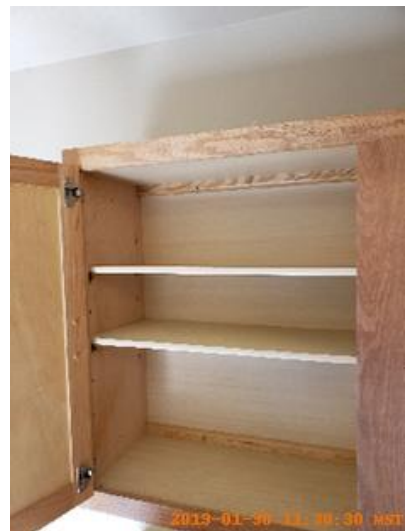
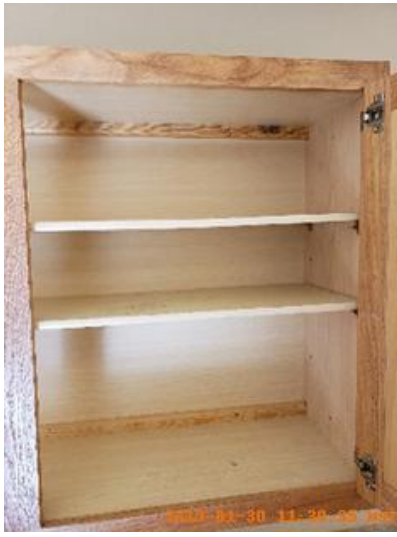
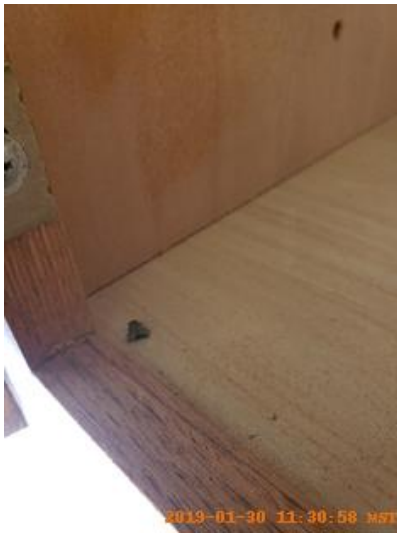
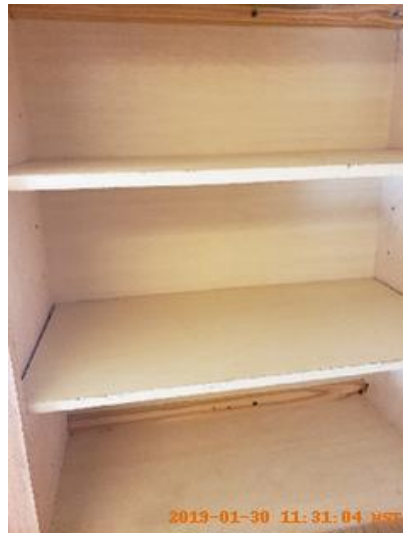
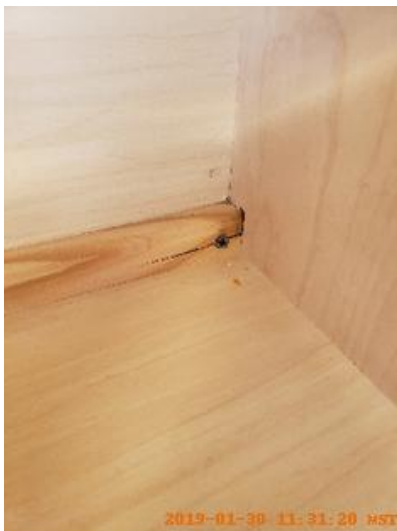
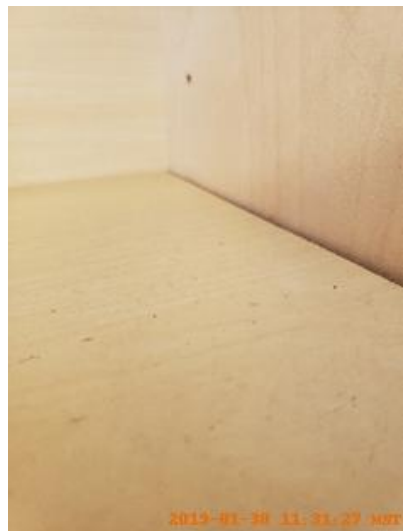
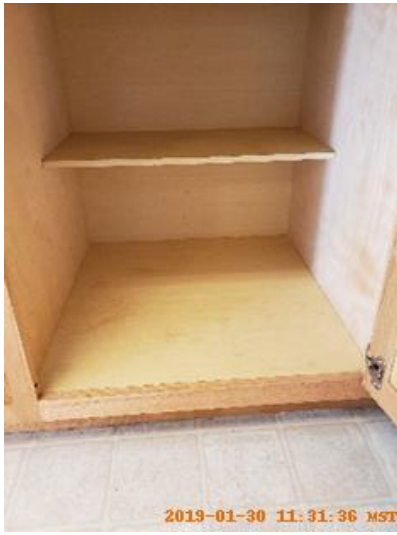
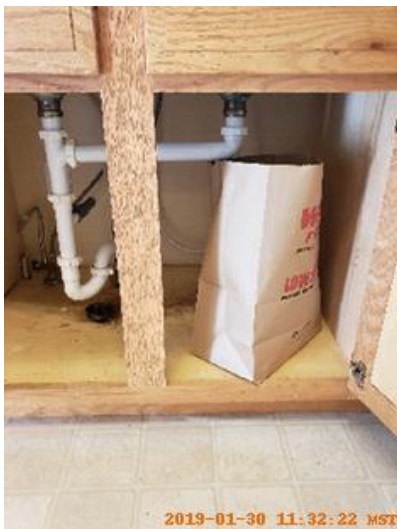
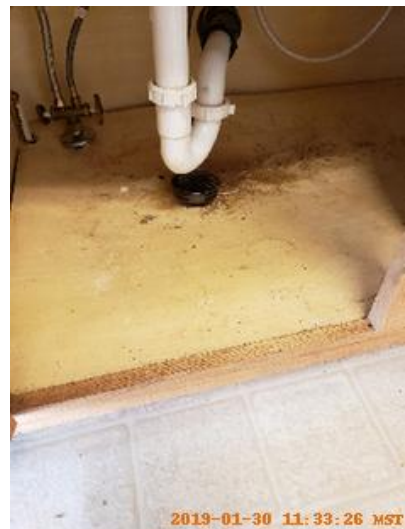
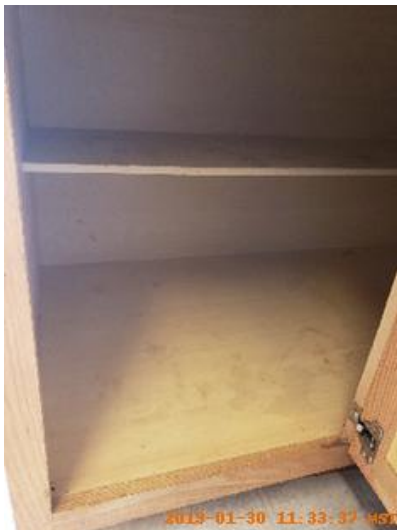
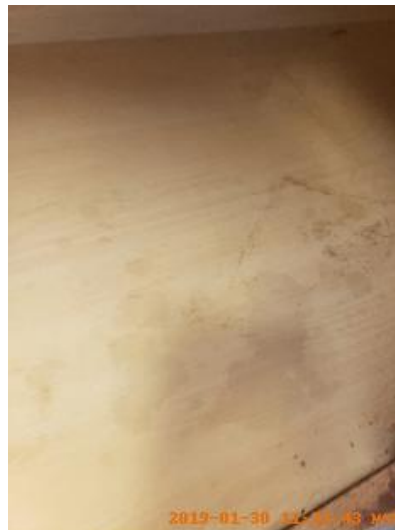
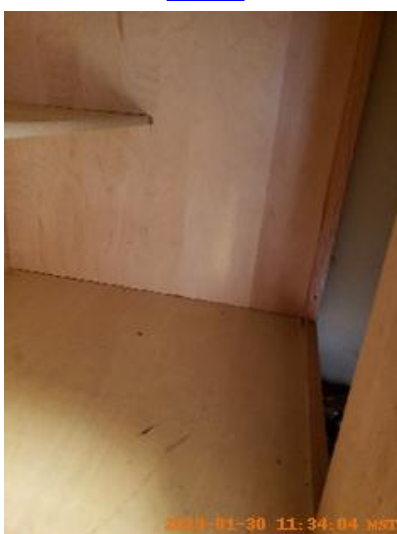
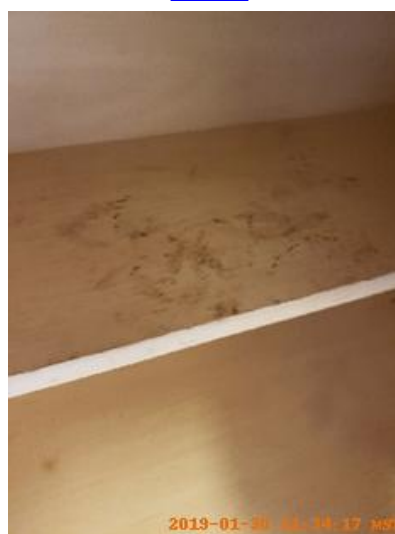
| Kitchen | CONDITION | ACTION | COMMENTS |
|---|---|---|---|
| Cabinets/Drawers | - - - D | None | scratched and worn |

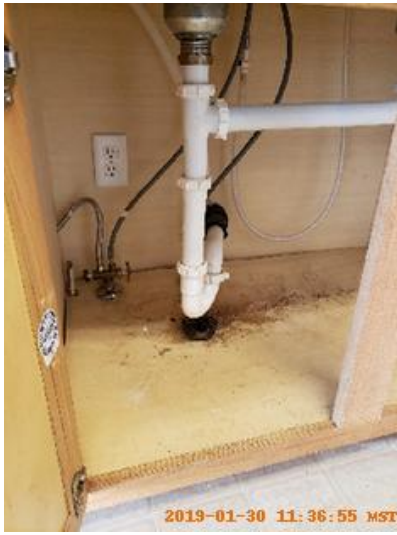
| Kitchen | CONDITION | ACTION | COMMENTS |
|---|---|---|---|
| Faucet/Plumbing | - - - D | None | water damage under kitchen sink |

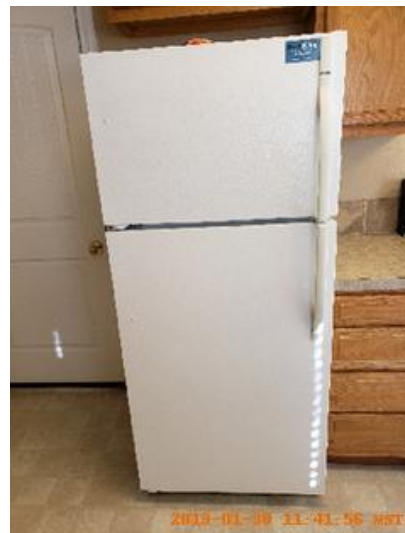
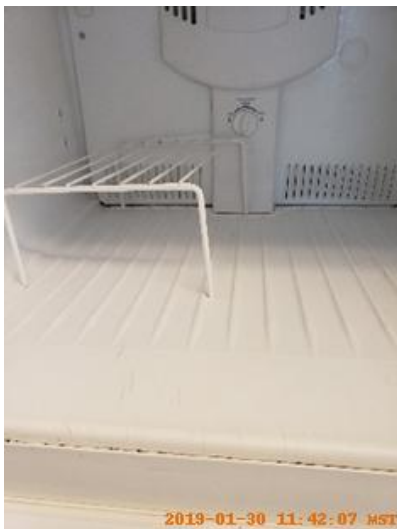
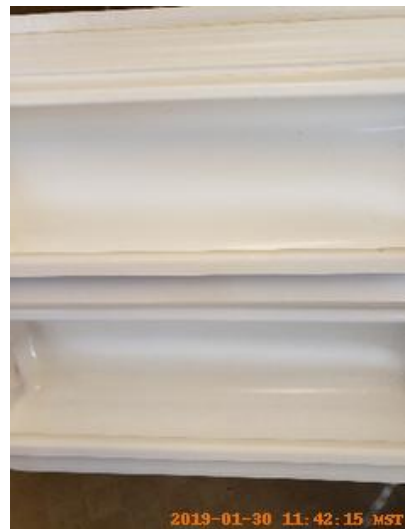
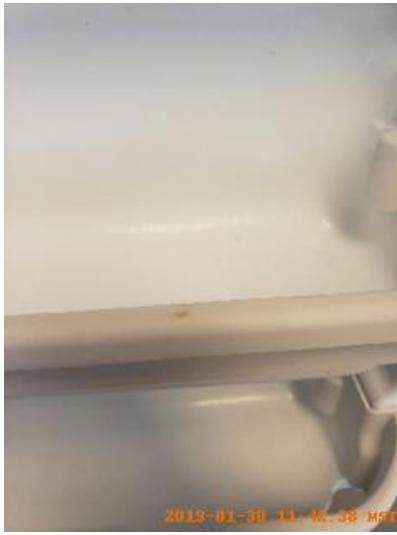
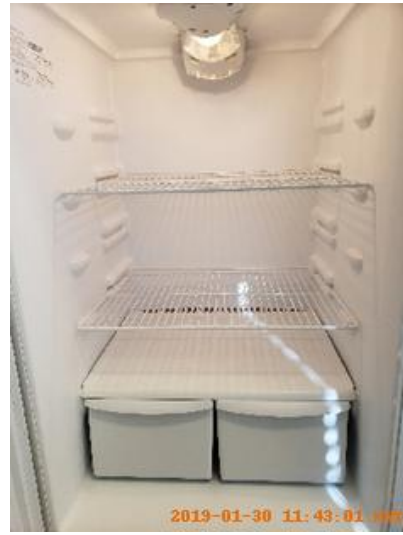
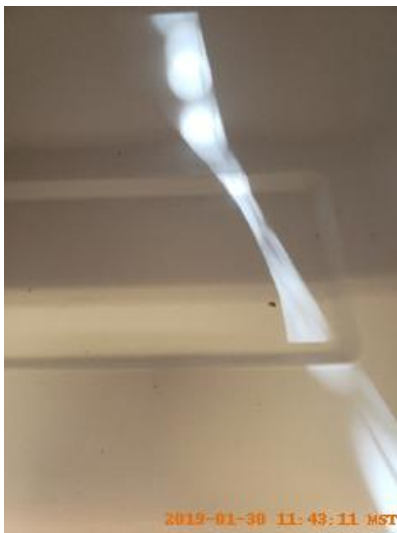
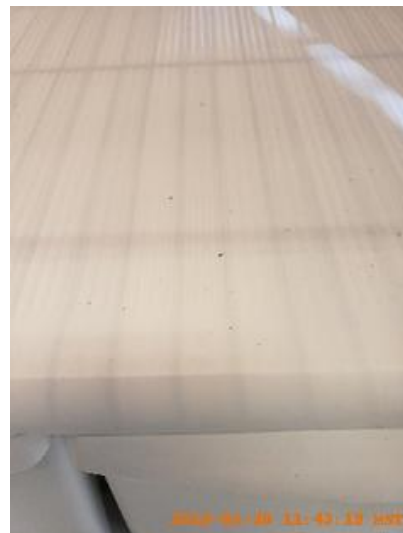
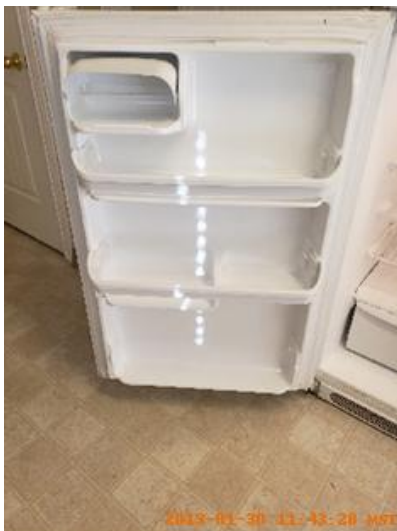
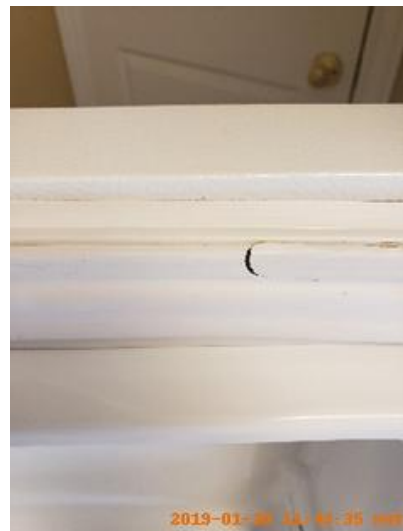
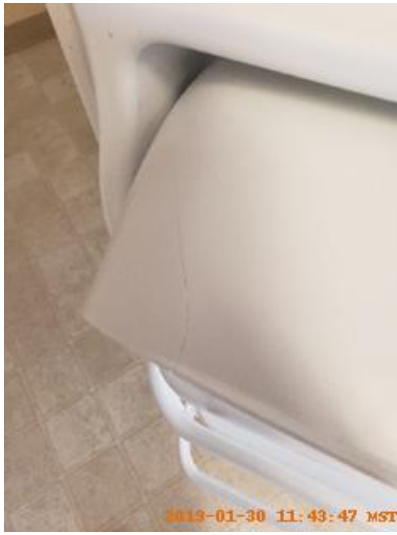
| Kitchen | CONDITION | ACTION | COMMENTS |
|---|---|---|---|
| Refrigerator | - - - D | None | missing 1 door rack, butter door is cracked, dirty |

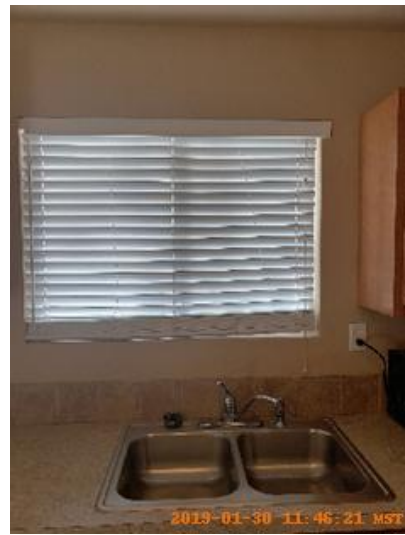
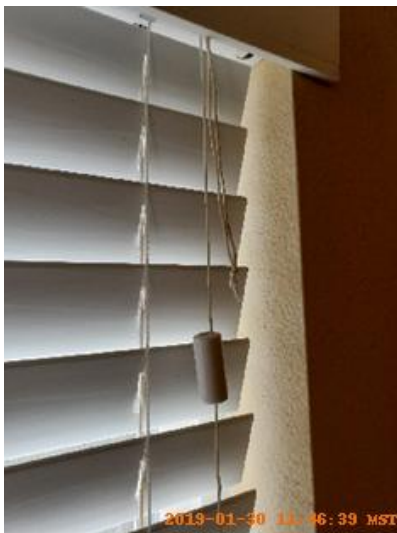
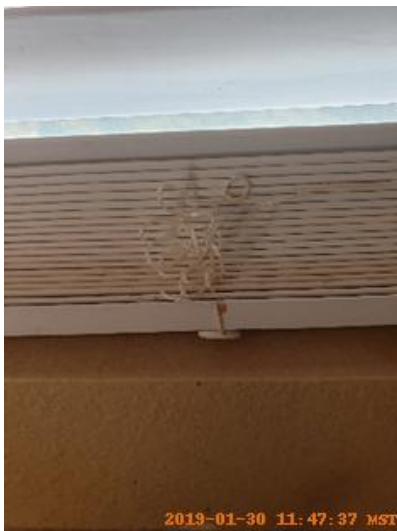
| Kitchen | CONDITION | ACTION | COMMENTS |
|---|---|---|---|
| Window Covering | - - - D | None | dirty blinds, missing plastic cap ends |

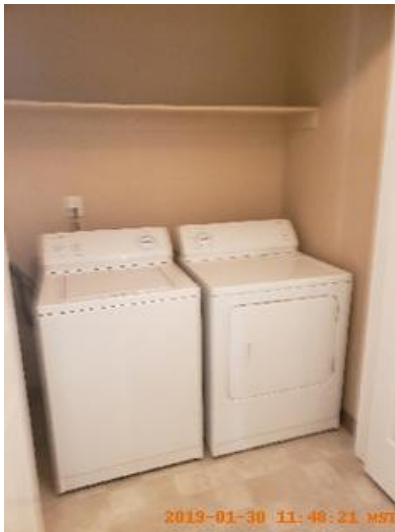
| Cabinet/Counter/Shelving | - - - D | None | dirty |

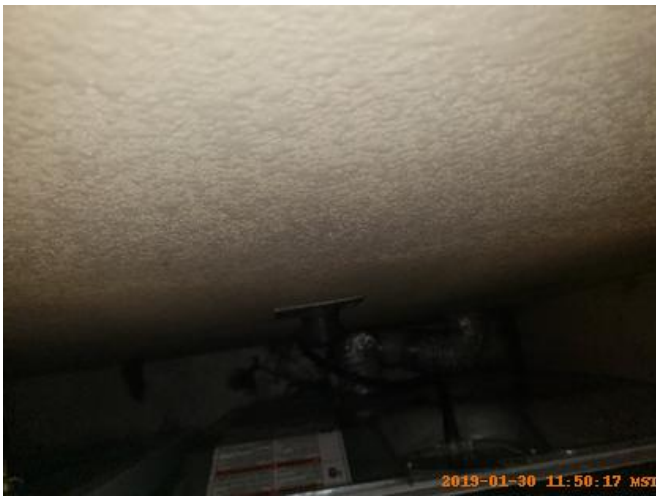
| Other | - - - D | None | debris behind washer and dryer |

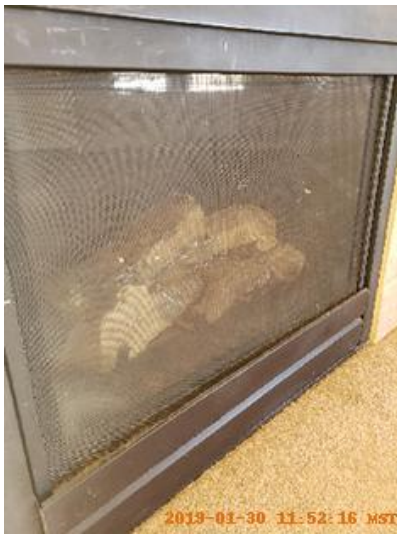
| Living Room | CONDITION | ACTION | COMMENTS |
|---|---|---|---|
| Fireplace Equipment | - - - D | None | unknown substance on fireplace glass and screen |

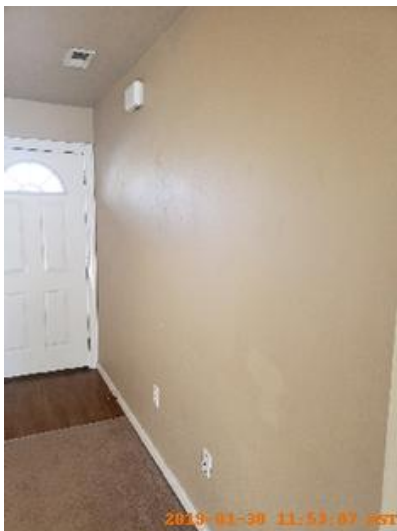
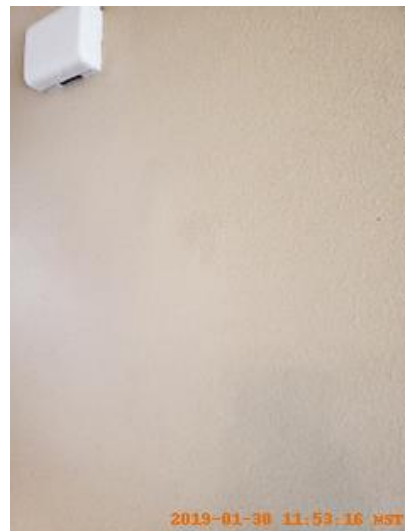
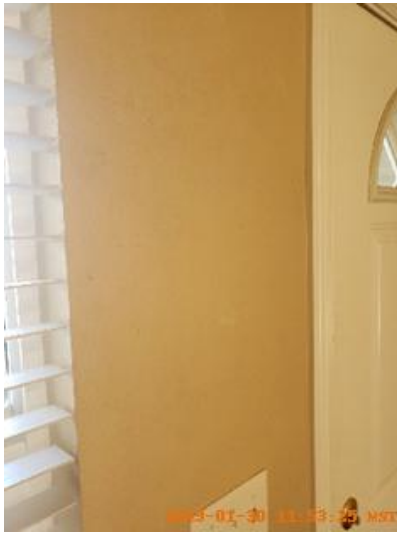
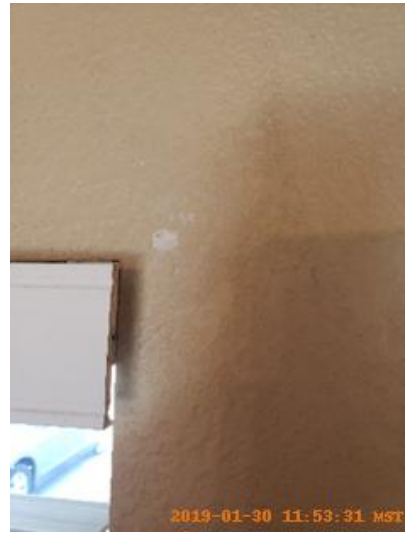
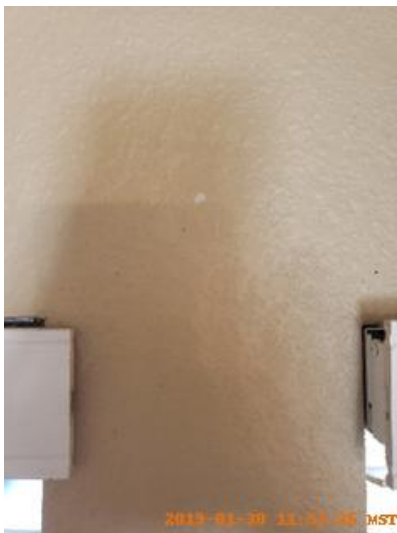
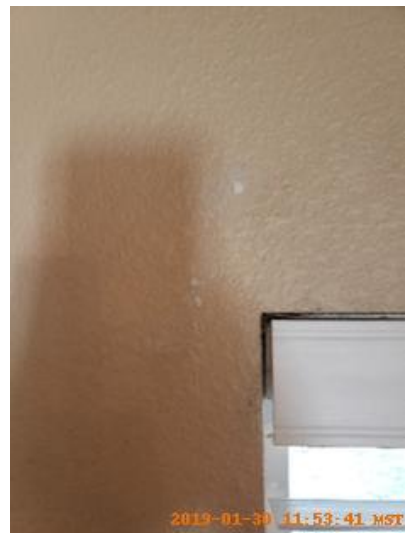
| Living Room | CONDITION | ACTION | COMMENTS |
|---|---|---|---|
| Wall/Ceiling | - - - D | None | mismatch paint, patched but not painted in some areas |
