# Move Out

201 w 1st st, Middleton , ID, US

2019-01-31

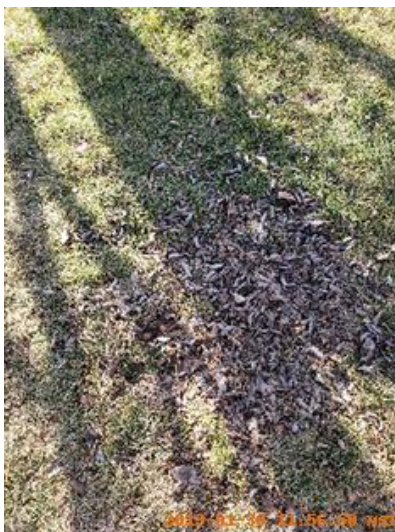
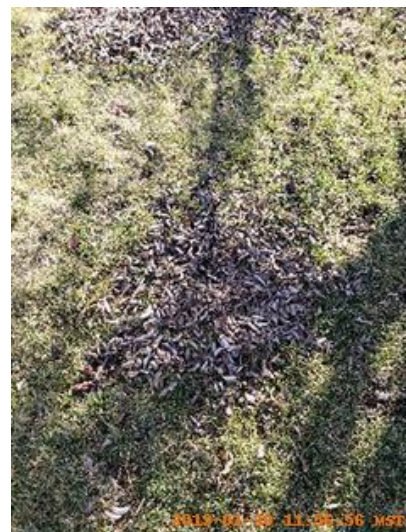
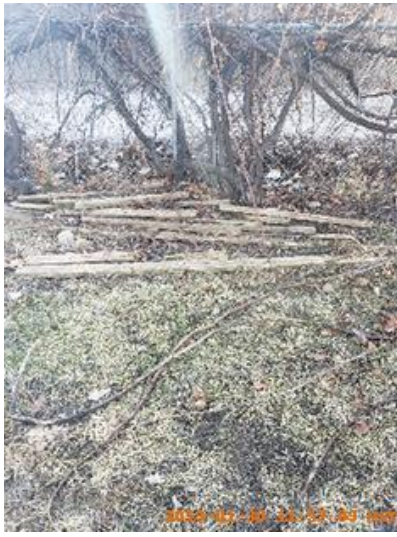
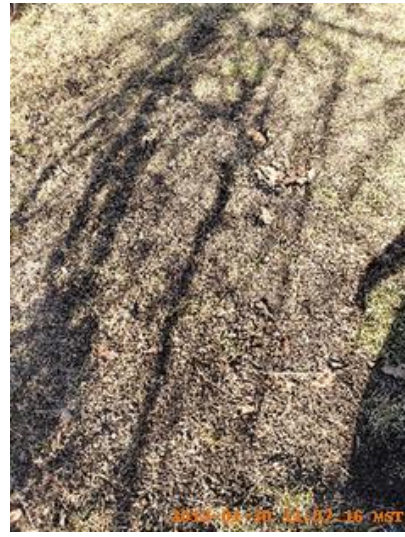
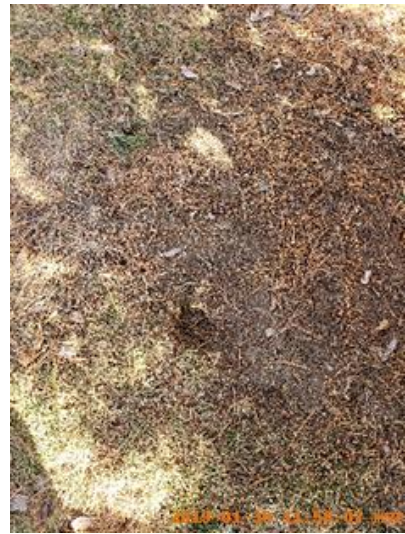
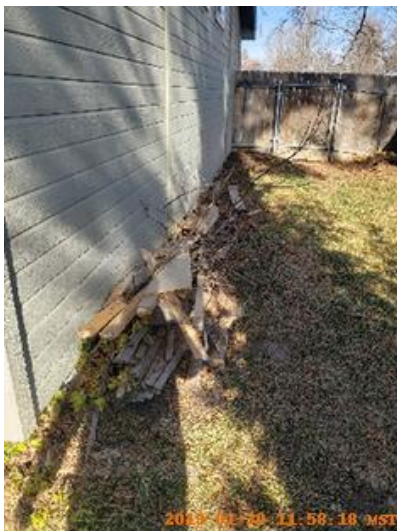
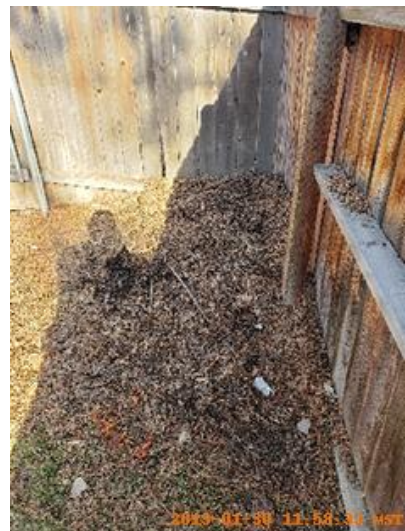
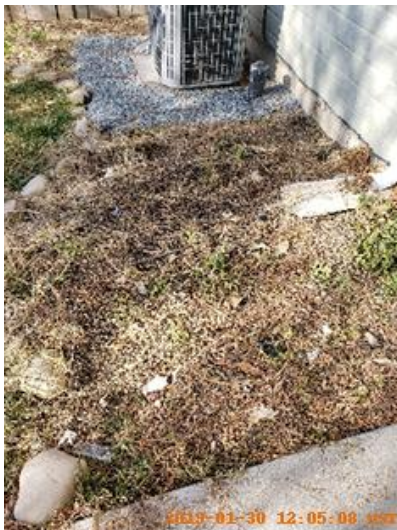
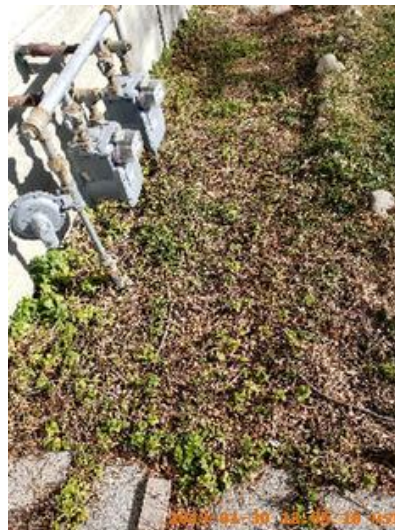
Landscaping  
Taken on: 2019-01-30 11:56:50  
Taken at: [43.70716356, -116.62567877](#)  
[Image](#)

weeds next to house, in corner  
wood is strapped to back fence,  
trash and leaves throughout yard,  
holes throughout yard

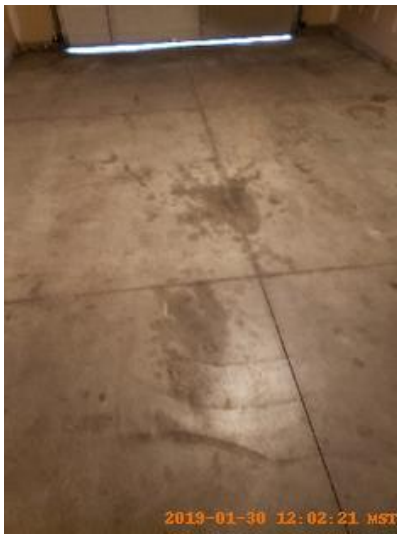
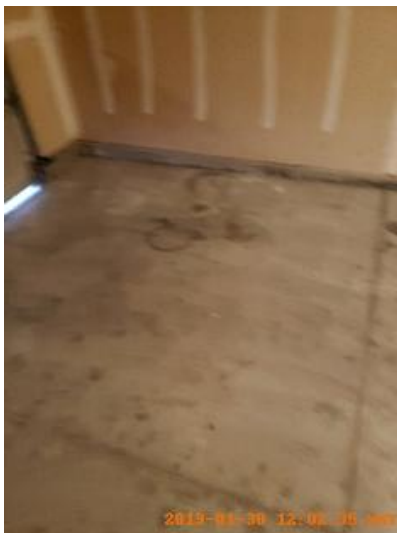
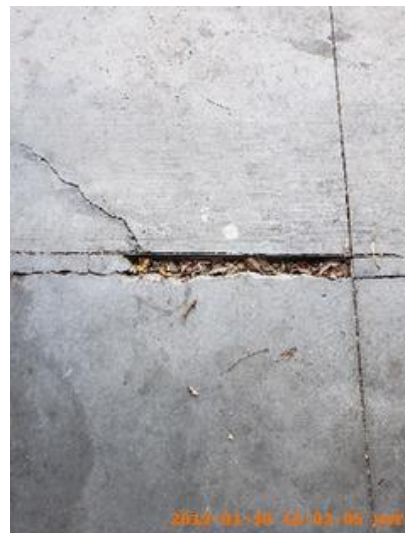
| Garage/Parking | CONDITION | ACTION | COMMENTS |
|---|---|---|---|
| Driveway/Floor | - - - D | None | near garage door chucks are missing in cement, rust and oil stains |

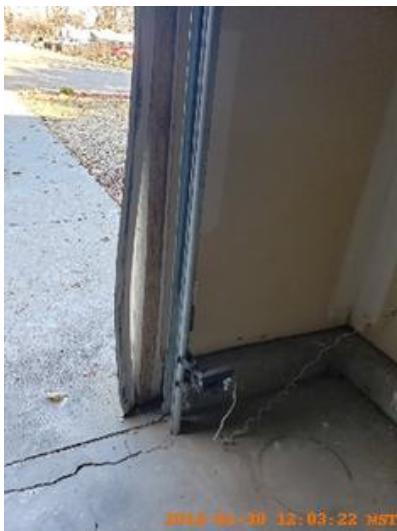
| Garage/Parking | CONDITION | ACTION | COMMENTS |
|---|---|---|---|
| Garage Door | - - - D | None | weather stripping is damaged |
